Home Pro Miami

Home Inspection Report

1175 Sample Dr

Inspected on Thu, Aug 29 2019 at 10:00 AM

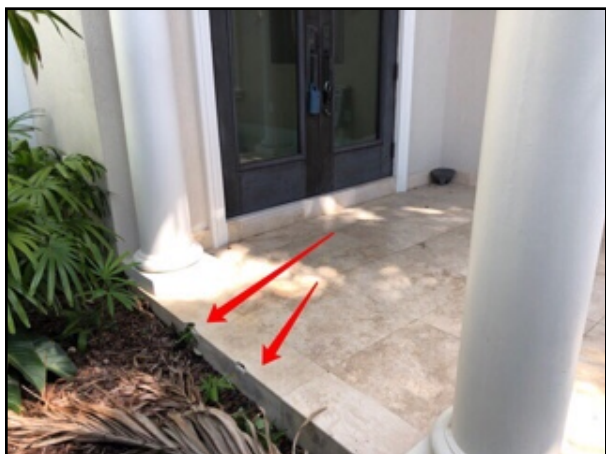
Figure 8-1

Broken exterior tile along front porch.

Replace broken exterior tiles along front porch. (Estimate: \$250 - \$500)

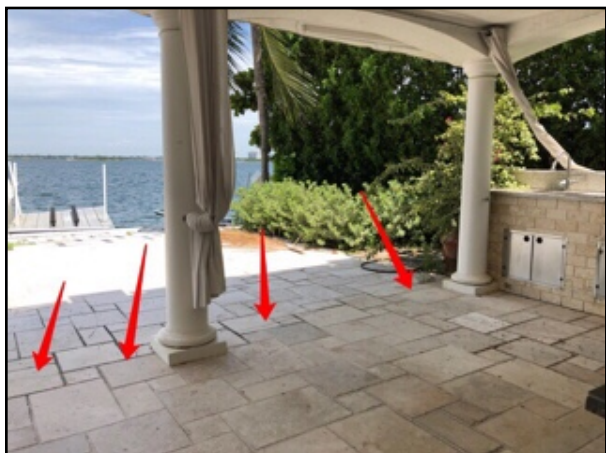
Figure 14-1

Apparent settlement cracking along exterior tiling/pavers in back of property. Replace cracked/broken tile/pavers to remove settlement cracking. (Estimate: \$1,000 - \$2,500)

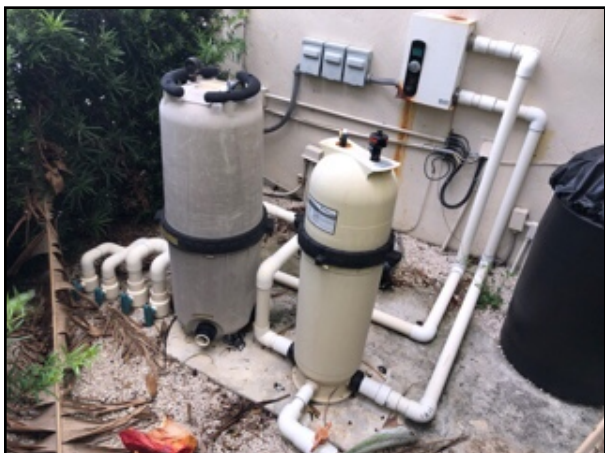
Figure 16-1

- Minor leaking apparent from connecting pipe fitting to pool pump & filtration equipment at the time of the inspection.

Recommend repair/replace damaged & leaking piping to pump & filtration equipment to prevent further leaking. (Estimate: \$100 - \$250)

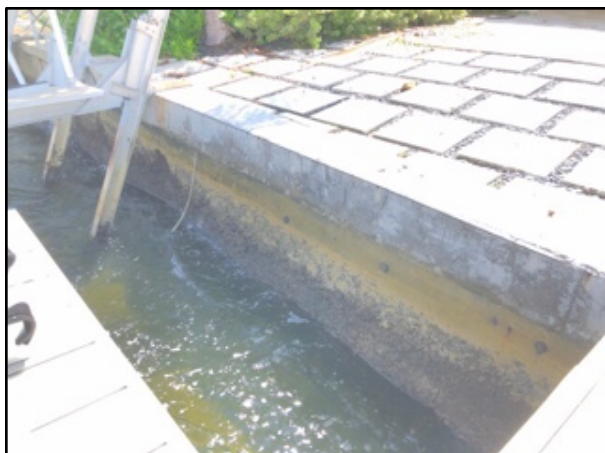
Figure 18-1

- Seawall appears to be in overall fair condition at time of inspection.
- Apparent structurally cracking & spalling along concrete seawall/bulkhead on south side of seawall.
- Spalling/deterioration appears to be exposing rebar reinforcement from within structure due to apparent oxidation/rusting around cracking.

Recommend having a structural engineer or seawall contractor further evaluate spalling, and advise for proper repairs. (Detailed quotation required)

As we can only check for visual deficiencies above water level, we recommend further evaluation of dock & seawall by a licensed structural engineer or seawall contractor for proper structural evaluation of seawall.

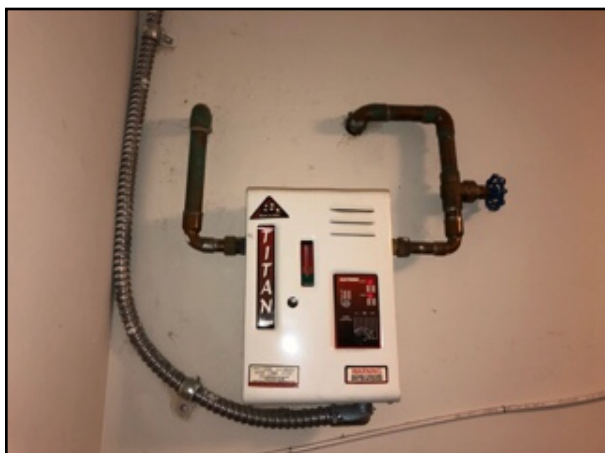
Figure 33-1

Hot water heater functioning properly at the time of inspection.

- Water heater currently 14 years old.
- Due to age of unit, water heater is nearing end of efficient life expectancy and may need to be replaced in near future. (Estimate: \$1,000 - \$1,500)

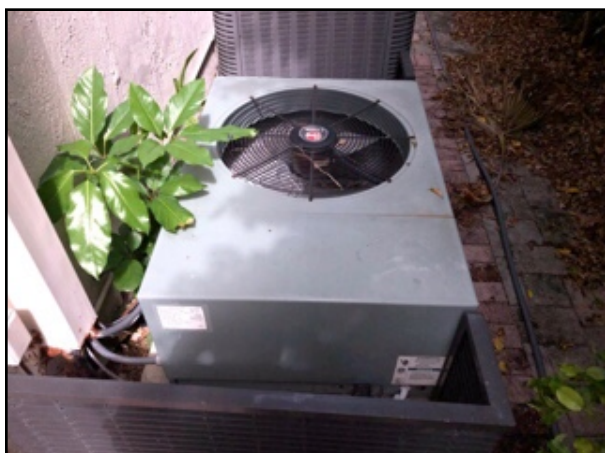
Figure 42-1

- HVAC currently 15 years old.
- HVAC system does not appear to be compressing or cooling refrigerant line properly at the time of the inspection. As HVAC system unit is nearing end off efficient life expectancy, estimate system may need to be replaced. (Estimate: \$2,000 - \$4,000)

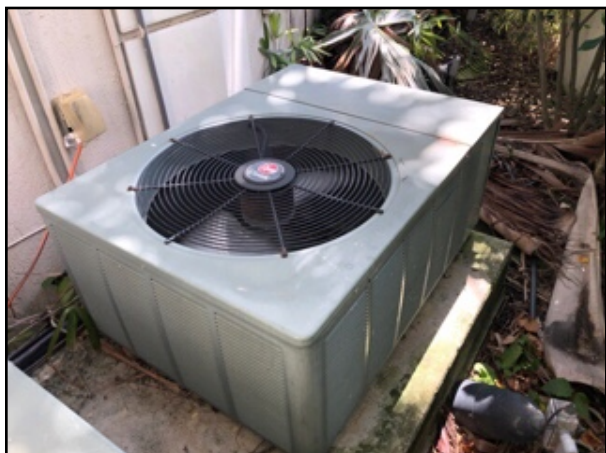
Figure 51-1

- HVAC currently 15 years old.
- HVAC system does not appear to be compressing or cooling refrigerant line properly at the time of the inspection. As HVAC system unit is nearing end of efficient life expectancy, estimate system may need to be replaced. (Estimate: \$2,000 - \$4,000)

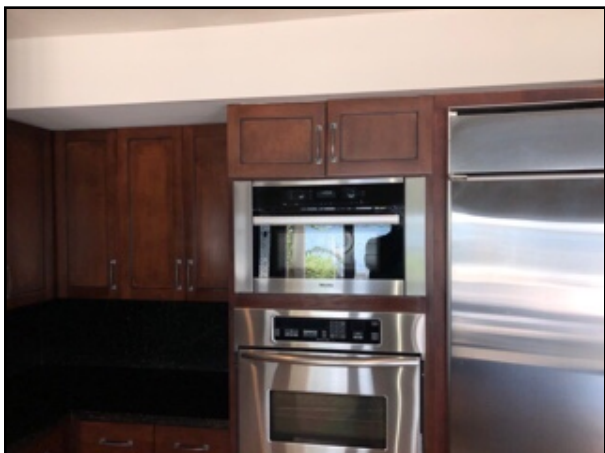
Figure 60-1

Comment 60:
Microwave functioning properly at the time of inspection.
- Control panel is currently broken/loose.
Recommend further evaluation by a licensed technician and repair/replace accordingly. (Estimate: \$100 - \$250)

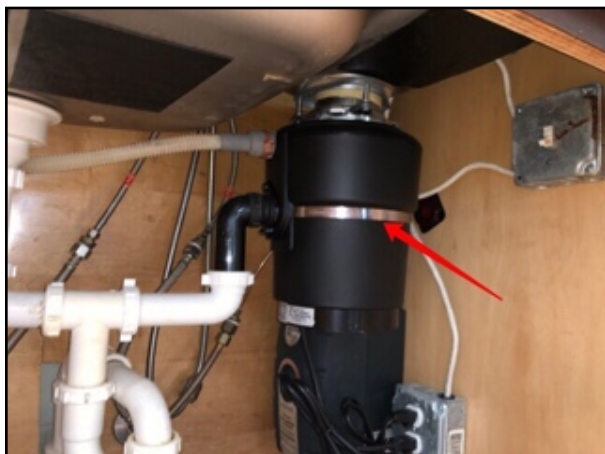
Figure 62-1

- Comment 62:
Garbage disposal not functioning at the time of inspection.
- Disposal appears to be functional but internal blade is stuck.
Repair or replace garbage disposal unit below sink. (Estimate: \$100 - \$350)

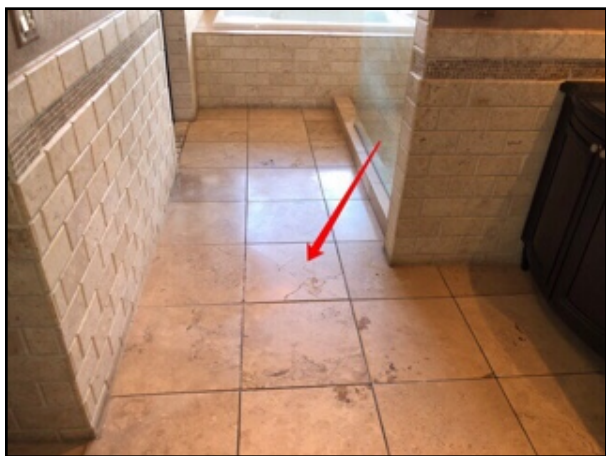
Figure 95-1

**Comment 95:**
Broken flooring tile within master bathroom.
Replace broken flooring tile. (Estimate: \$150 - \$300)

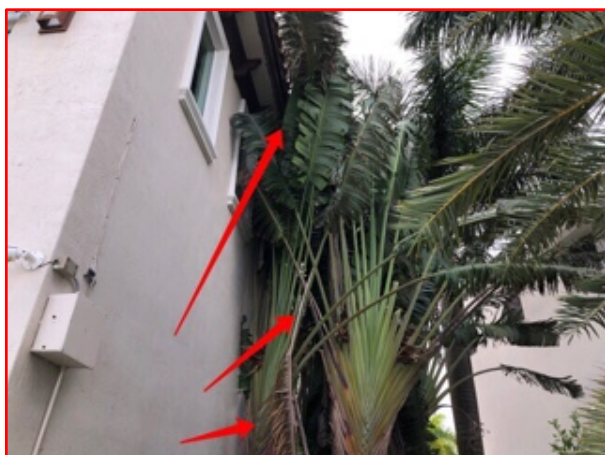
Figure 1-1

1) Comment 1: Vegetation/trees growing along siding & roof.
Recommend cutting back vegetation/trees from side of home and roof to prevent damage to home siding & roof coverings. (Estimate: \$500 - \$1,000)

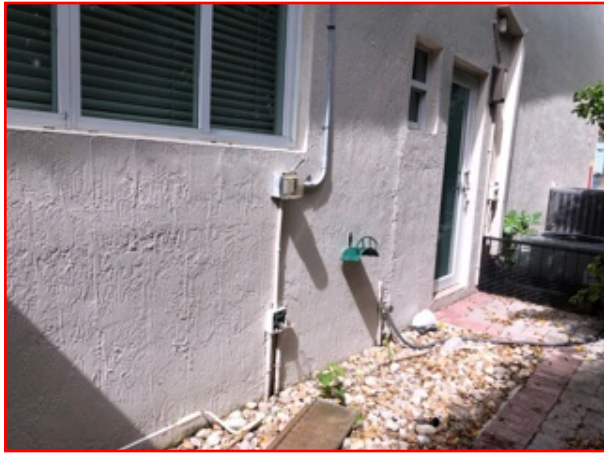
Figure 10-1

8) Comment 10: Electrical junction box left open within exterior wall on north side of property exposing live wiring. Recommend enclosing electrical junction box within exterior wall to properly conceal live wiring. (Estimate: \$50 - \$100)

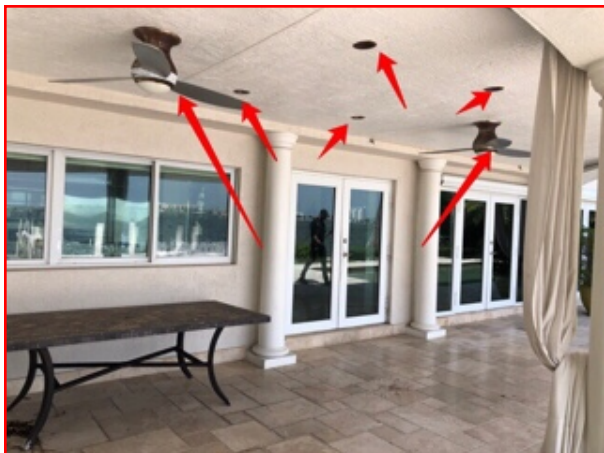
Figure 12-1

10) Comment 12: Heavily oxidized/rusted exterior lighting & fan fixtures over rear patio. Recommend replacing fixtures with proper outdoor fixtures to prevent excessive oxidation/rusting. (Estimate: \$500 - \$1,500)

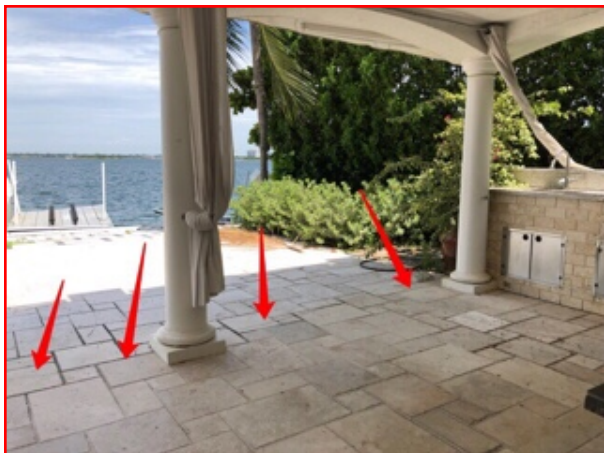
Figure 14-1

11) Comment 14: Apparent settlement cracking along exterior tiling/pavers in back of property.
Replace cracked/broken tile/pavers to remove settlement cracking. (Estimate: \$1,000 - \$2,500)

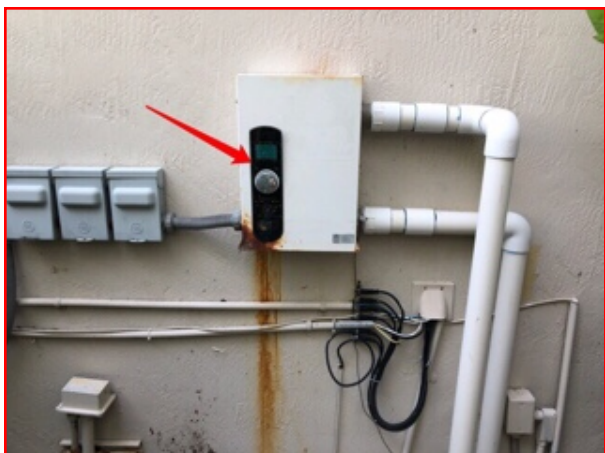
Figure 17-1

14) Comment 17: Pool heater appears in poor condition, and does not appear to be functioning properly at time of inspection. Recommend further evaluating by a licensed professional and repair or replace accordingly. (Estimate: \$2,000 - \$3,500)

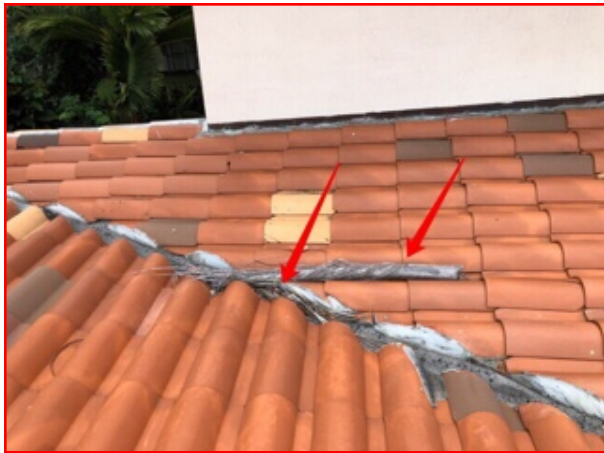
Figure 25-1

21) Comment 25: Heavy debris from surrounding vegetation collecting along roof. Recommend removing debris from roof to prevent damage to roof coverings. (Estimate: \$200 - \$400)

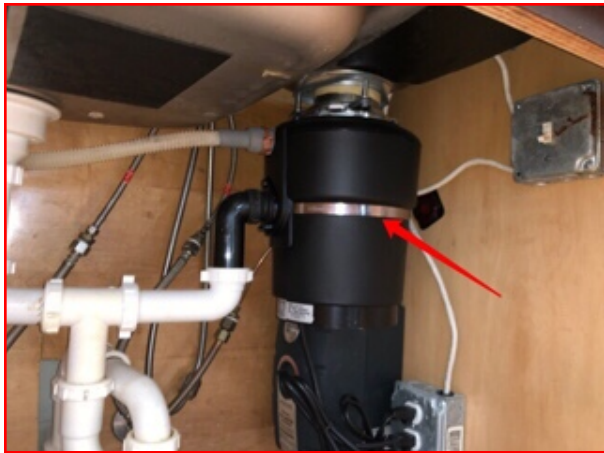
Figure 62-1

40) Comment 62: Garbage disposal not functioning at the time of inspection.
- Disposal appears to be functional but internal blade is stuck.
Repair or replace garbage disposal unit below sink. (Estimate: \$100 - \$350)

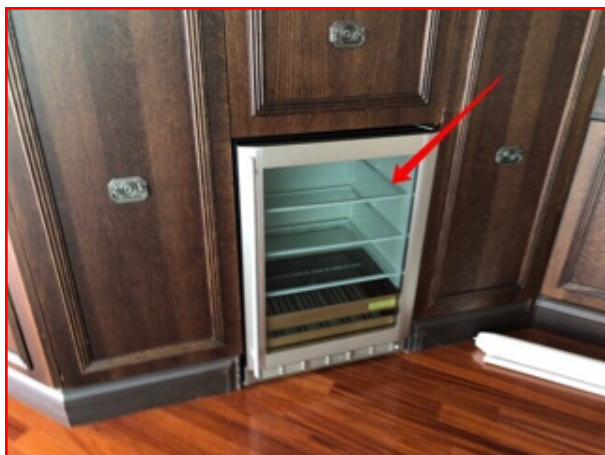
Figure 75-1

44) Comment 75: Built-in mini wine refrigerator within upstairs master bedroom not functioning properly at the time of inspection.

Repair or replace mini wine refrigerator. (Estimate: \$400 - \$800)

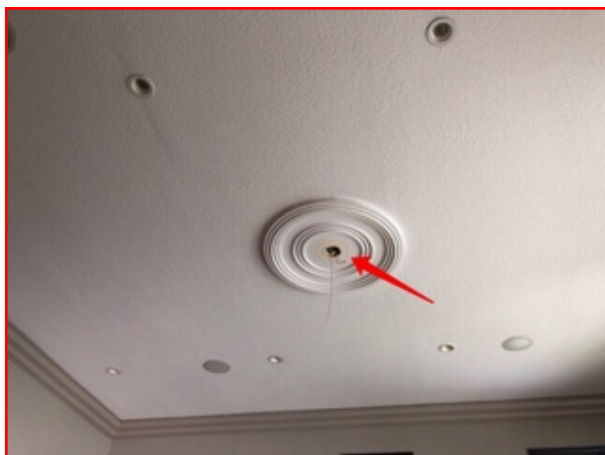
Figure 77-1

46) Comment 77: Missing overhead lighting fixture in upstairs master bedroom leaving exposed wiring.

Replace missing lighting fixture. (Detailed quotation required)

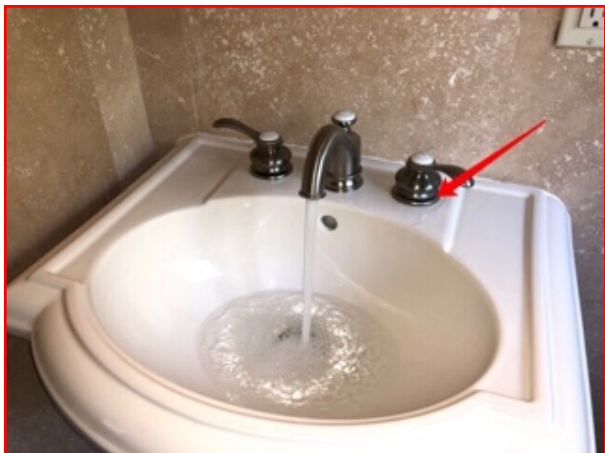
Figure 91-1

55) Comment 91: Sink fixture cold water valve handle leaking above sink.
Repair/replace cold water valve handle to sink faucet fixture. (Estimate: \$100 - \$200)

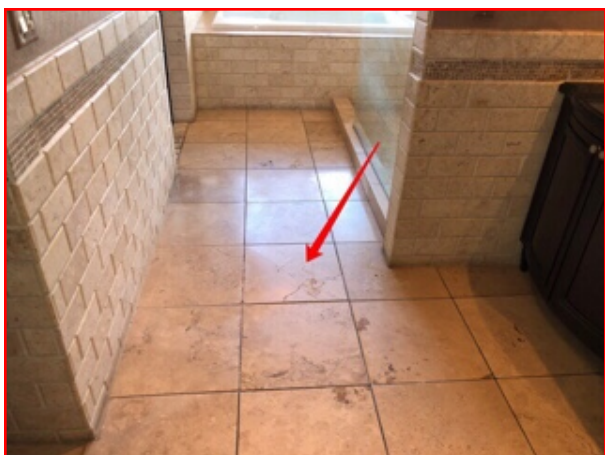
Figure 95-1

58) Comment 95: Broken flooring tile within master bathroom.
Replace broken flooring tile. (Estimate: \$150 - \$300)
