## Home Inspection Report

**60 Sample Dr**

**Unit 1234**

Inspected on Tue, Feb 7 2017 at 1:00 PM

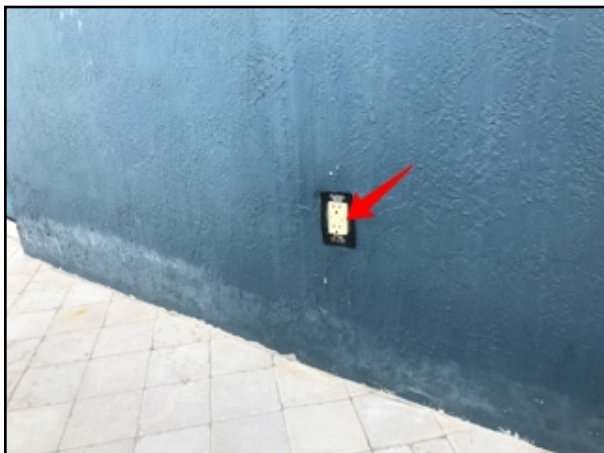
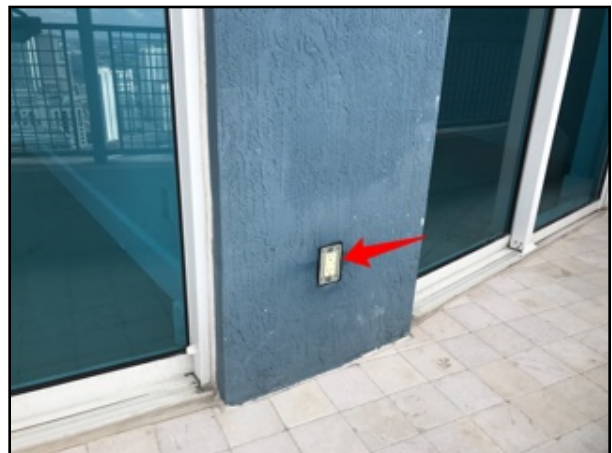
The exterior outlets are missing a weather proof cover along lower and upper balconies.

- Outlet on lower balcony functioning properly at the time of inspection.
- Outlet on upper balcony not functioning.

Replace exterior GFCI outlet along upper balcony and weather proof exterior covers over exterior outlets. (Estimate: \$100 - \$250)

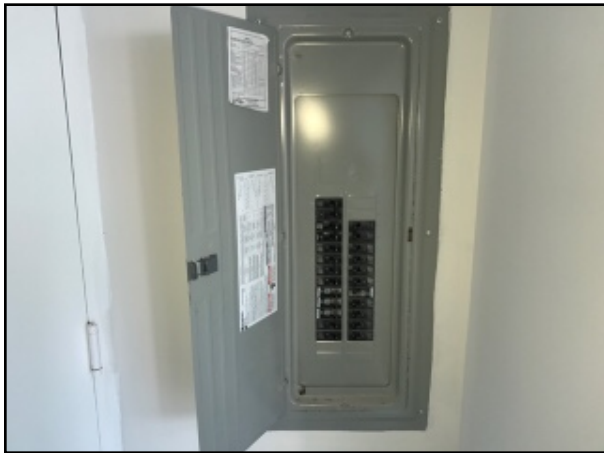
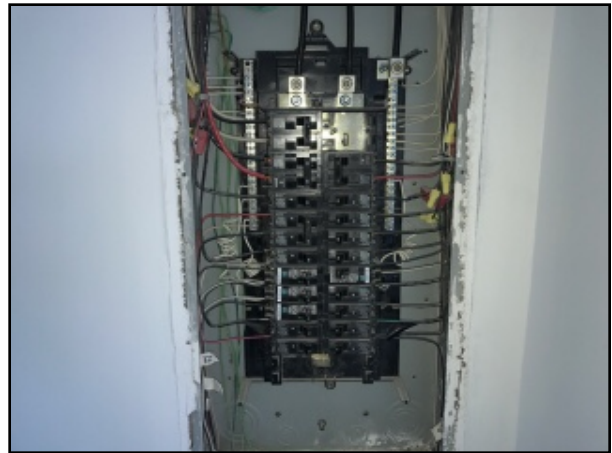
Main distribution panel (125 AMPs) located next to front door entrance.

- Distribution panel, circuit breakers, and branch wiring appear in good & working condition at the time of inspection.

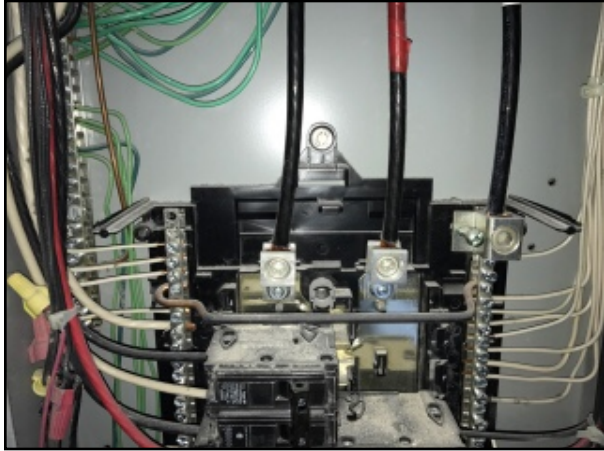
Figure 7-1

Electrical service entrance conductors are in good & working condition within main distribution panel.

- Electrical service is properly grounded in main distribution panel.

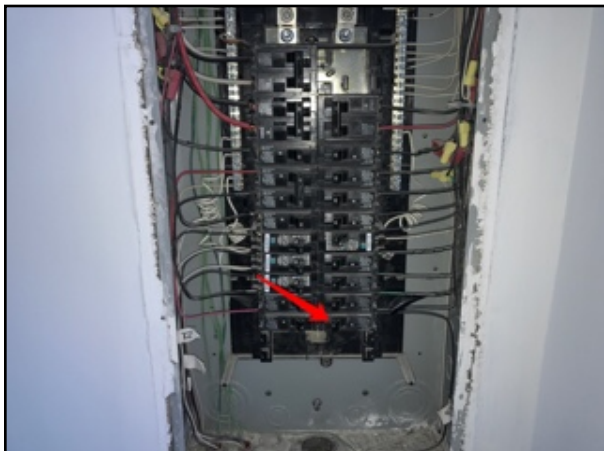
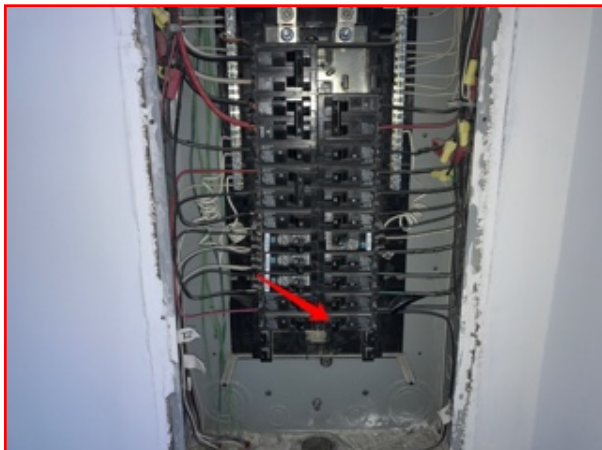
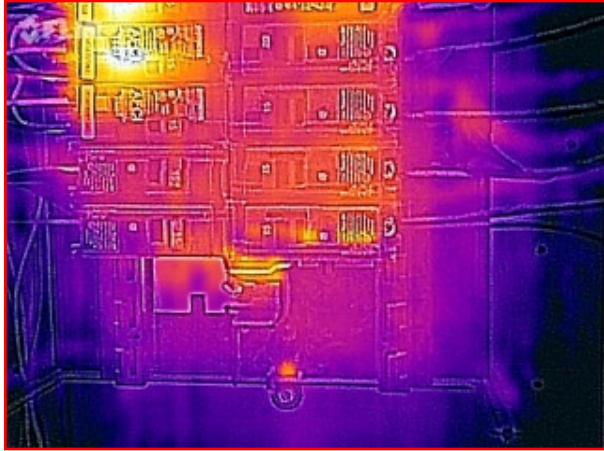
- Double-tapped 15 AMP breaker present with multiple circuits connected to a single circuit breaker within main distribution panel. (Breaker does not appear to be over heating or over loaded at the time of inspection.)

Recommend having a licensed electrician install additional circuit breakers and connecting multiple double-tapped circuits to their own individual circuit breaker within main distribution panel. (Estimate \$150 - \$300)

Recommend having a licensed electrician install additional circuit breakers and connecting m double-tapped circuits to their own individual circuit breaker within main distribution panel. (Estimate \$150 - \$300)

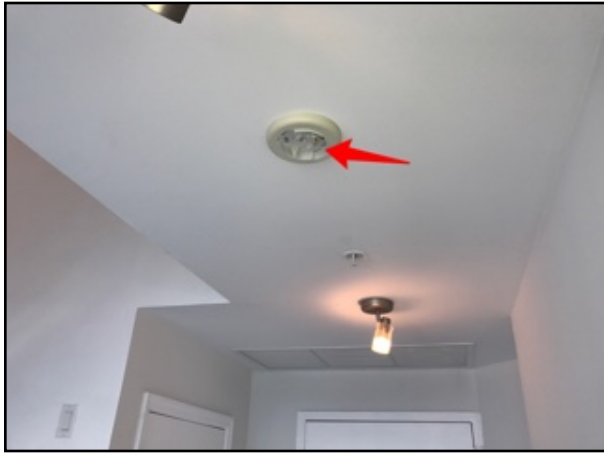
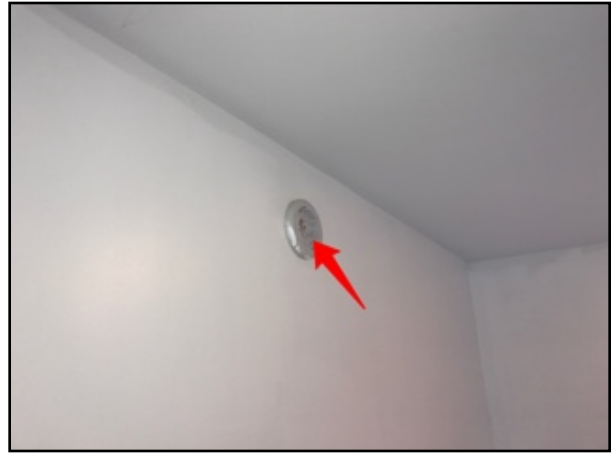
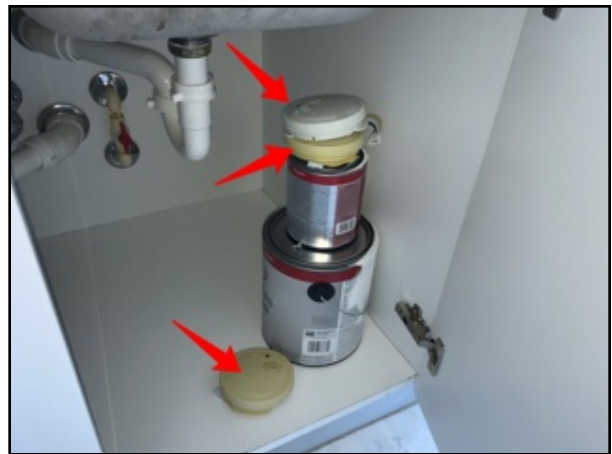
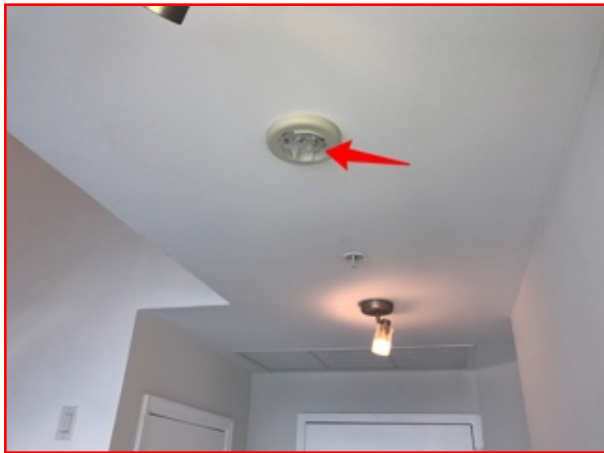
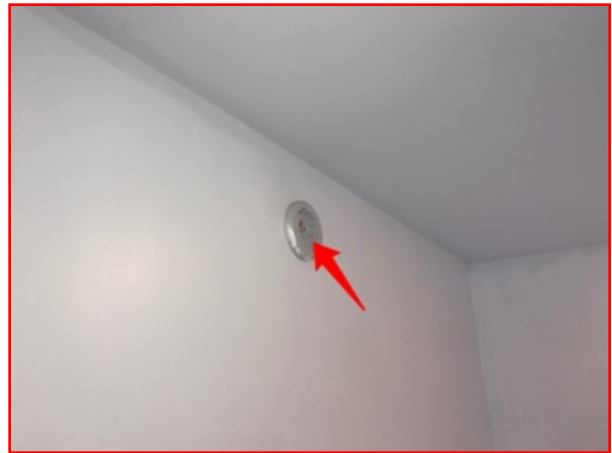
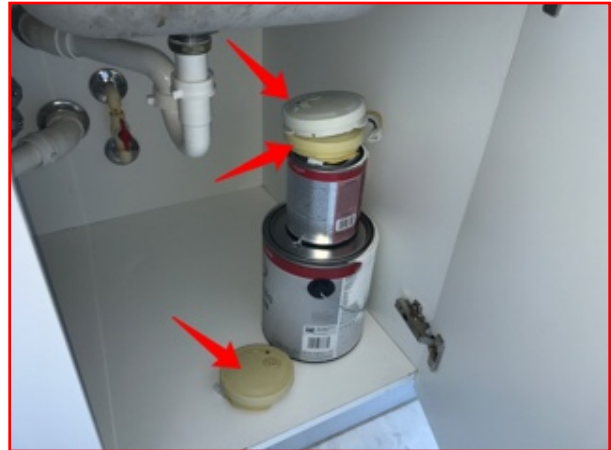
**Comment 9:**  
Hard wired smoke detectors removed from throughout unit.  
- Removed smoke detectors currently being stored under kitchen sink.  
Re-connect smoke detectors and replace 9V batteries if needed.

3) Comment 9: Hard wired smoke detectors removed from throughout unit.  
- Removed smoke detectors currently being stored under kitchen sink.  
Re-connect smoke detectors and replace 9V batteries if needed.

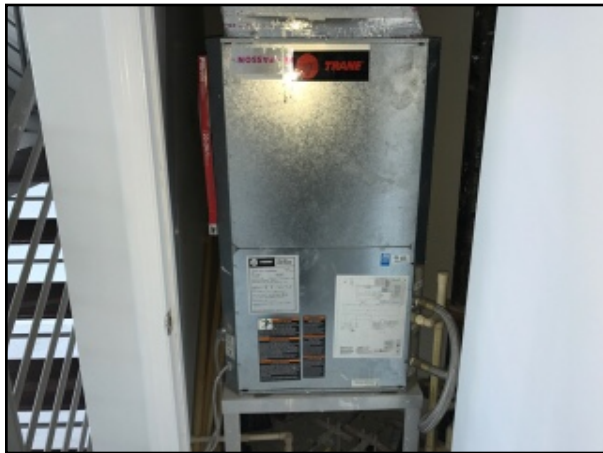
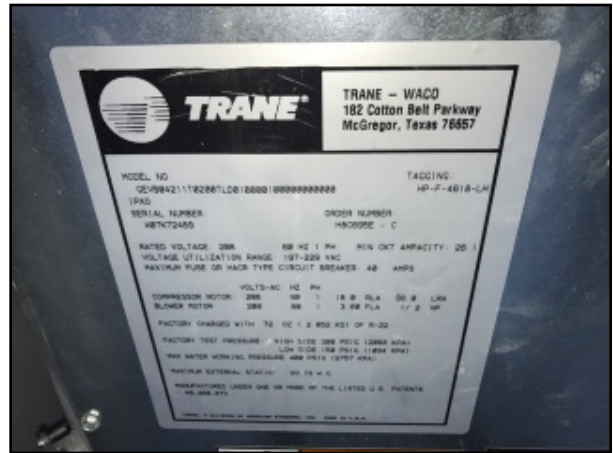
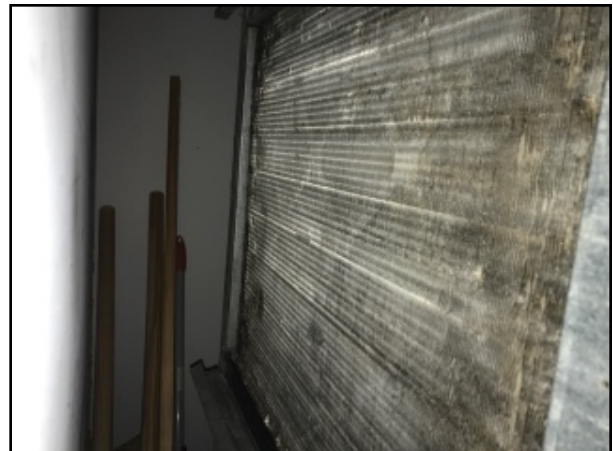
- HVAC system in good & working condition at the time of inspection.
- A/C radiator & coils appear in good condition at the time of inspection.
- Minor debris build up along exterior of radiator.

Recommend having HVAC system serviced/cleaned periodically by a licensed HVAC technician for better maintenance.wsdldsdssee

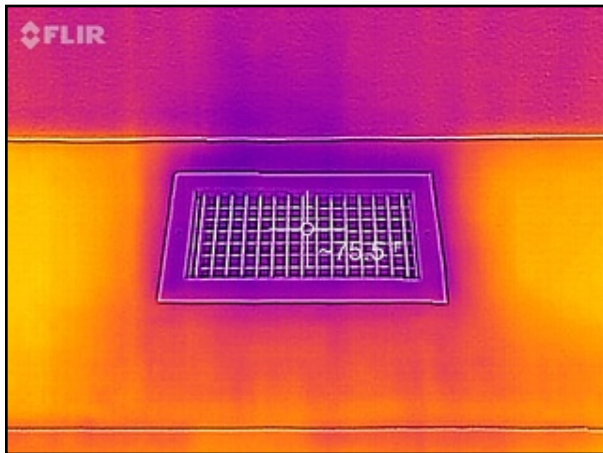
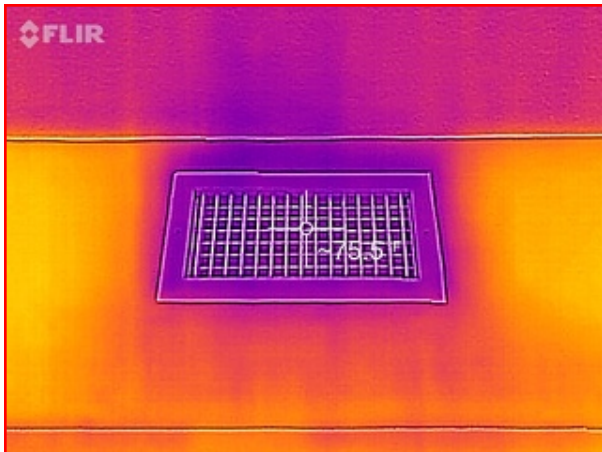
4) Comment 11: HVAC system not heating at the time of inspection. Recommend having a licensed HVAC technician repair/replace heating element within unit. (Estimate: \$150 - \$300)

Recommend having a licensed HVAC technician repair/replace heating element within unit. (Estimate: \$150 - \$300)

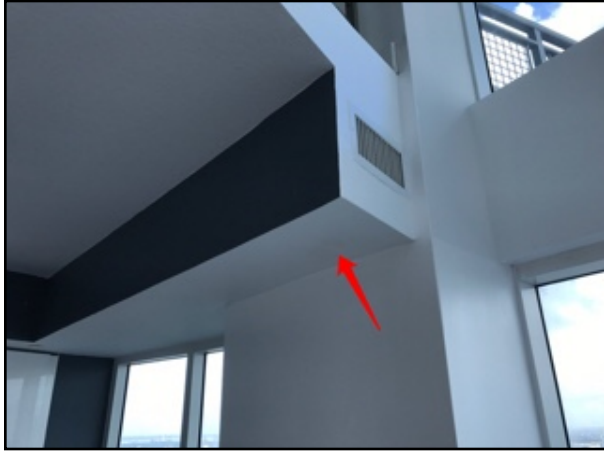
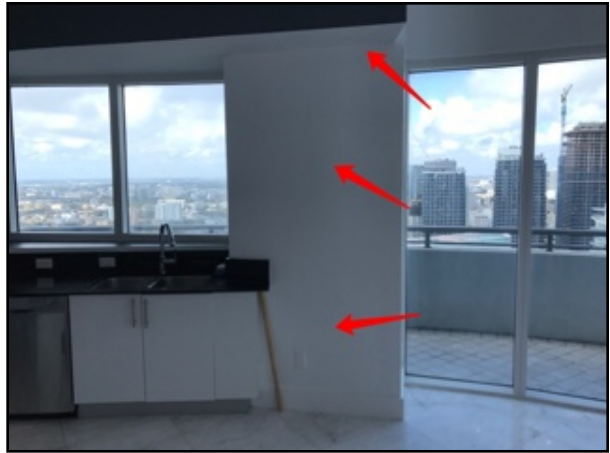
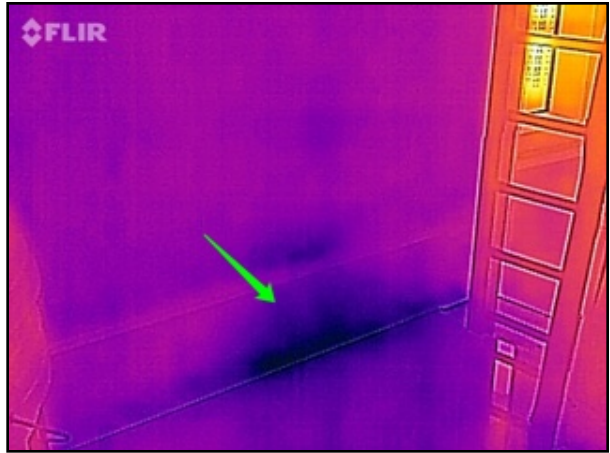
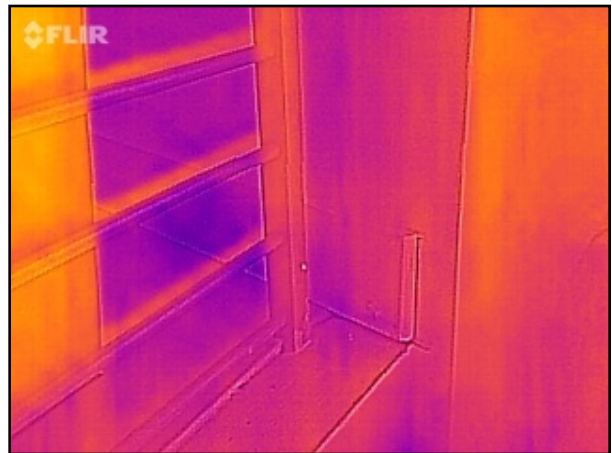
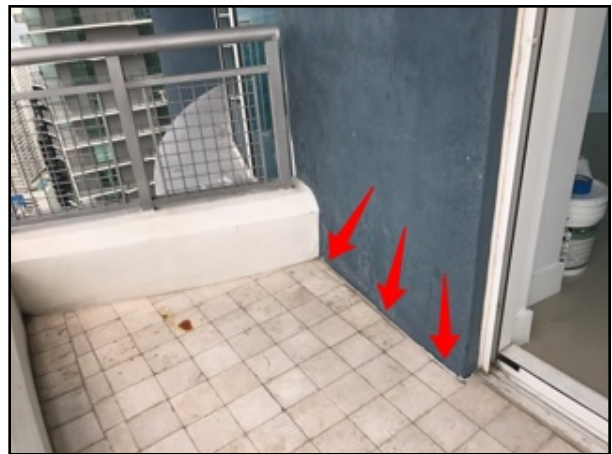
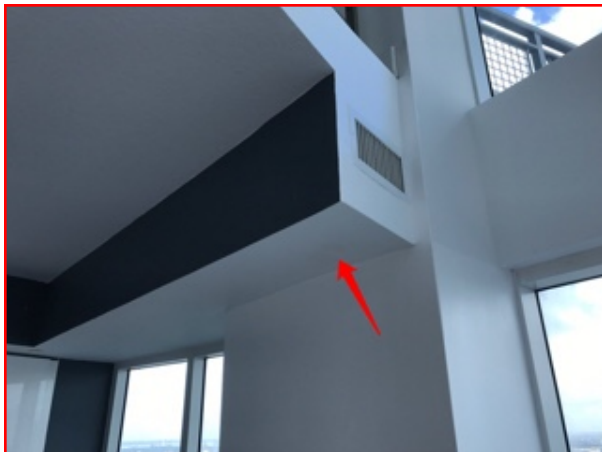
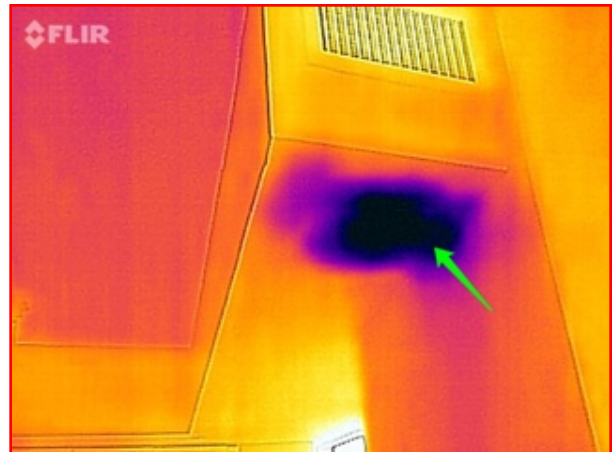
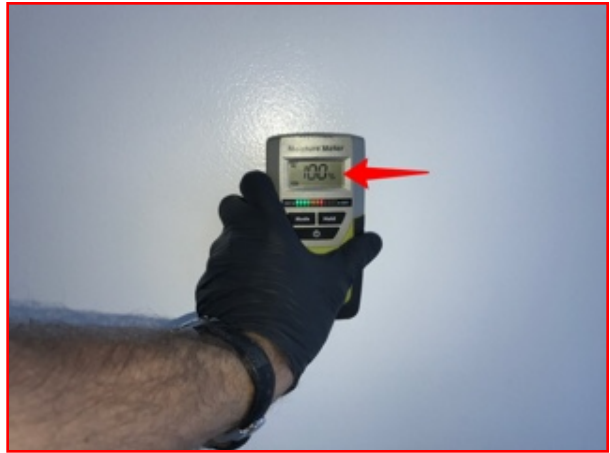
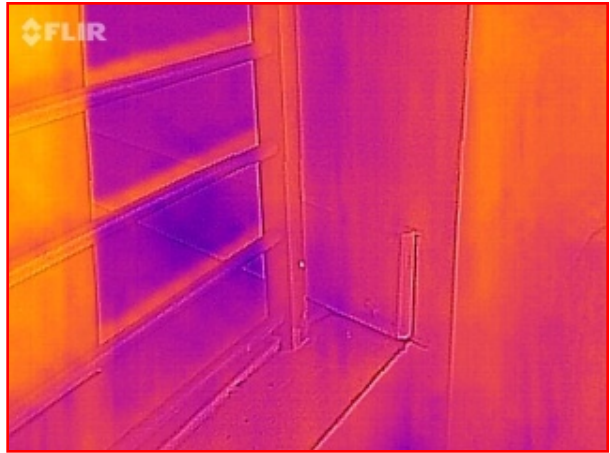
Apparent water staining to soffit around A/C duct over kitchen.

- When checking area using thermal imaging equipment & moisture meters, moisture intrusion/water damage detected along surrounding kitchen wall and base of wall in upstairs bedroom directly above kitchen.
- Indications of current moisture intrusion & water damage to the interior at the time of inspection (base of upstairs bedroom wall adjacent to balcony and downstairs kitchen wall and soffit around A/C duct).
- Estimate moisture intrusion source to be coming from balcony joint for upstairs second bedroom where balcony Slab meets exterior wall.
- Exterior of building to be covered/maintained by building association. Report moisture intrusion/ water damage to building to be further investigated by building engineer and repaired accordingly. (Estimate: Detailed quotation required)

5) Comment 13: Apparent water staining to soffit around A/C duct over kitchen.

- When checking area using thermal imaging equipment & moisture meters, moisture intrusion/water damage detected along surrounding kitchen wall and base of wall in upstairs bedroom directly above kitchen.

- Indications of current moisture intrusion & water damage to the interior at the time of inspection (base of upstairs bedroom wall adjacent to balcony and downstairs kitchen wall and soffit around A/C duct).

- Estimate moisture intrusion source to be coming from balcony joint for upstairs second bedroom where balcony Slab meets exterior wall.

- Exterior of building to be covered/maintained by building association.

Report moisture intrusion/ water damage to building to be further investigated by building engineer and repaired accordingly. (Estimate: Detailed quotation required)

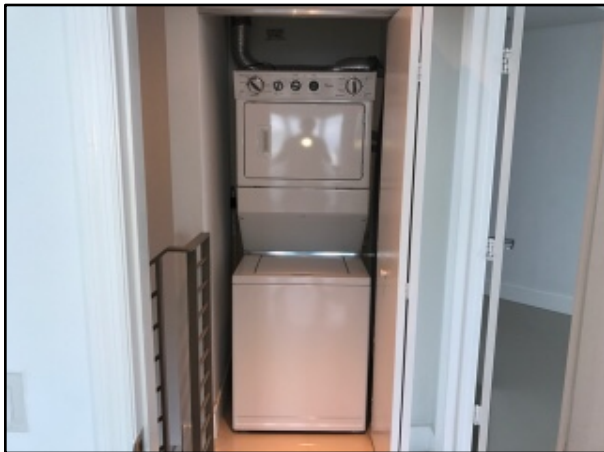
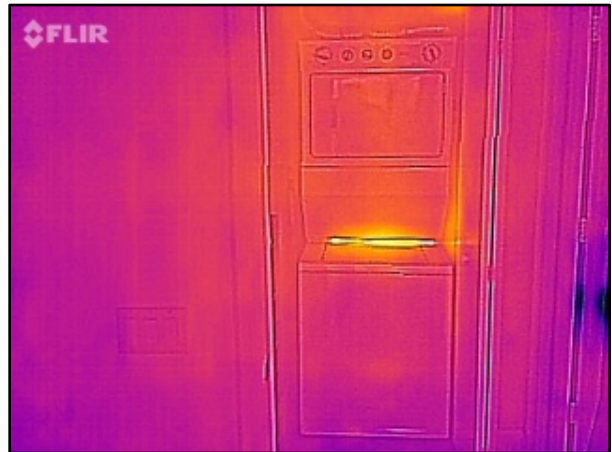
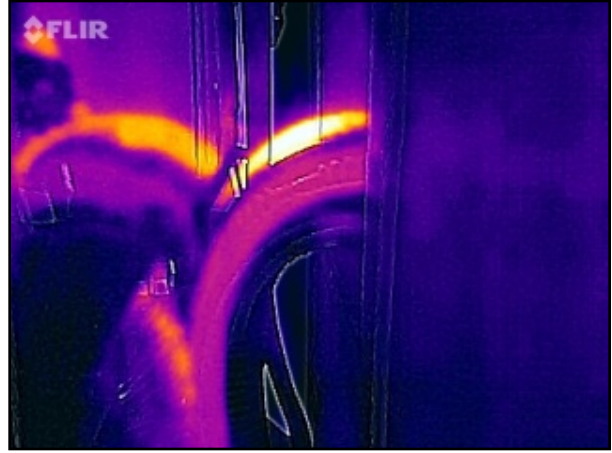
**Comment 16:**  
Laundry closet located within upstairs hallway closet.  
- No indications of water damage or leaking at the time of inspection.

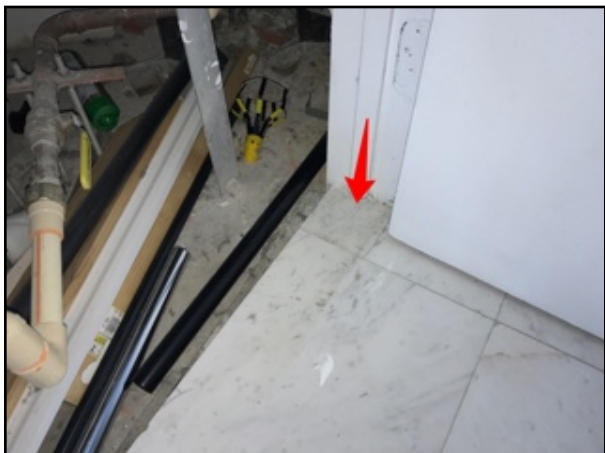
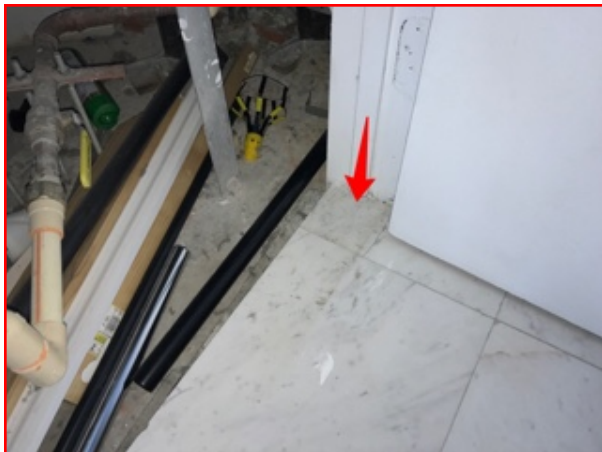
Comment 21:  
Cracked/broken flooring tile next to front entrance hallway along doorway to A/C closet.  
Repair/replace broken flooring tile in doorway. (Estimate: \$100 - \$250)

6) Comment 21: Cracked/broken flooring tile next to front entrance hallway along doorway to A/C closet.

Repair/replace broken flooring tile in doorway. (Estimate: \$100 - \$250)

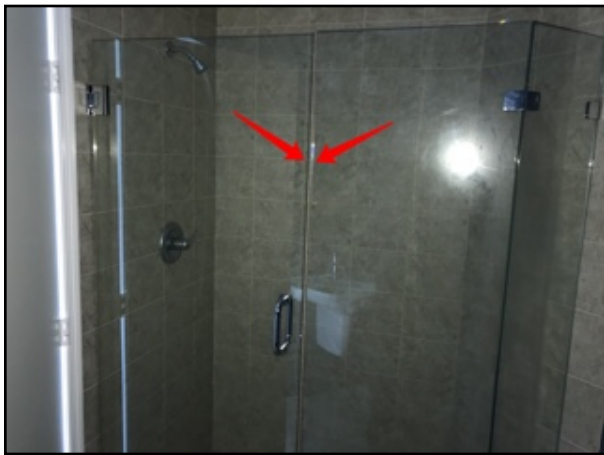
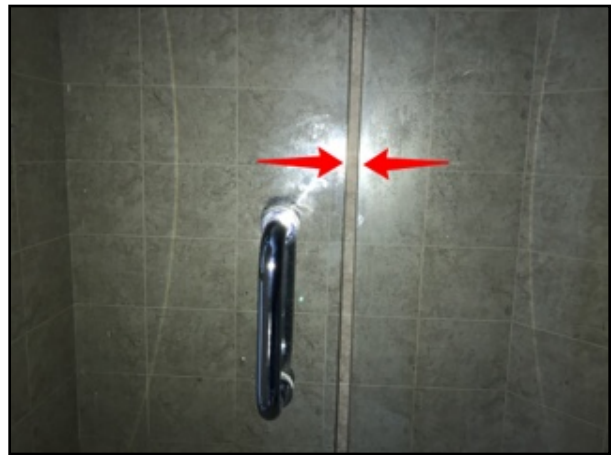
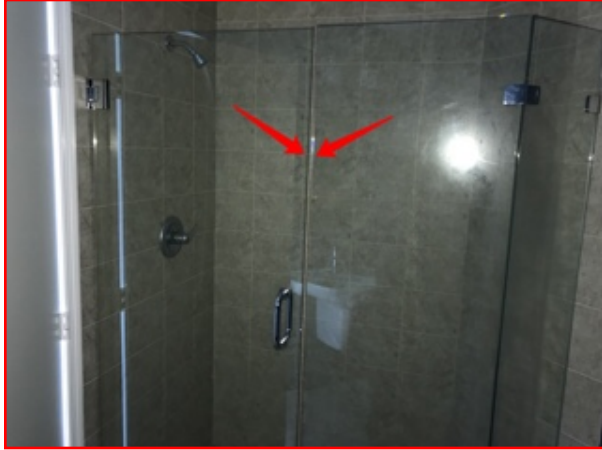
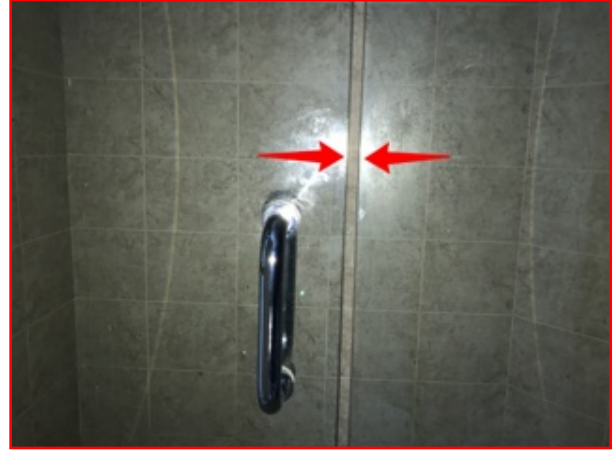
Frameless glass shower door/enclosure leaving large gap in doorway when closed. Recommend adding seal along side of glass door or wall to better seal-off shower while in use to prevent leaking out of shower. (Estimate: \$50 - \$100)

7) Comment 23: Frameless glass shower door/enclosure leaving large gap in doorway when closed.

Recommend adding seal along side of glass door or wall to better seal-off shower while in use to prevent leaking out of shower. (Estimate: \$50 - \$100)

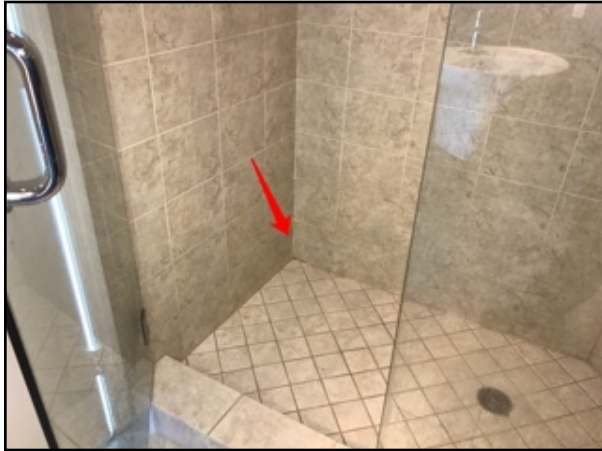
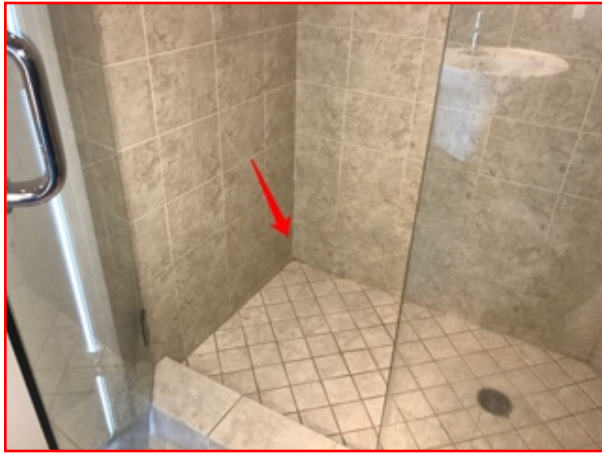
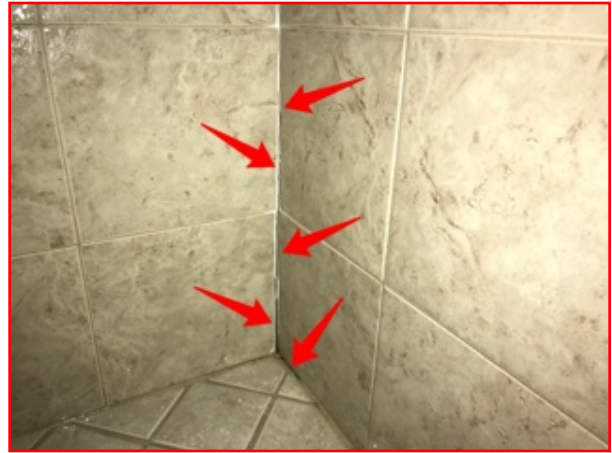
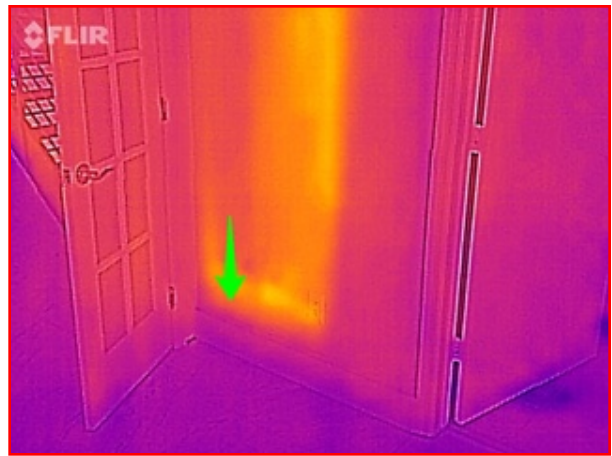
Shower walls have missing or loose grout.

- No indications of moisture intrusion or water damage to interior walls around shower.

8) Comment 24: Shower walls have missing or loose grout.

Recommend re-grouting/caulking shower tiles to prevent possible moisture intrusion into wall. (Estimate: \$100 - \$200)

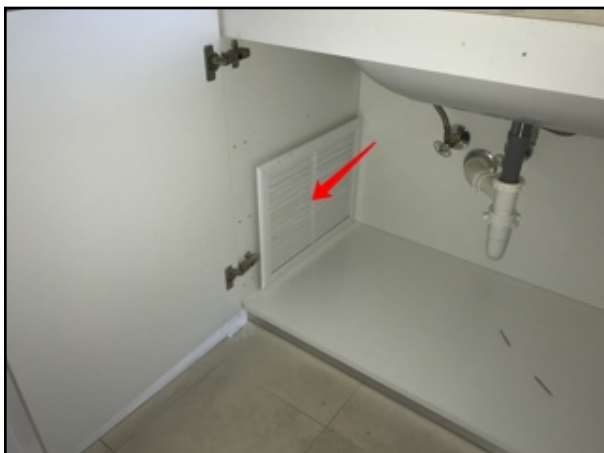
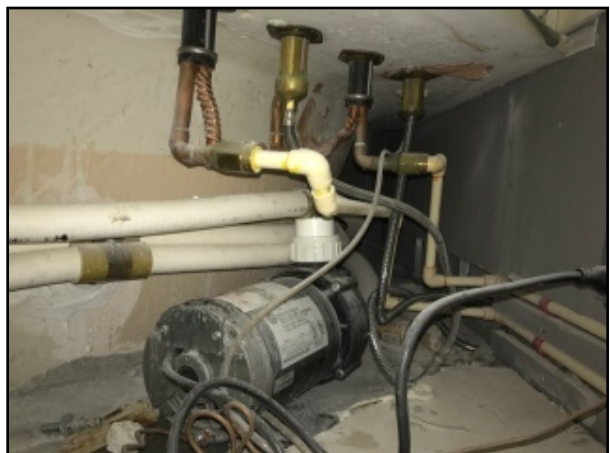
Jacuzzi tub access panel located within mast bathroom vanity below sink.

- Jacuzzi motor functioning properly at the time of inspection.
- No indications of leaking from jacuzzi pump system below tub fixture at the time of inspection.

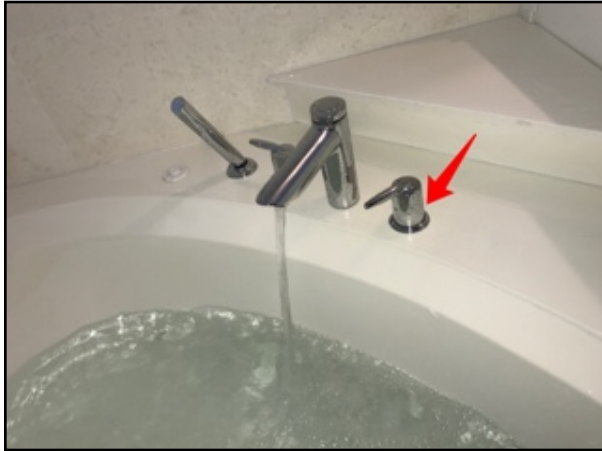
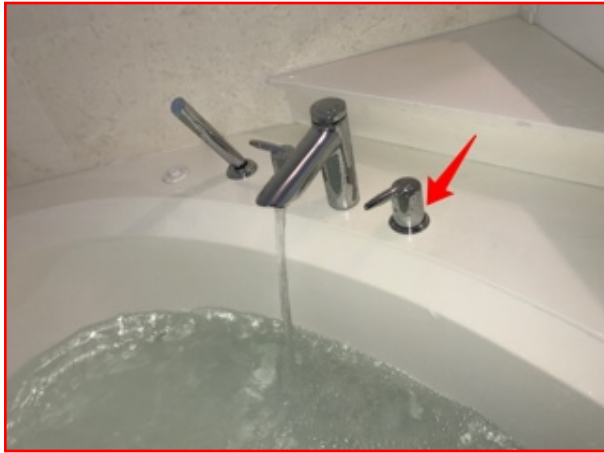
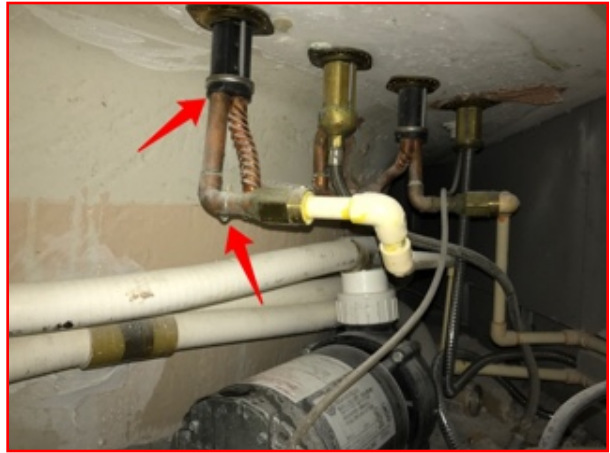
Indications of minor leaking from hot water valve handle to jacuzzi tub fixture.

- Valve handle working properly, but minor leaking detected from below fixture connection to plumbing accessible from jacuzzi motor access panel within bathroom vanity.

9) Comment 28: Indications of minor leaking from hot water valve handle to jacuzzi tub fixture.

Repair/replace hot water valve handle to tub faucet fixture. (Estimate: \$100 - \$250)

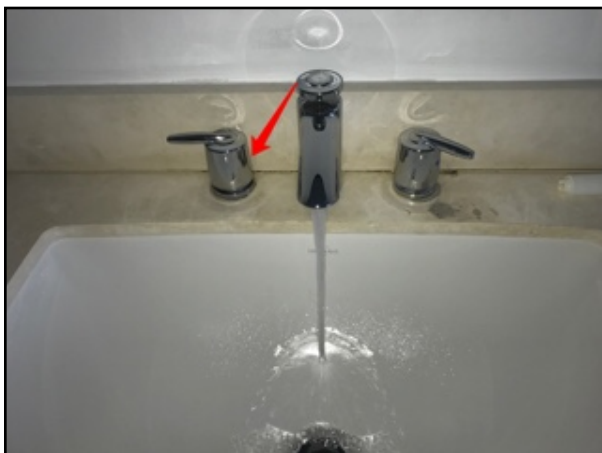
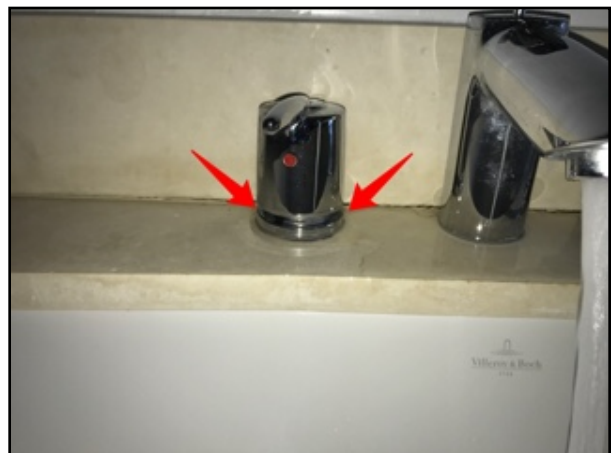
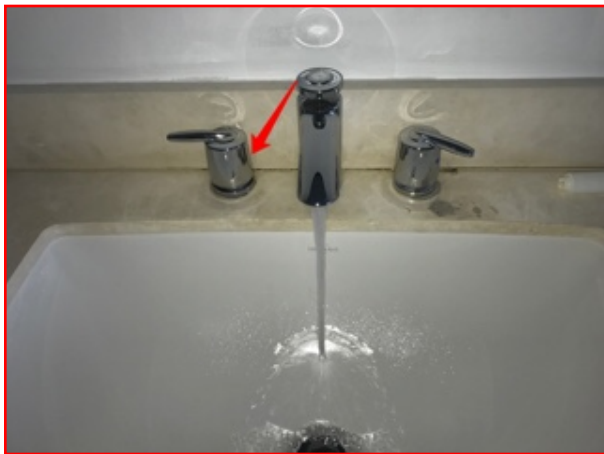
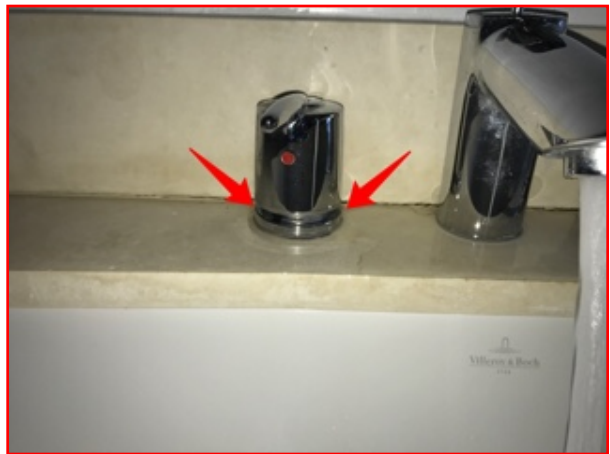
Sink fixture hot water valve handle leaking above vanity countertop.

10) Comment 29: Sink fixture hot water valve handle leaking above vanity countertop.

Repair/replace hot water valve handle to sink faucet fixture. (Estimate: \$100 - \$200)

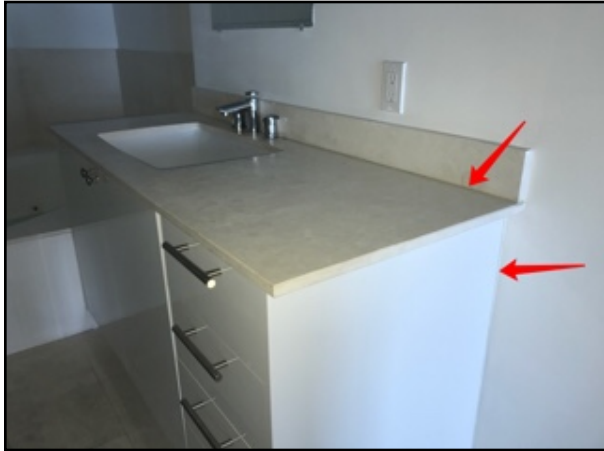
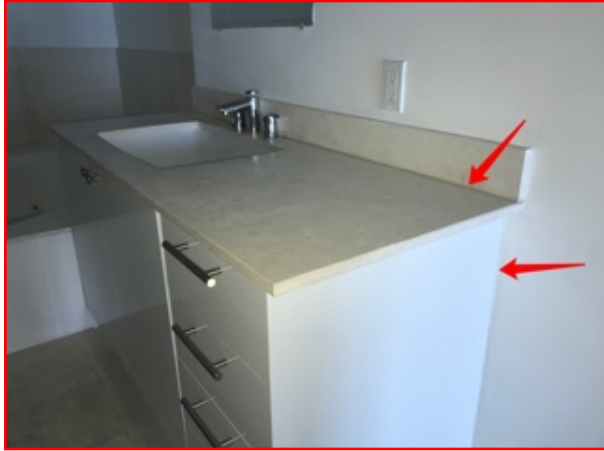
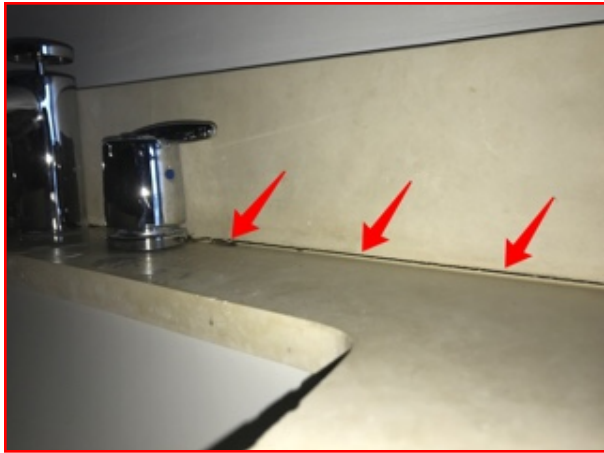
Vanity & countertop are loose and grouting/seal along back wall is deteriorated. Recommend re/sealing vanity countertop in place. (Estimate: \$50 - \$150)

11) Comment 30: Vanity & countertop are loose and grouting/seal along back wall is deteriorated.

Recommend re/sealing vanity countertop in place. (Estimate: \$50 - \$150)

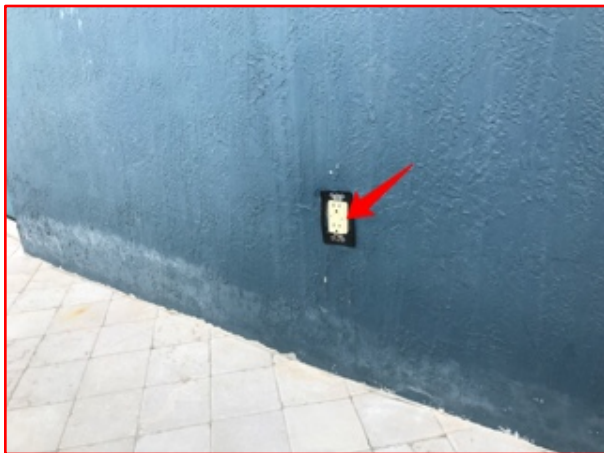
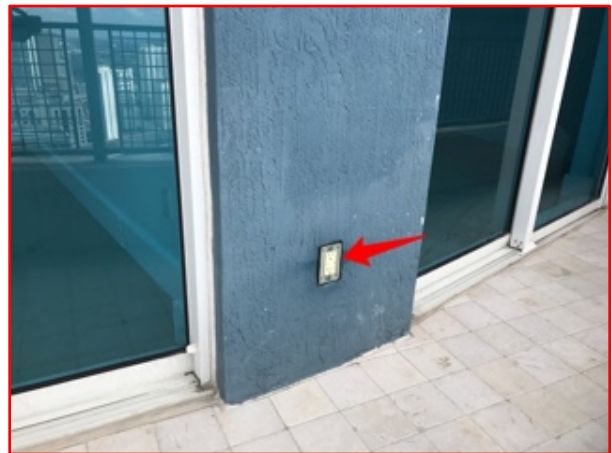
1) Comment 3: The exterior outlets are missing a weather proof cover along lower and upper balconies.

- Outlet on lower balcony functioning properly at the time of inspection.
- Outlet on upper balcony not functioning.

Replace exterior GFCI outlet along upper balcony and weather proof exterior covers over exterior outlets. (Estimate: \$100 - \$250)
