Home Pro Miami

Home Inspection Report

1175 Sample Dr

Inspected on Thu, Aug 29 2019 at 10:00 AM

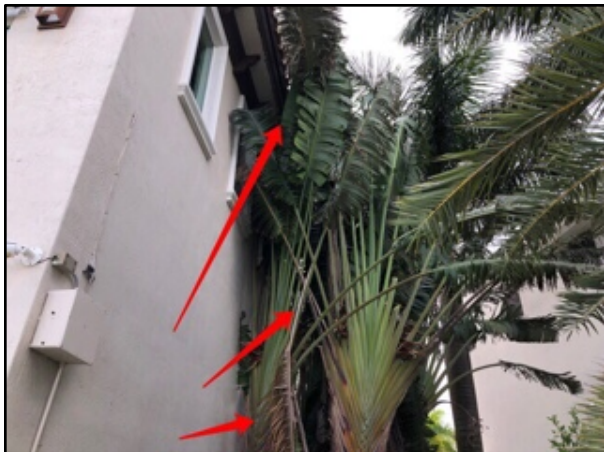
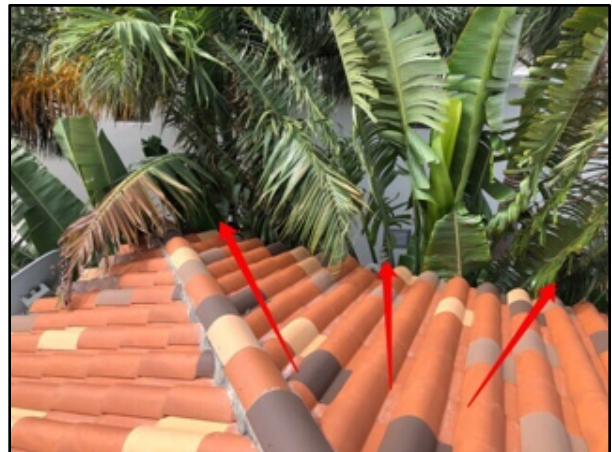
Vegetation/trees growing along siding & roof.

Recommend cutting back vegetation/trees from side of home and roof to prevent damage to home siding & roof coverings. (Estimate: \$500 - \$1,000)

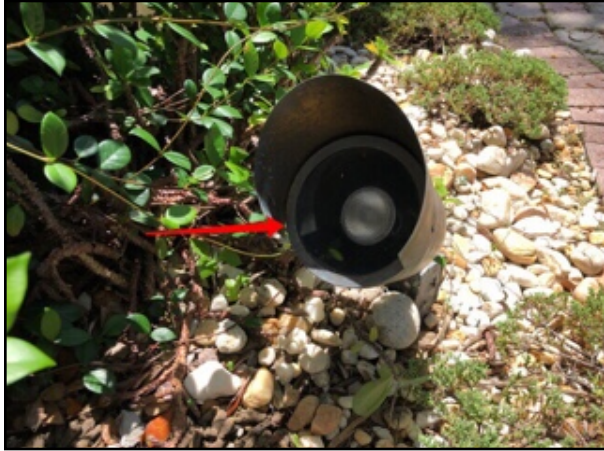
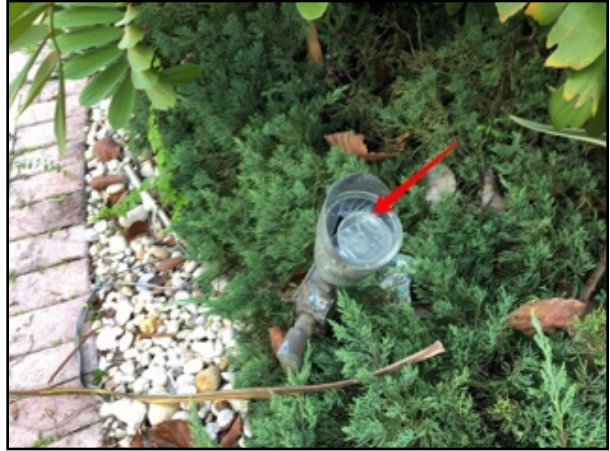
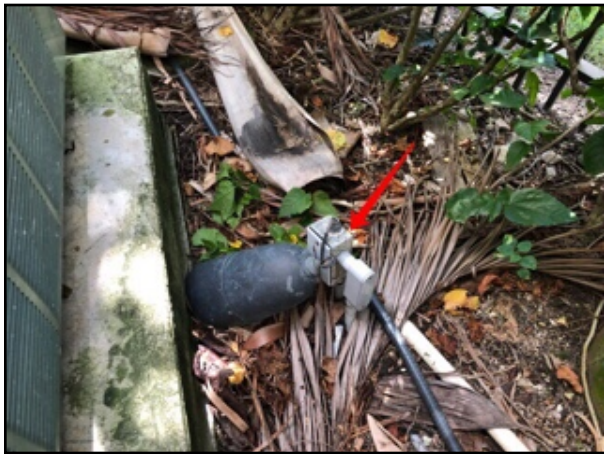
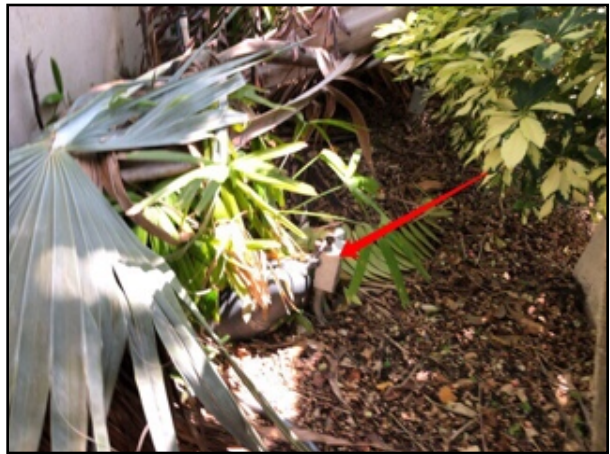
Landscaping lighting around exterior of property currently appears in poor condition, and does not appear to be functional.

- Multiple damaged & broken exterior landscape lighting at the time of inspection. Recommend further evaluation by a licensed contractor and repair/replace landscape lighting accordingly. (Estimate: \$500 - \$1,000)

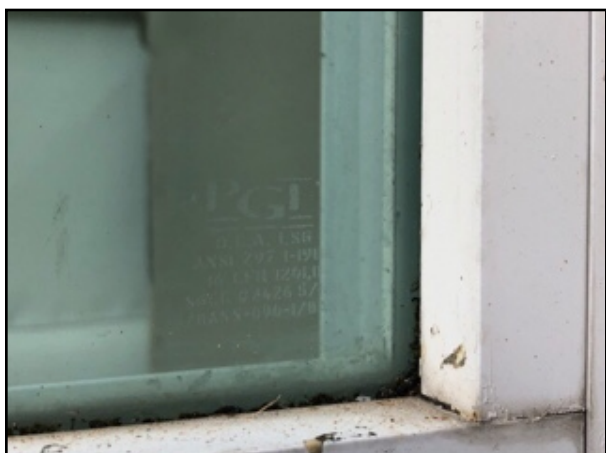
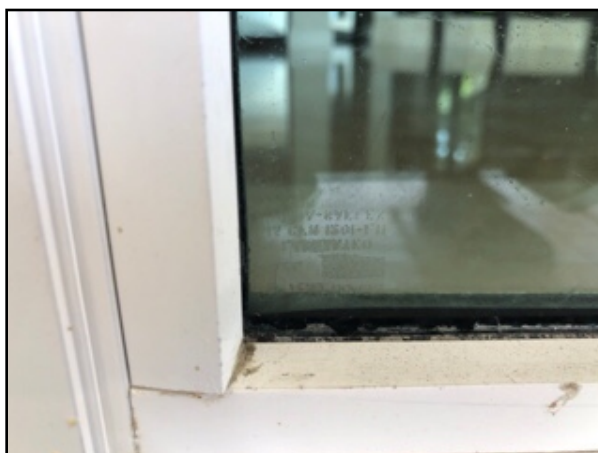
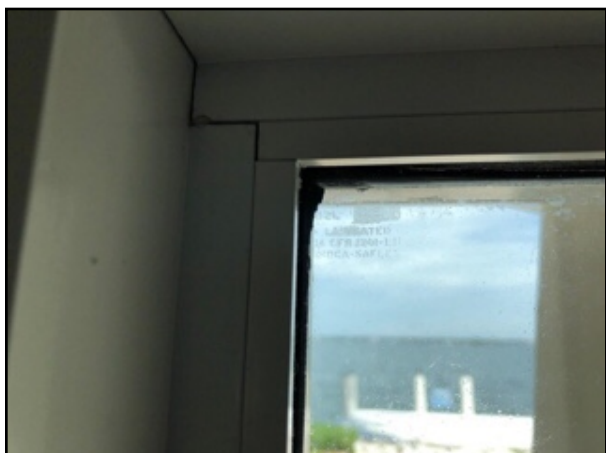
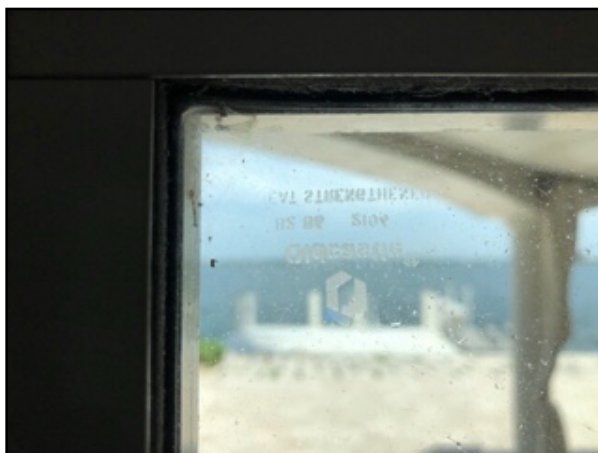
Comment 5:
Wind Mitigation / Storm Protection.
- Impact Windows

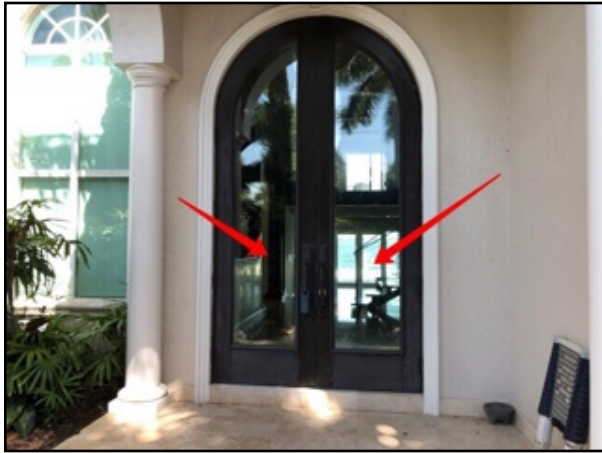
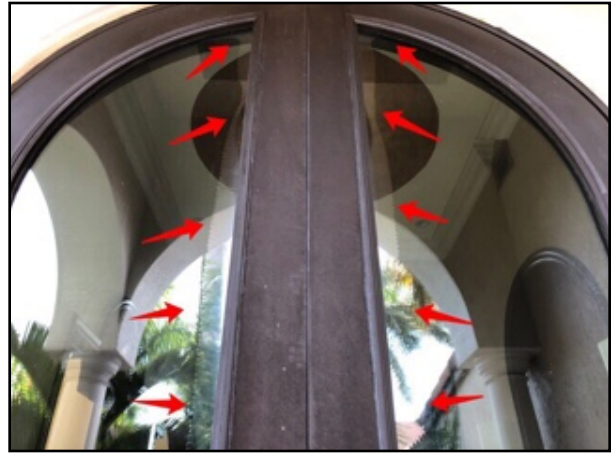
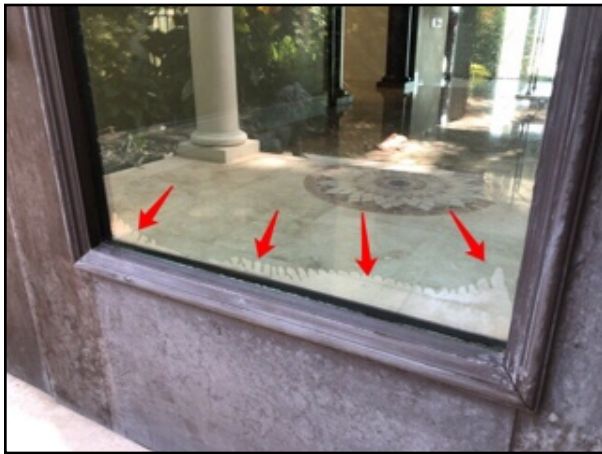
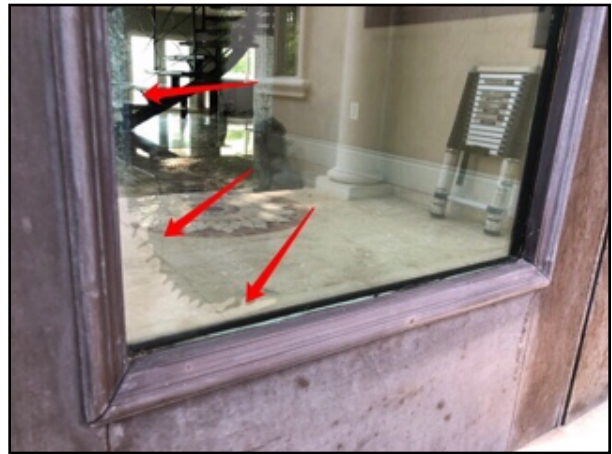
- Estimate over time the double-pane window seal may have failed allowing the inert gas within the window to leak out and moisture from outside air to seep into the space between window panes.

Recommend replacing damaged glazing within doors, or entire front entrance door. (Estimate \$5,000 - \$10,000)

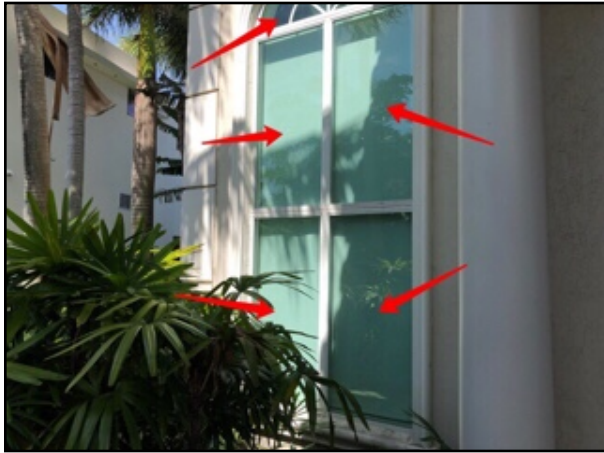
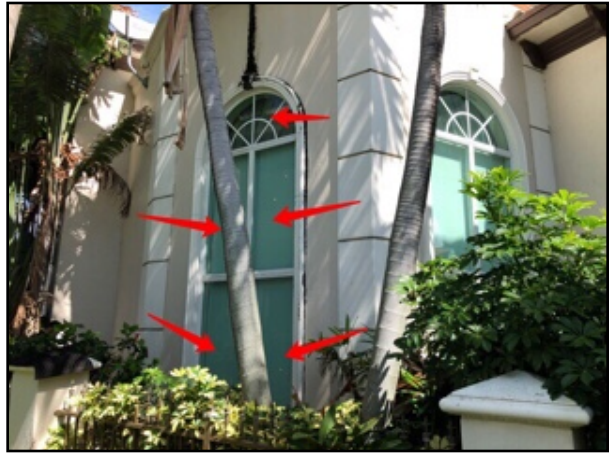
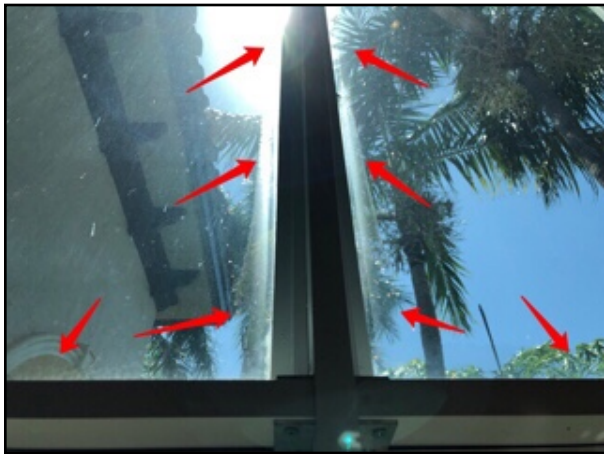
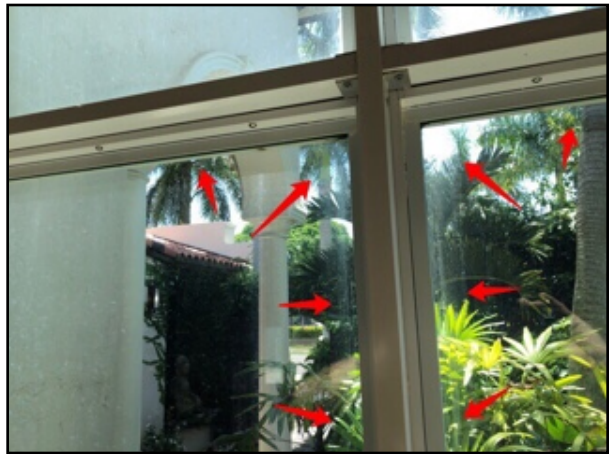
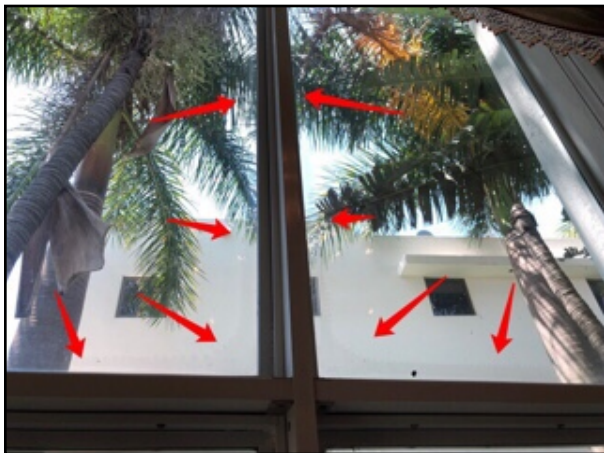
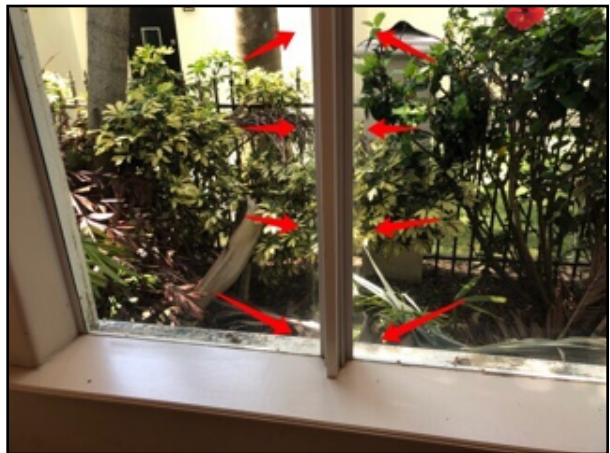
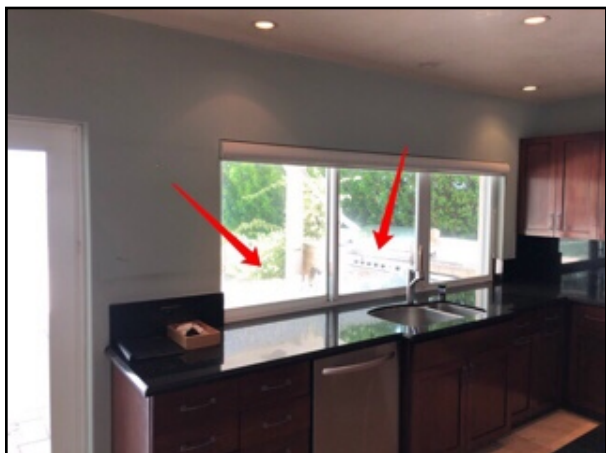
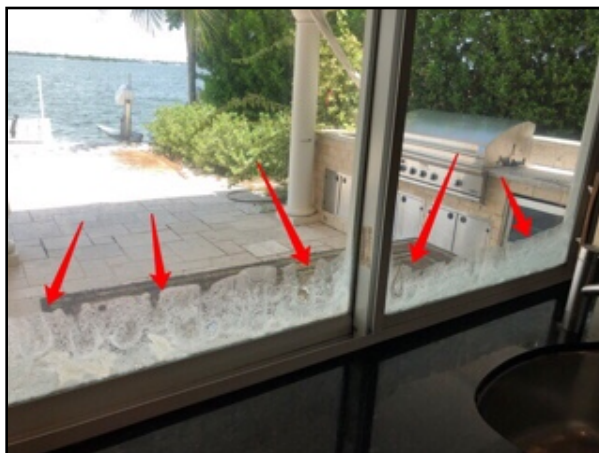
- Estimate over time the double-pane window seal may have failed allowing the inert gas within the window to leak out and moisture from outside air to seep into the space between window panes.

Recommend replacing all damaged exterior windows. (Estimate \$15,000 - \$20,000)

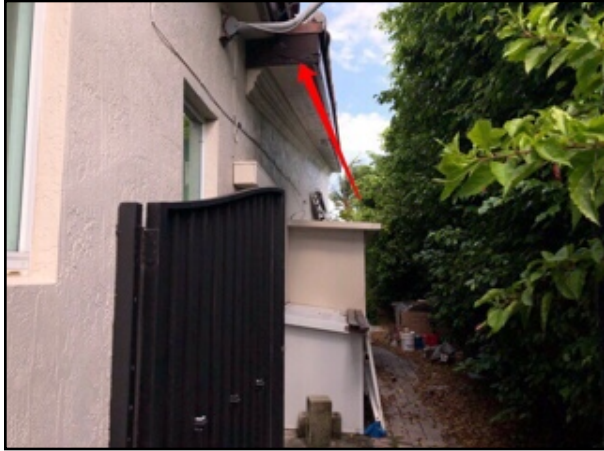
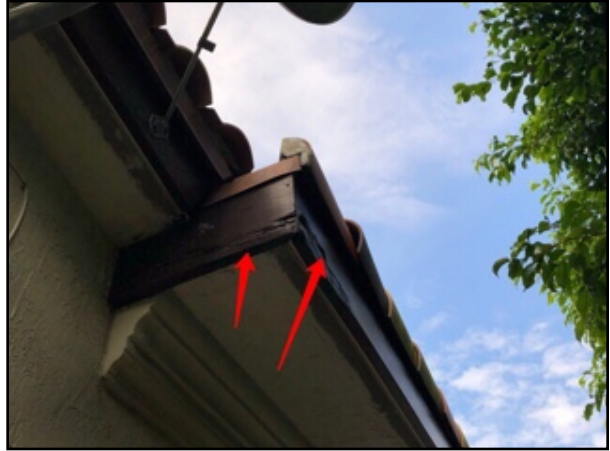
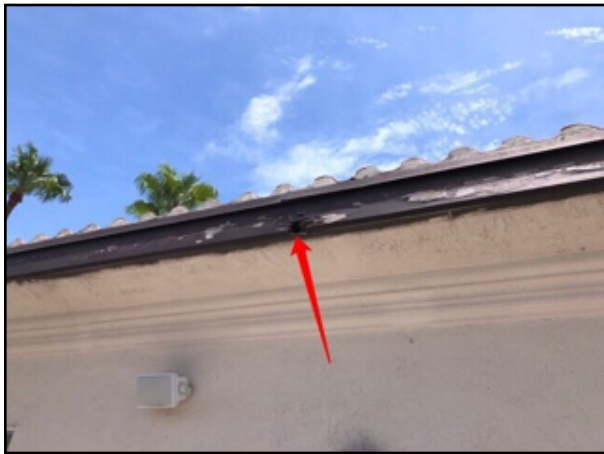
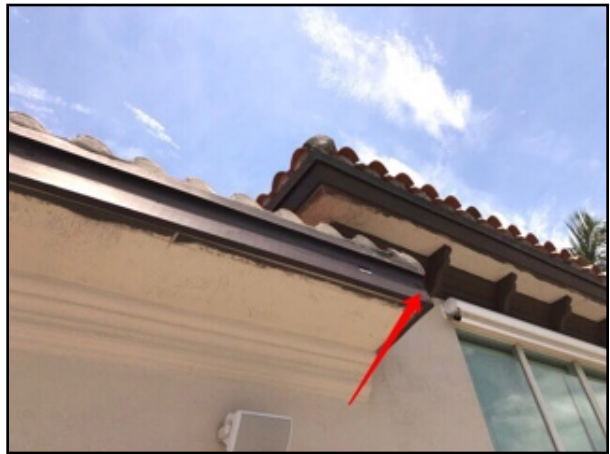
Apparent water damage/wood-rot to fascia within north & back sides of property. Recommend repairing/replacing damaged fascia boards. (Estimate: \$1,000 - \$2,000)

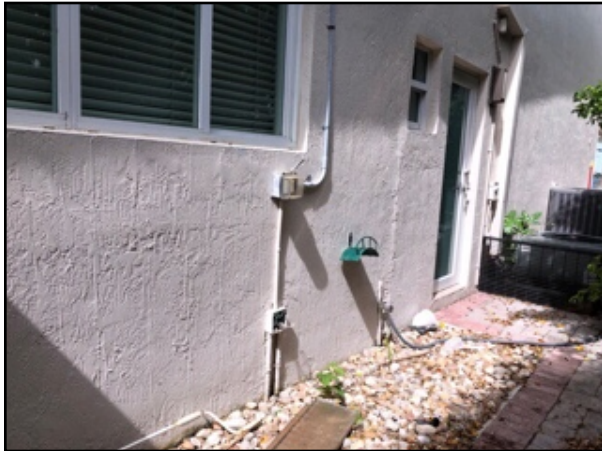
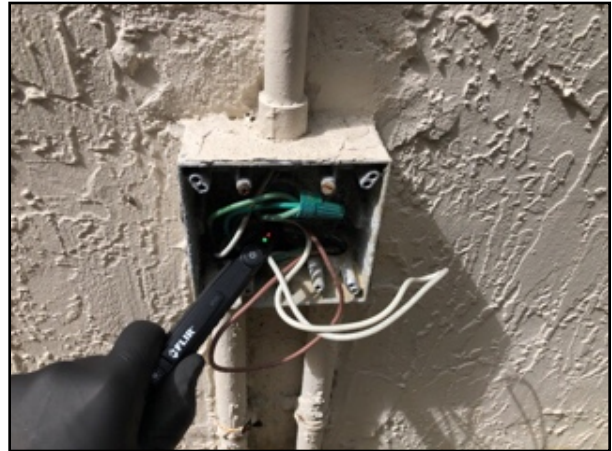
**Comment 10:**
Electrical junction box left open within exterior wall on north side of property exposing live wiring.
Recommend enclosing electrical junction box within exterior wall to properly conceal live wiring. (Estimate: \$50 - \$100)

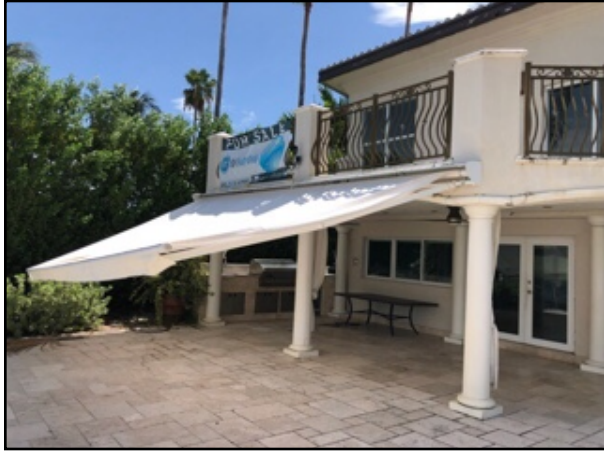
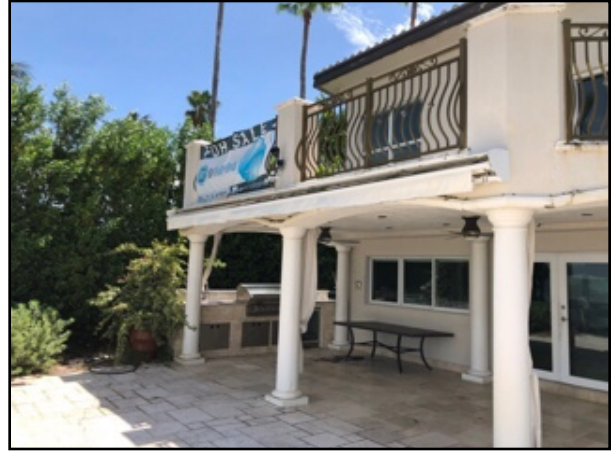
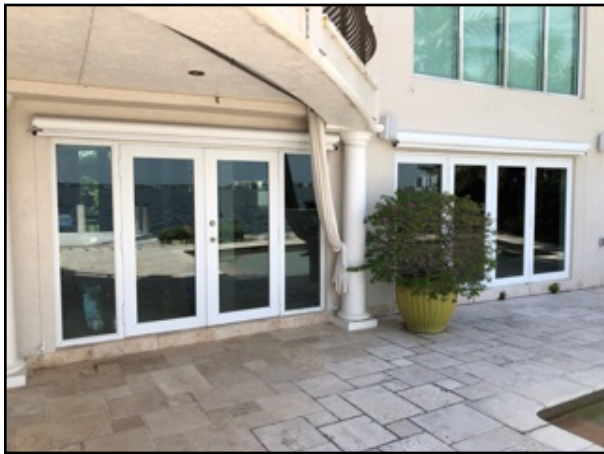
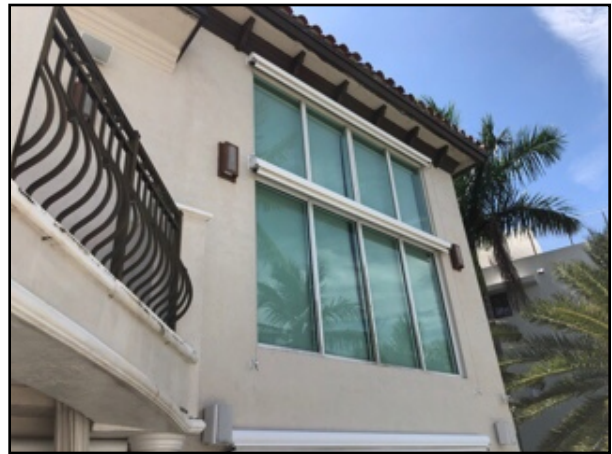
**Comment 11:**
Automatic screen covering around back of property not functioning at the time of inspection.
- Automatic awning over rear patio appears to be functional, but is not level. Recommend adjusting to open out & close properly.
 - Remaining screens over exterior windows and doors do not appear to be functional.
- Recommend further evaluation by a professional technician or contractor, and repair/replace accordingly. (Estimate: \$500 - \$2,500)

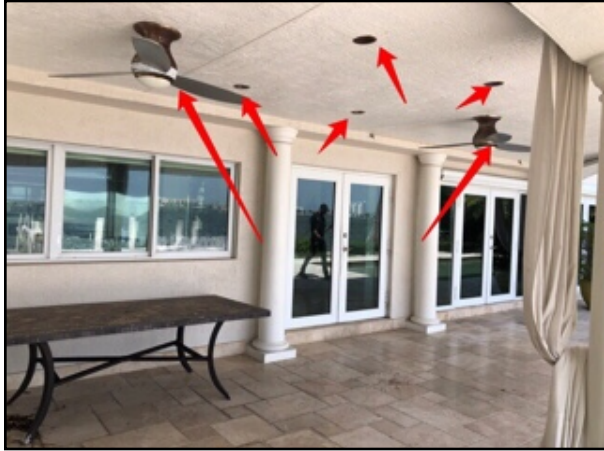
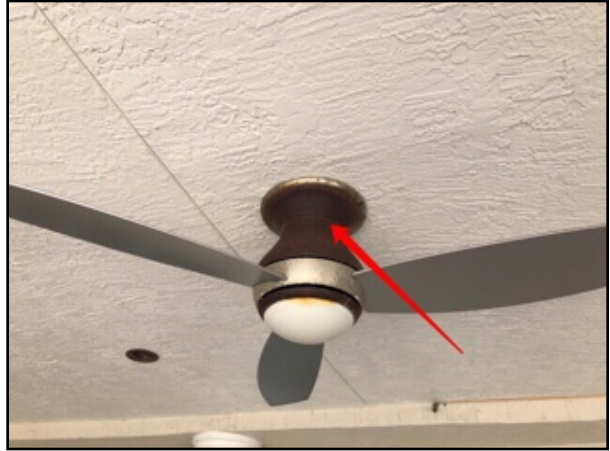
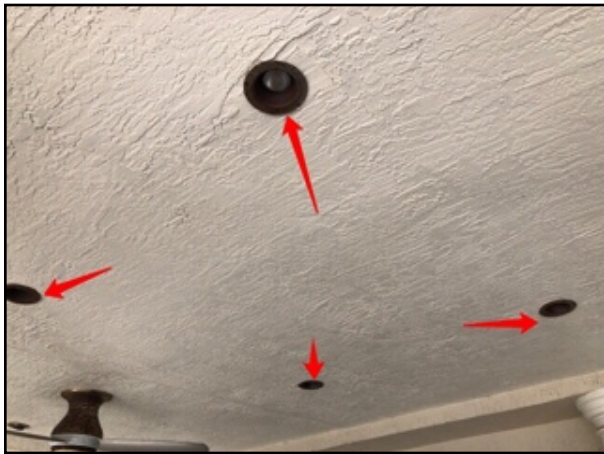
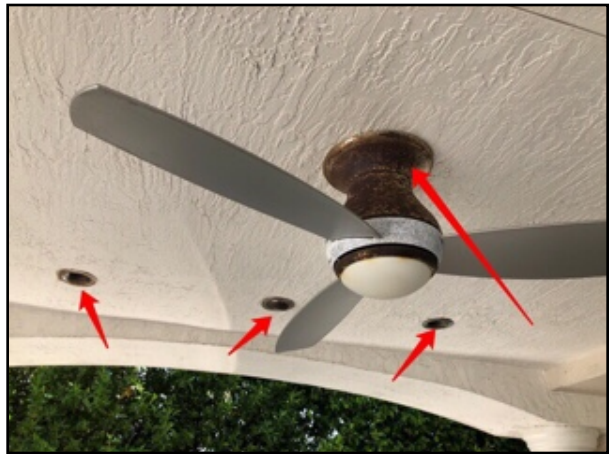
Heavily oxidized/rusted exterior lighting & fan fixtures over rear patio. Recommend replacing fixtures with proper outdoor fixtures to prevent excessive oxidation/rusting. (Estimate: \$500 - \$1,500)

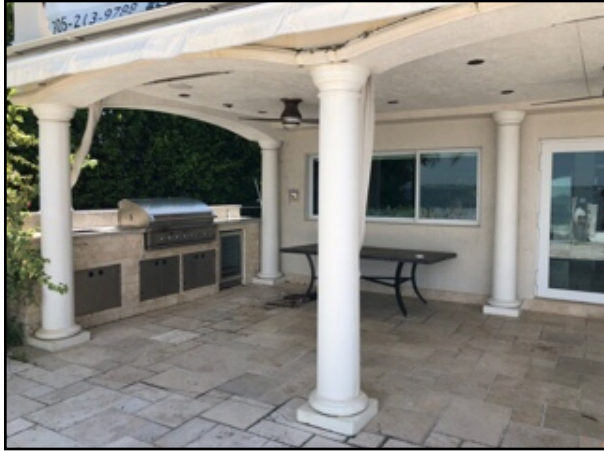
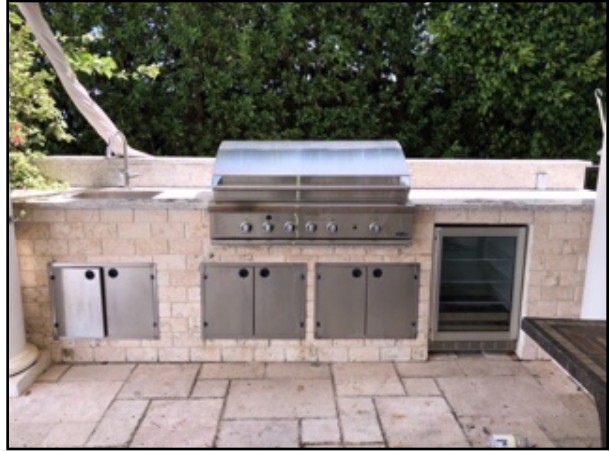
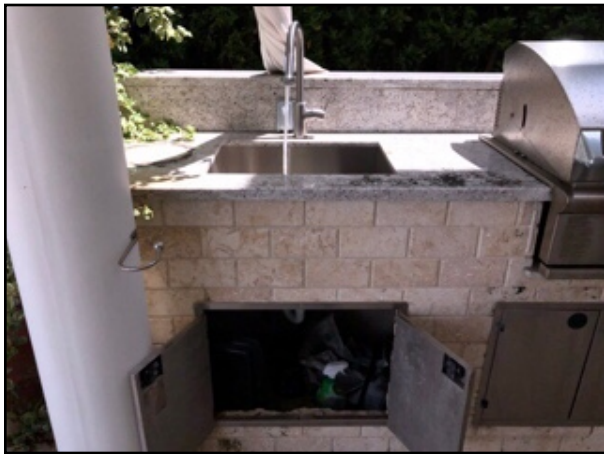
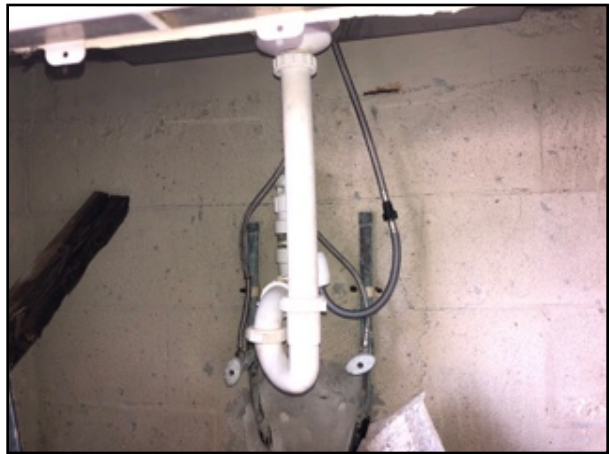
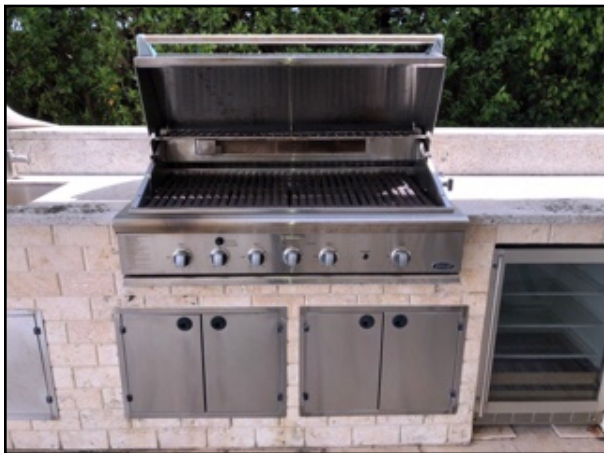
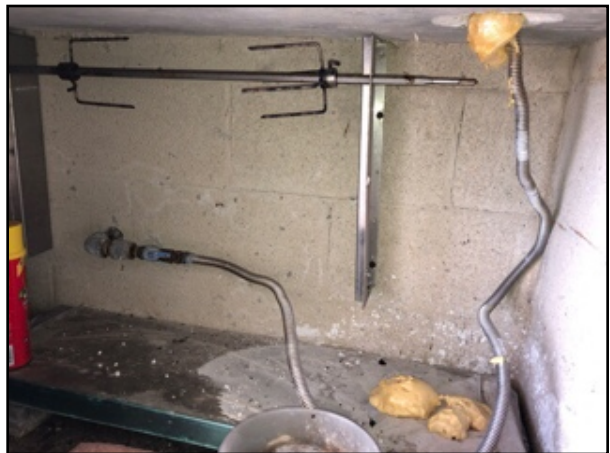
- Unable to properly test grill as utility gas currently shut off at the time of the inspection.

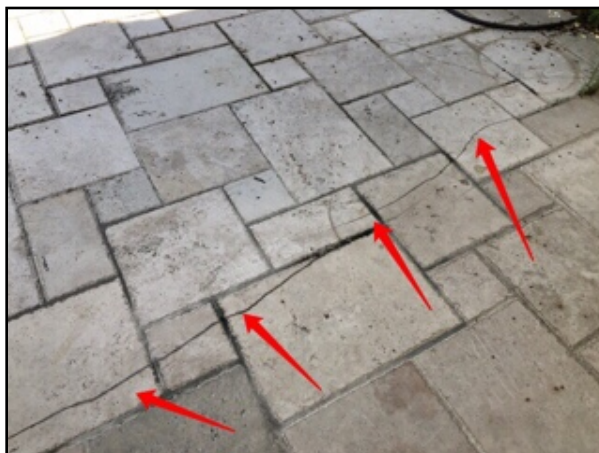
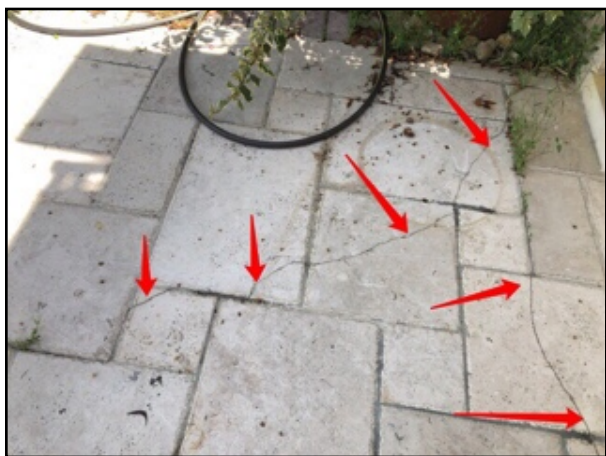
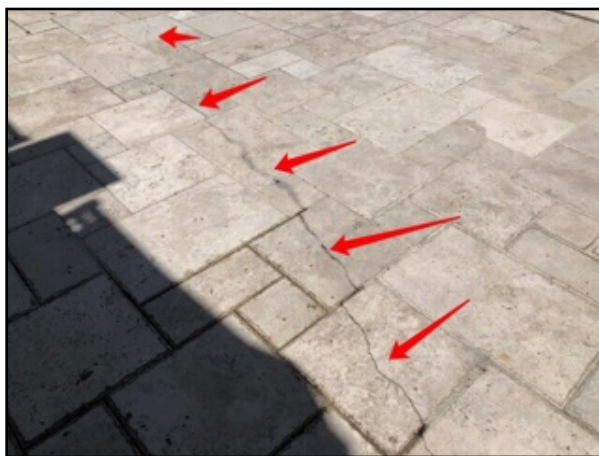
Apparent settlement cracking along exterior tiling/pavers in back of property. Replace cracked/broken tile/pavers to remove settlement cracking. (Estimate: \$1,000 - \$2,500)

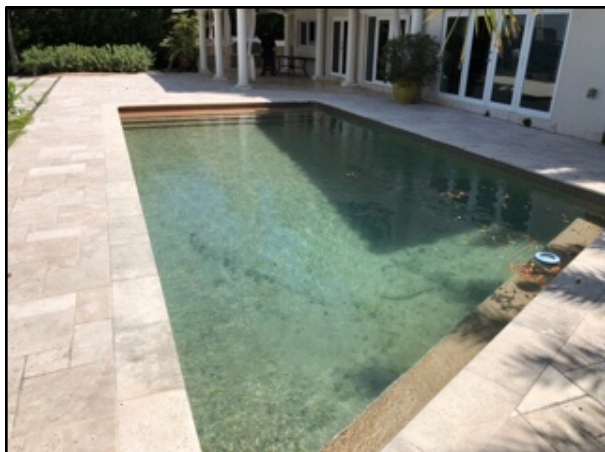
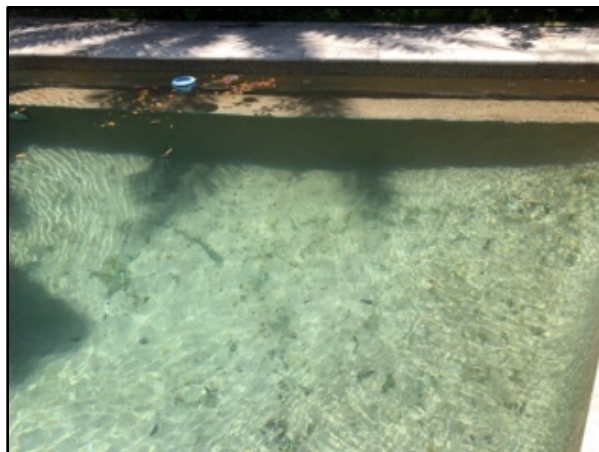
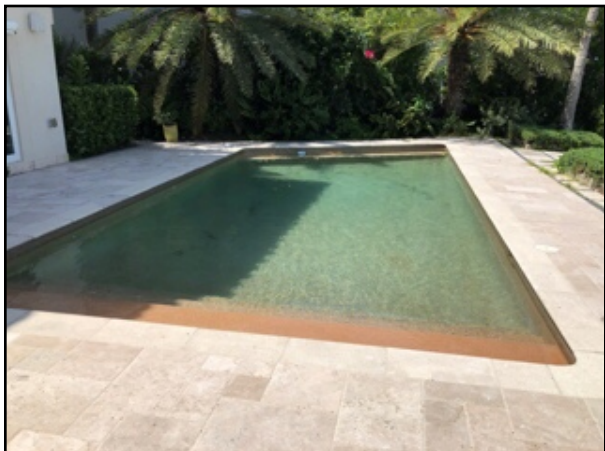
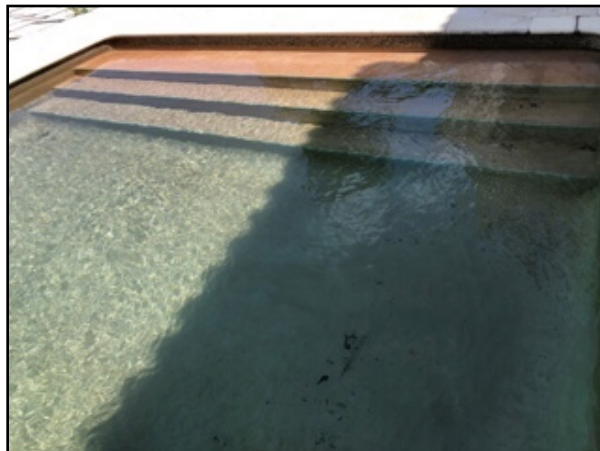
Pool and pool lining appears in fair condition.

- Pool appears to have not been properly maintained and currently full with debris. Recommend having a licensed professional drain pool & properly clean/acid wash pool lining. (Estimate: \$750 - \$1,500)

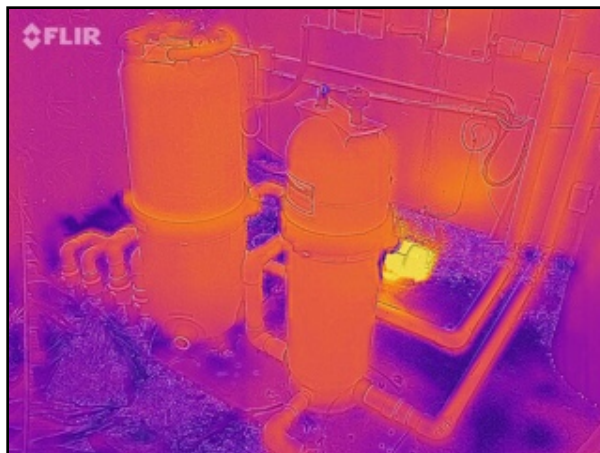
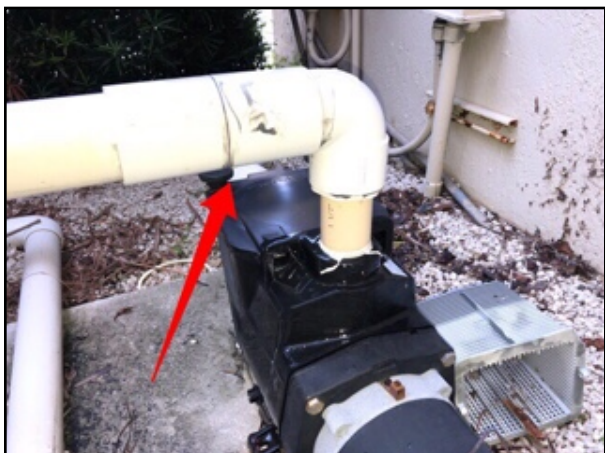
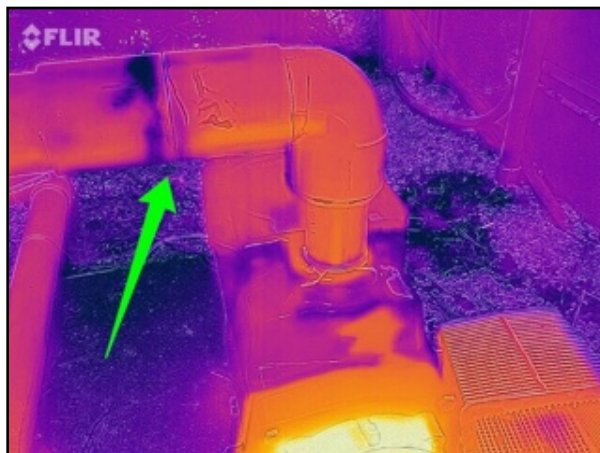
- Minor leaking apparent from connecting pipe fitting to pool pump & filtration equipment at the time of the inspection.

Recommend repair/replace damaged & leaking piping to pump & filtration equipment to prevent further leaking. (Estimate: \$100 - \$250)

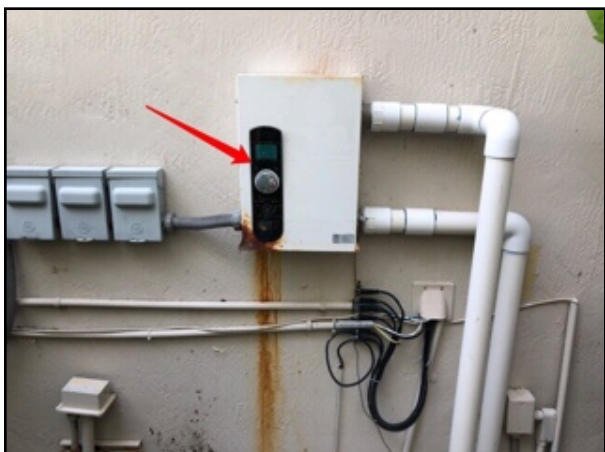
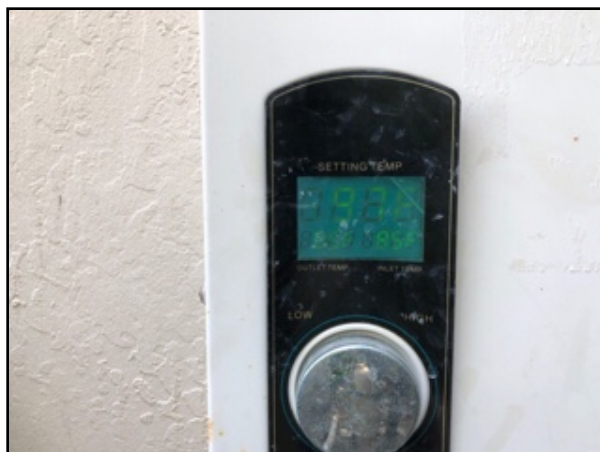
Pool heater appears in poor condition, and does not appear to be functioning properly at time of inspection.

Recommend further evaluating by a licensed professional and repair or replace accordingly. (Estimate: \$2,000 - \$3,500)

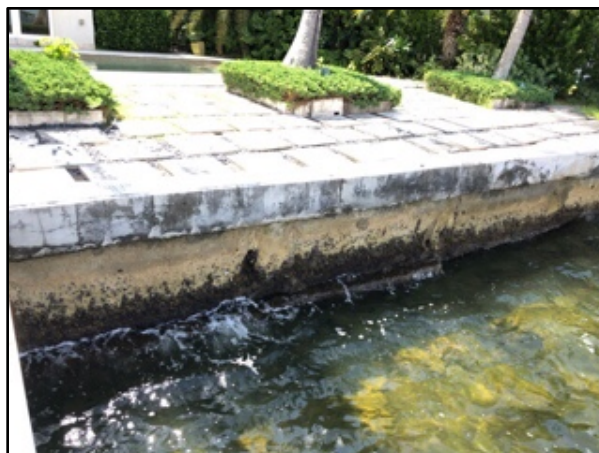
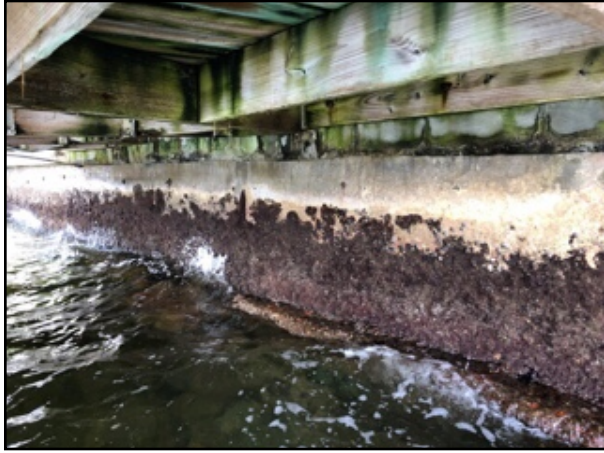
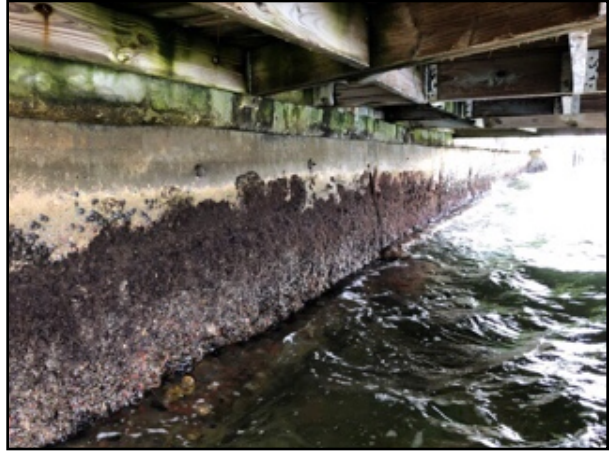
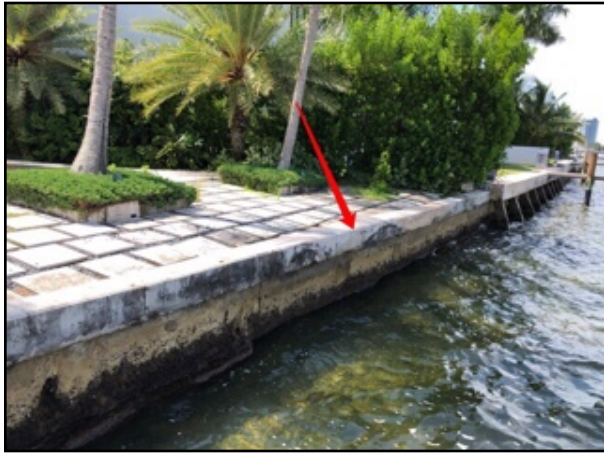
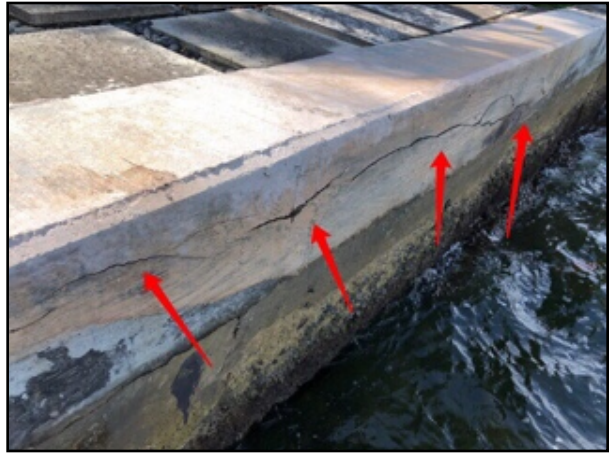
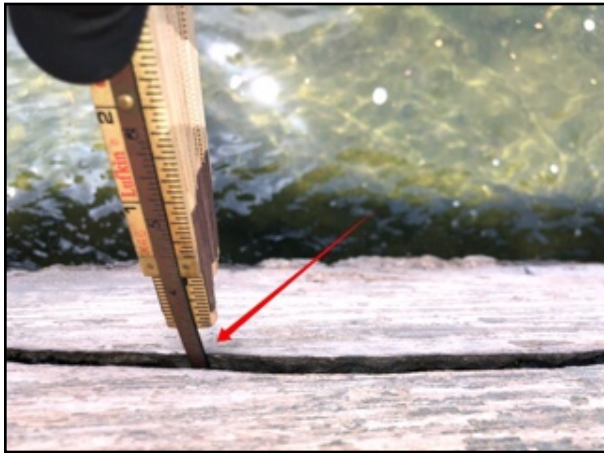
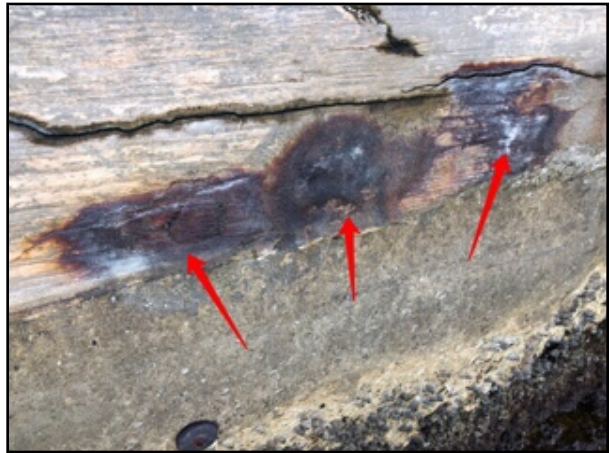
- Seawall appears to be in overall fair condition at time of inspection.
- Apparent structurally cracking & spalling along concrete seawall/bulkhead on south side of seawall.
- Spalling/deterioration appears to be exposing rebar reinforcement from within structure due to apparent oxidation/rusting around cracking.

Recommend having a structural engineer or seawall contractor further evaluate spalling, and advise for proper repairs. (Detailed quotation required)

As we can only check for visual deficiencies above water level, we recommend further evaluation of dock & seawall by a licensed structural engineer or seawall contractor for proper structural evaluation of seawall.

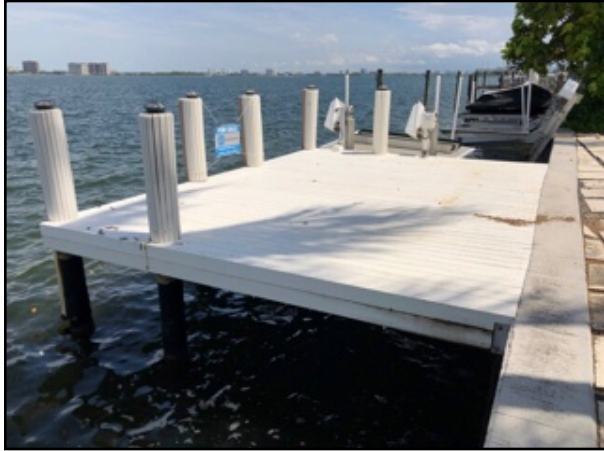
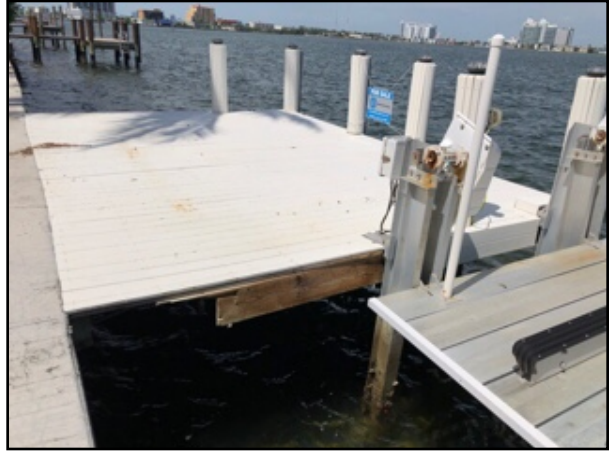
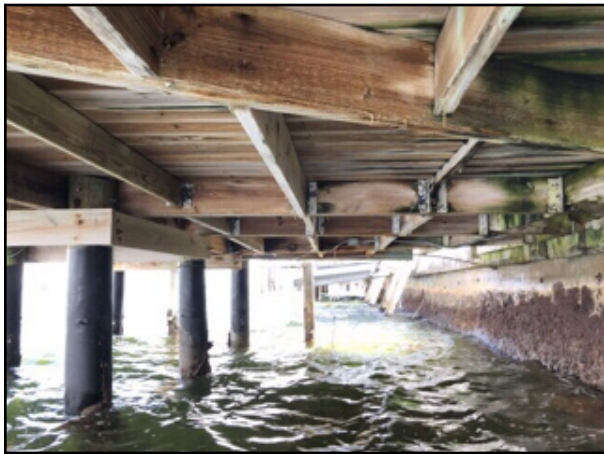
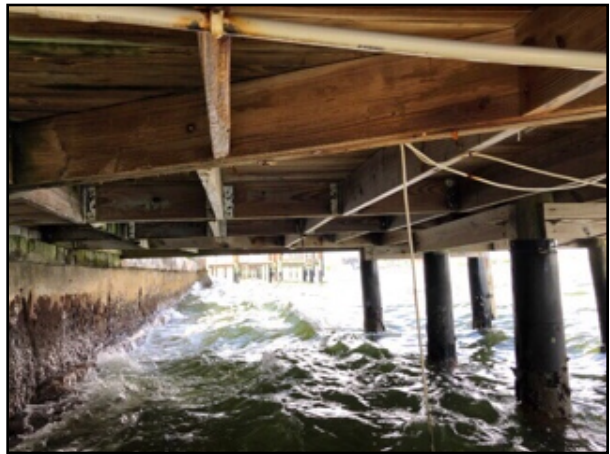
Dock located within back of property.

- Dock appears to be slightly weathered but in overall fair condition at time of inspection.

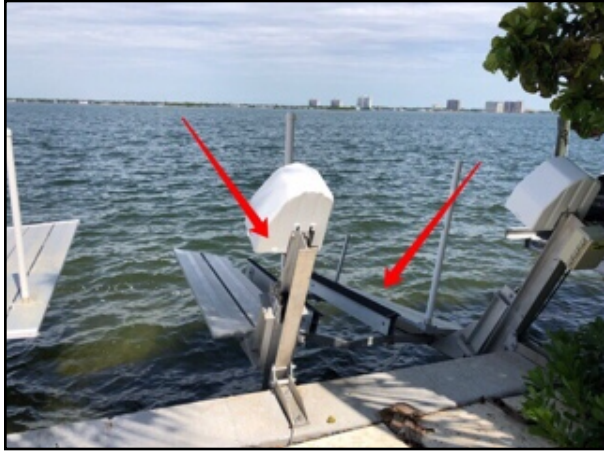
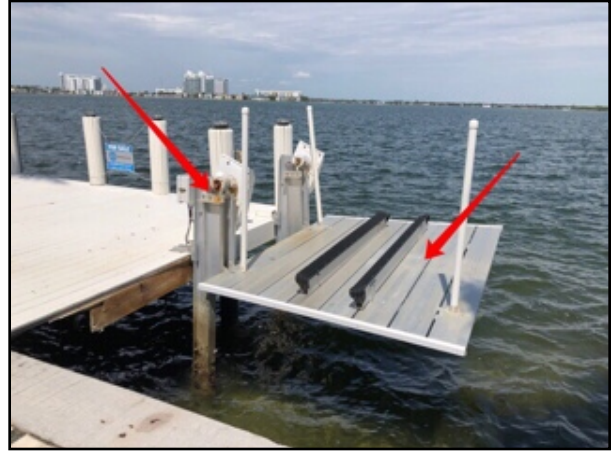
Dry-dock boat lifts appear to be damaged & not functional at the time of inspection. Recommend further evaluation by a licensed contractor, and repair or replace dry-dock boat lifts accordingly. (Detailed quotation required)

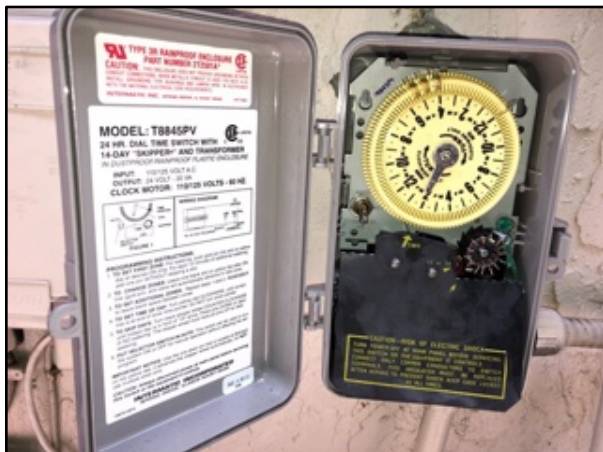
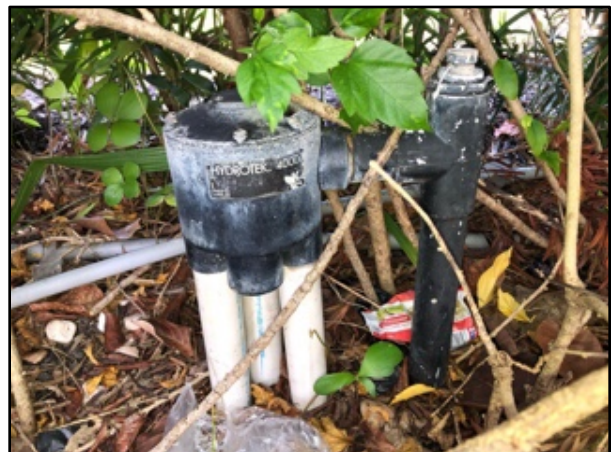
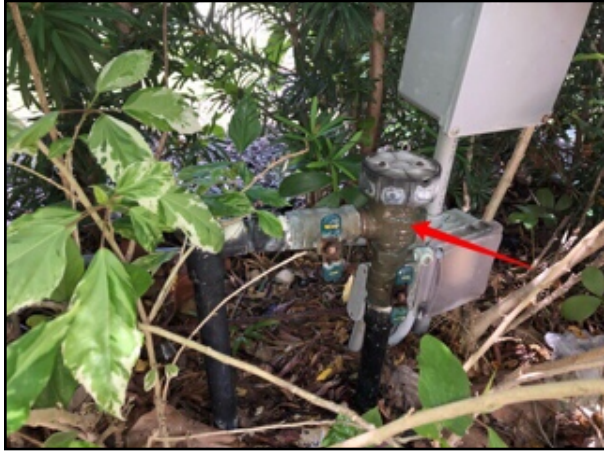
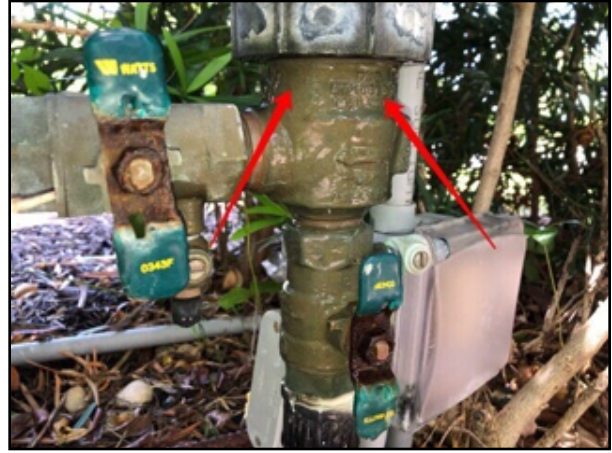
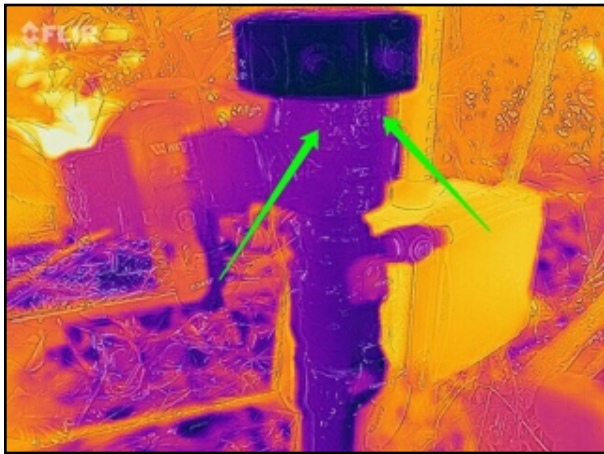
- Mechanical valves for irrigation system are buried around property.
- Sprinkler system does not appear to be functioning properly at the time of inspection.
- Excessive leaking apparent from irrigation system incoming water line in front corner of property.

Recommend further evaluation by a licensed contractor and repair or replace accordingly. (Estimate: \$500 - \$1,000)
