Home Pro Miami

Home Inspection Report

1175 Sample Dr

Inspected on Thu, Aug 29 2019 at 10:00 AM

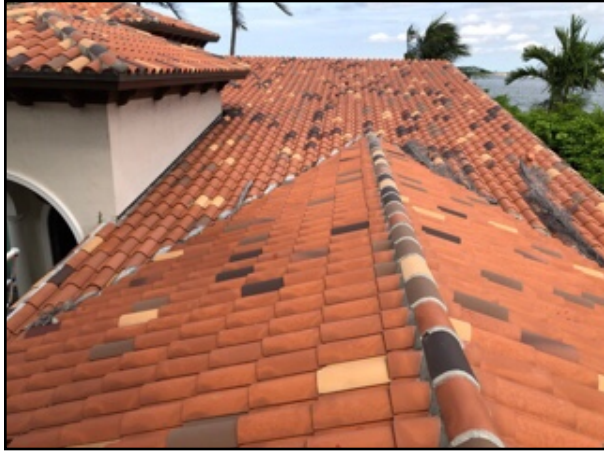
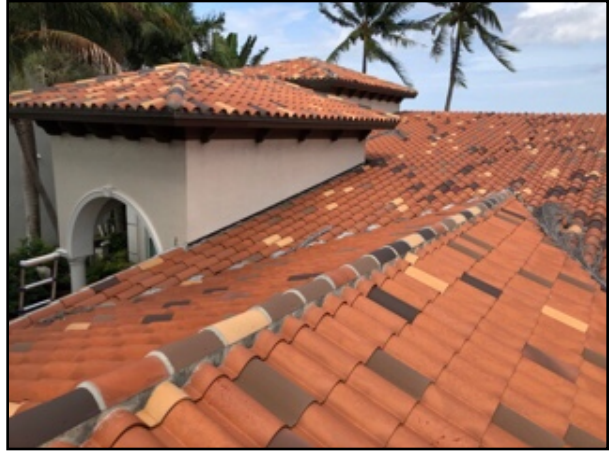
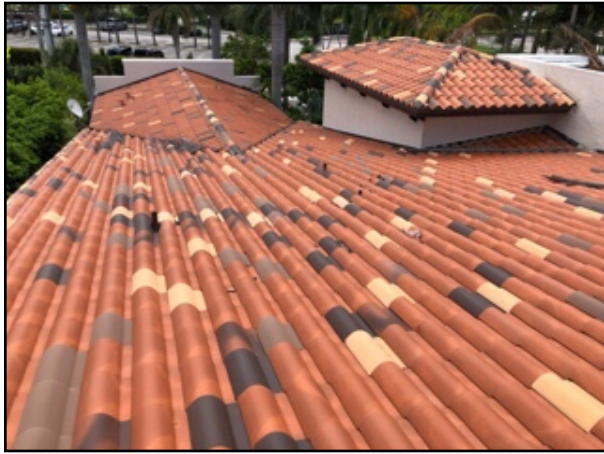
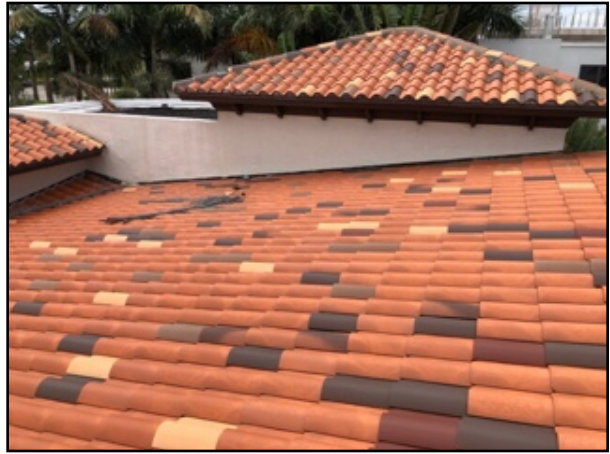
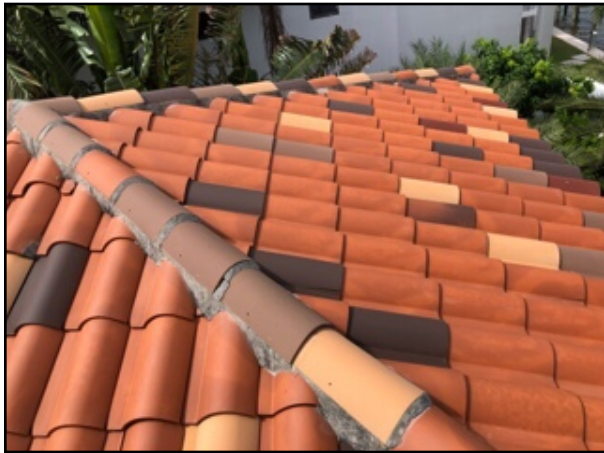
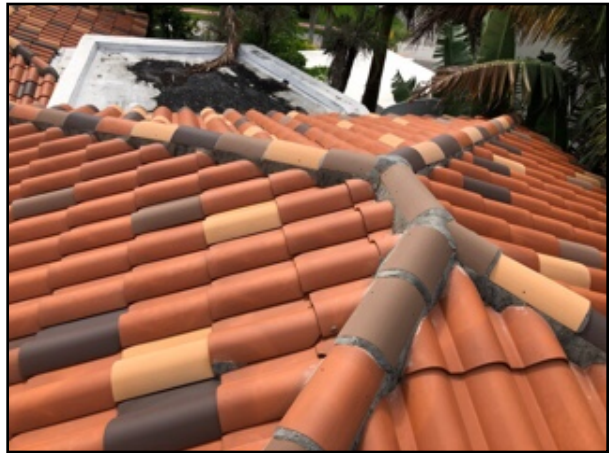
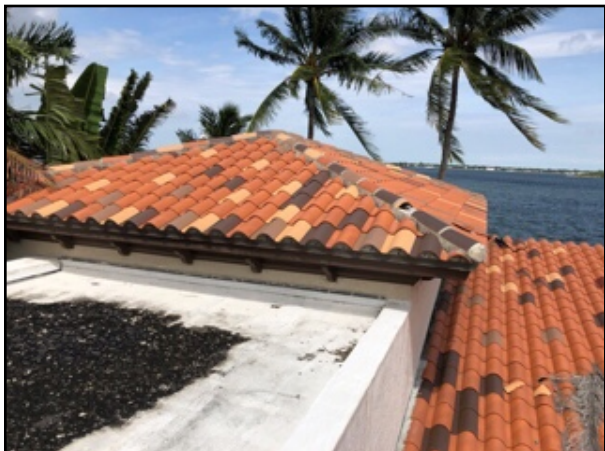
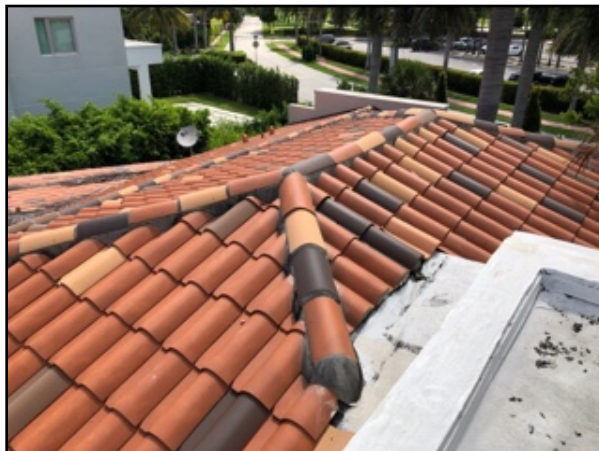
- Roof coverings replaced in 2004 (Permit #04-00089325), and currently appear in overall fair condition.
- Multiple indications of damage as well as active leaking from roof at the time of inspection.

Recommend further evaluation by a licensed contractor, and repair or replace roof coverings accordingly. (Estimate: \$10,000 - \$15,000)

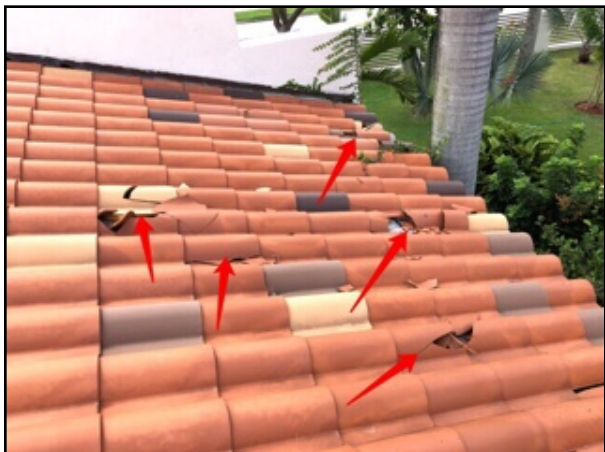
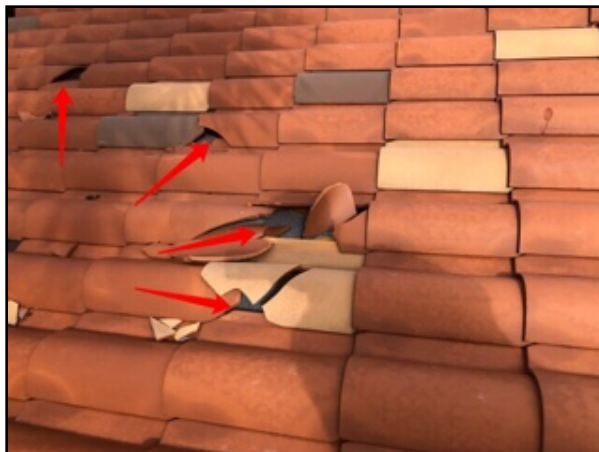
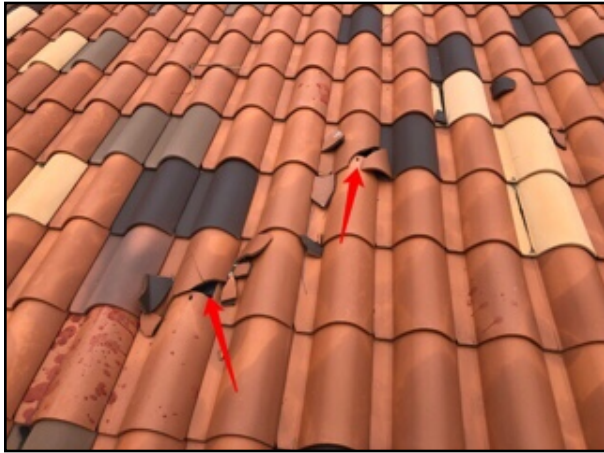
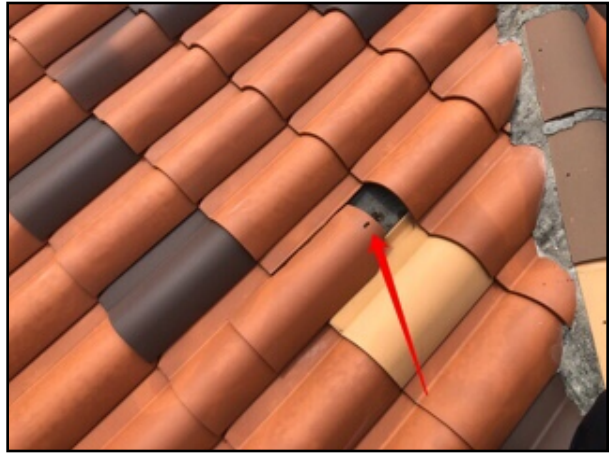
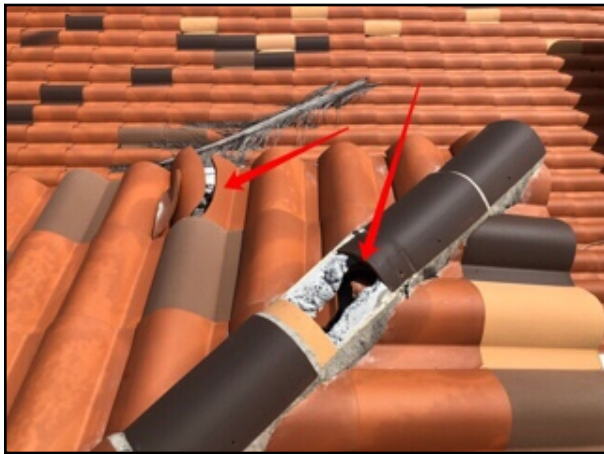
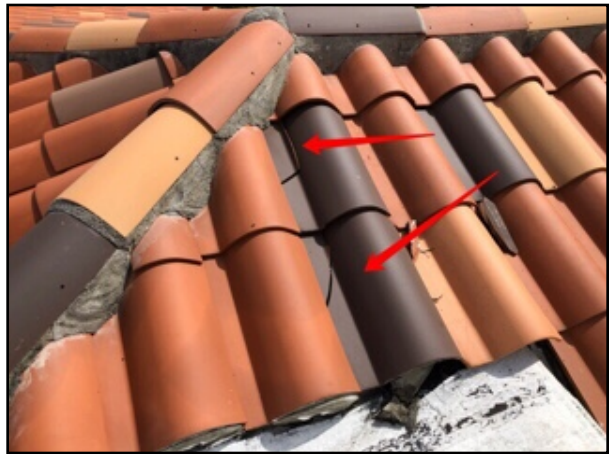
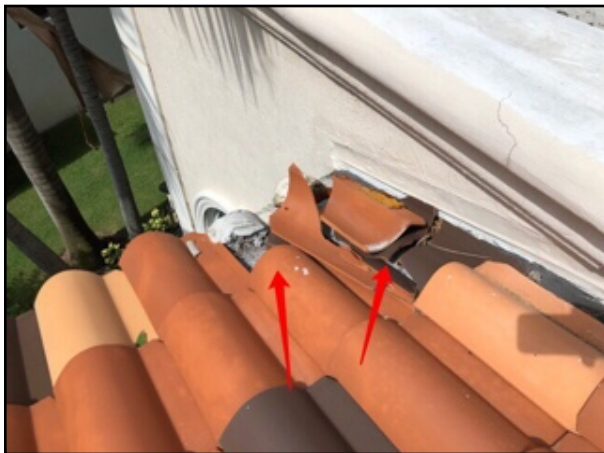
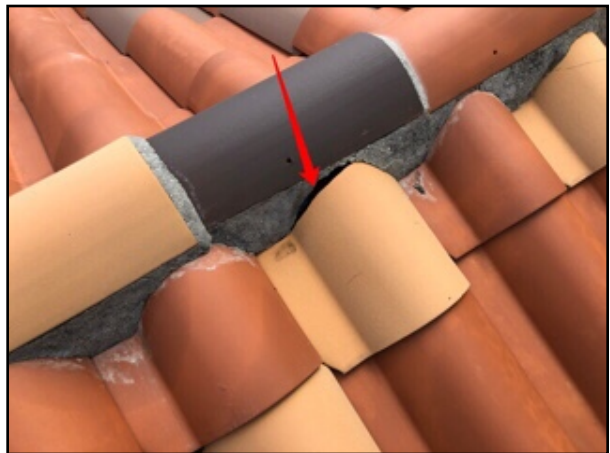
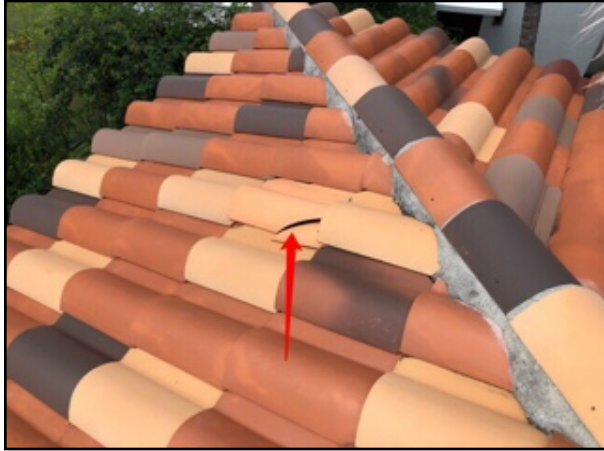
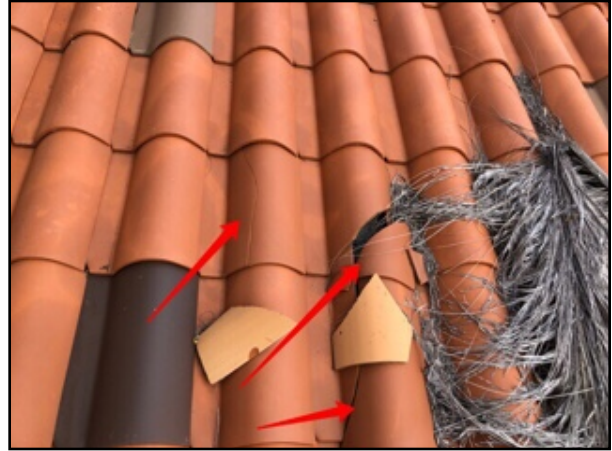
Multiple cracked broken tiles present along roof.

- Roughly 45 - 60 cracked/broken, loose, or missing clay barrel tiles found at the time of inspection.

Repair/replace cracked/broken roofing tiles.

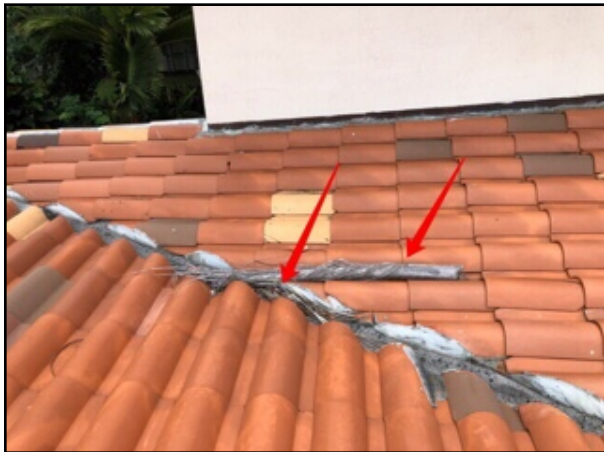
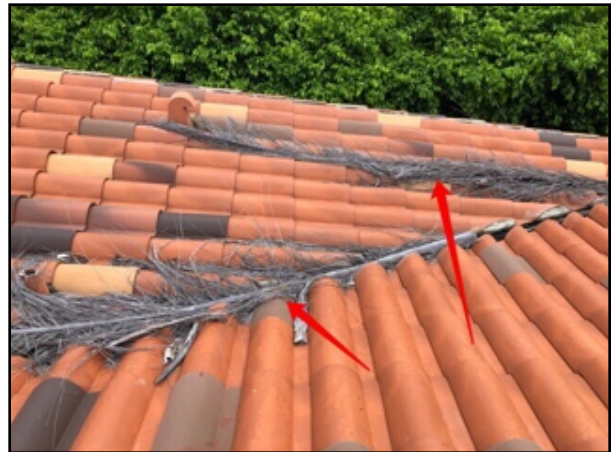
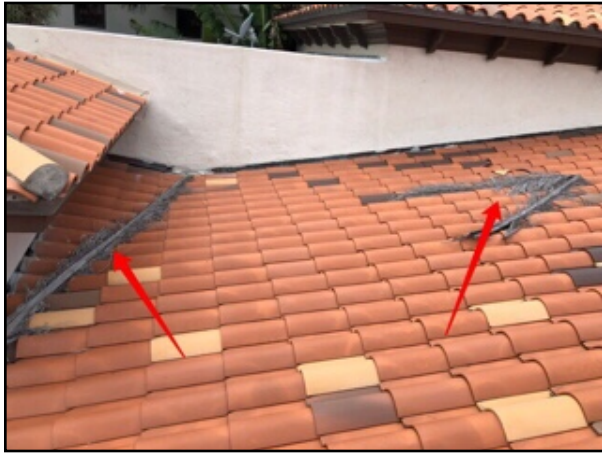
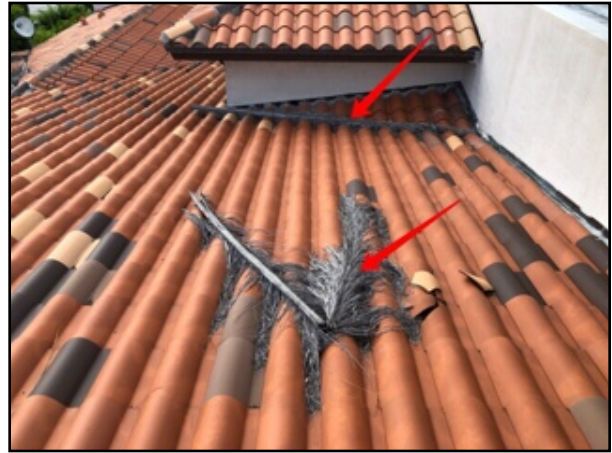
Heavy debris from surrounding vegetation collecting along roof.
Recommend removing debris from roof to prevent damage to roof coverings.
(Estimate: \$200 - \$400)

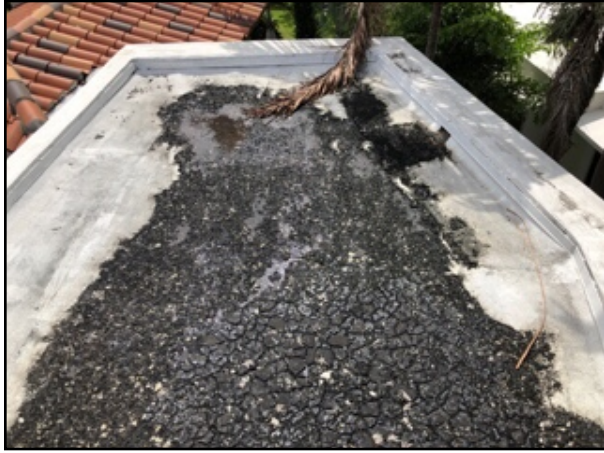
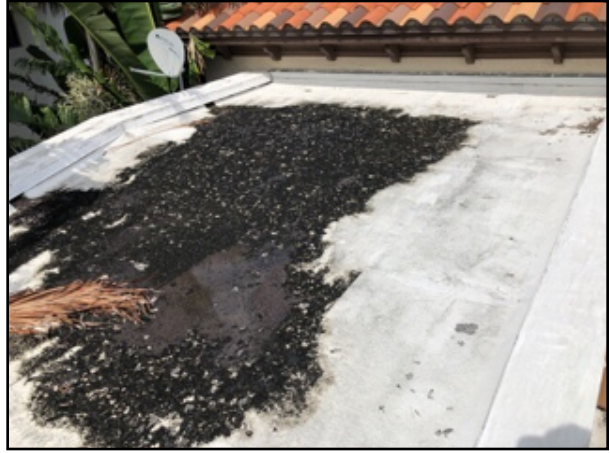
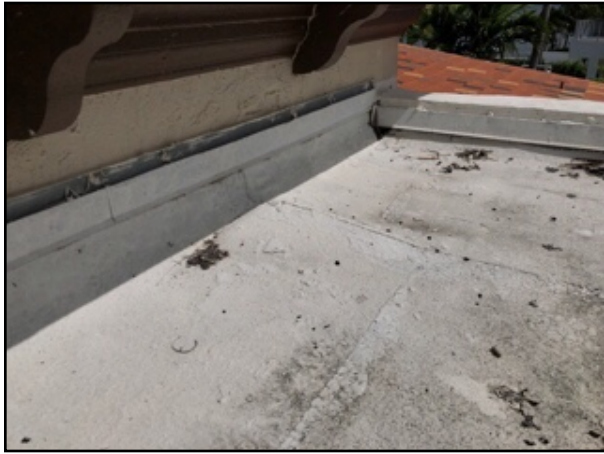
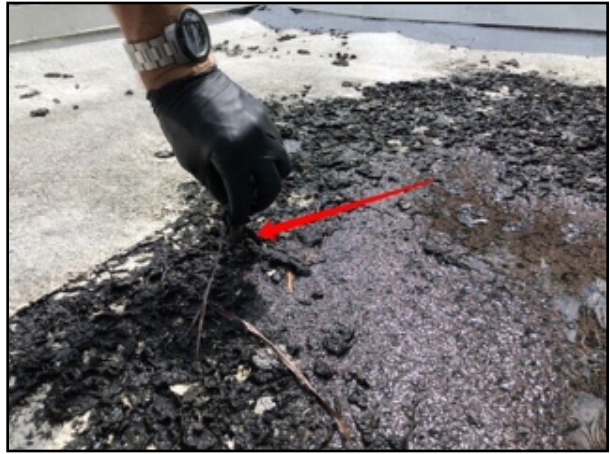
- Flat roof coverings last replaced along with primary roof coverings in 2004 (Permit #04-00089325), and currently appear weathered & worn condition at the time of inspection.
- Weather-seal coating appears to have been previously applied, but is currently worn, peeling-up, and in poor condition.
- Debris from surrounding vegetation currently clogging scupper drains from flat roof covering preventing proper drainage from flat roof.
- No indications of leaking from flat roof coverings at the time of inspection, but flat roof coverings are nearing end of efficient life expectancy, and due to current condition recommend to be replaced in near future. (Estimate: \$8,000 - \$10,000)

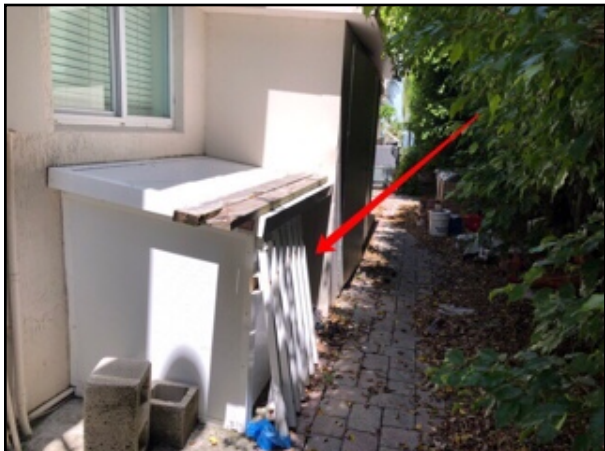
Figure 27-1

Main water shut off valve is located in north side of property.

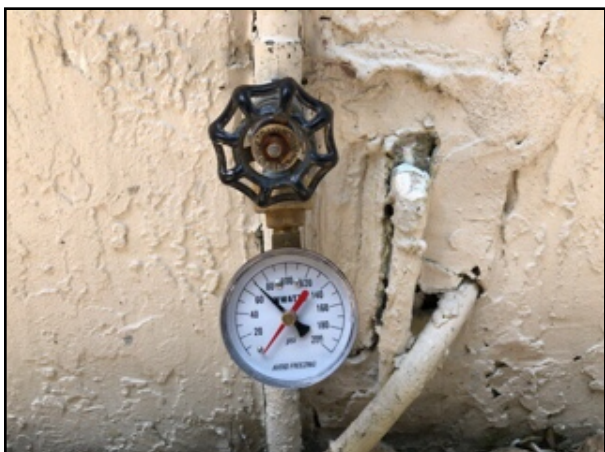
Figure 28-1

Water pressure is good going into home. (Around 70 PSI)

- Average water pressure for residential properties ranges between 30 - 50 PSI.

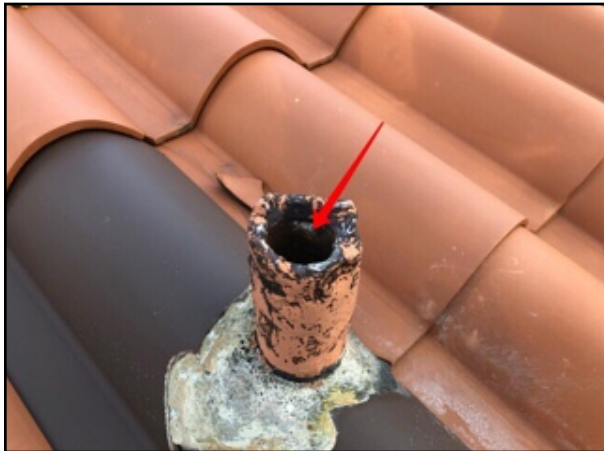
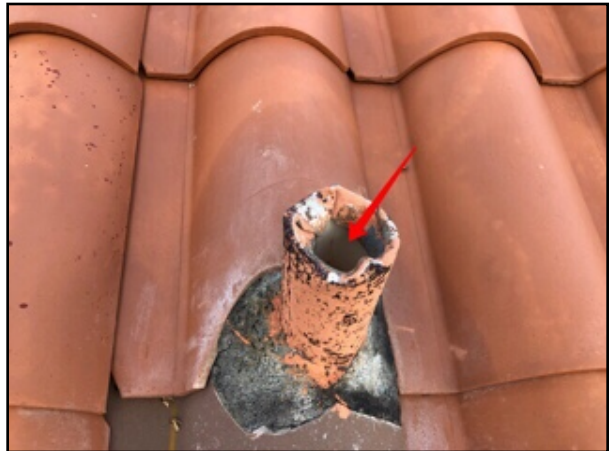
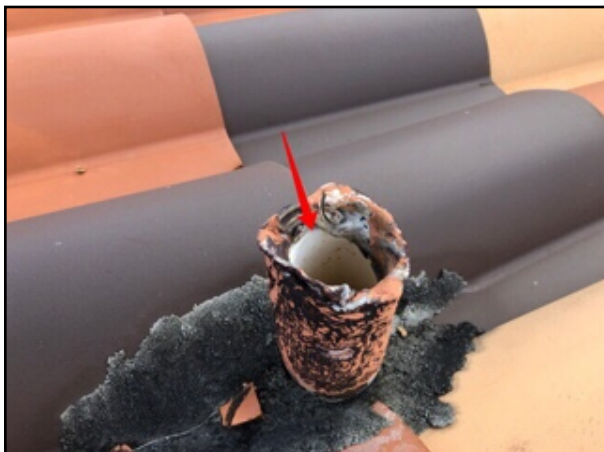
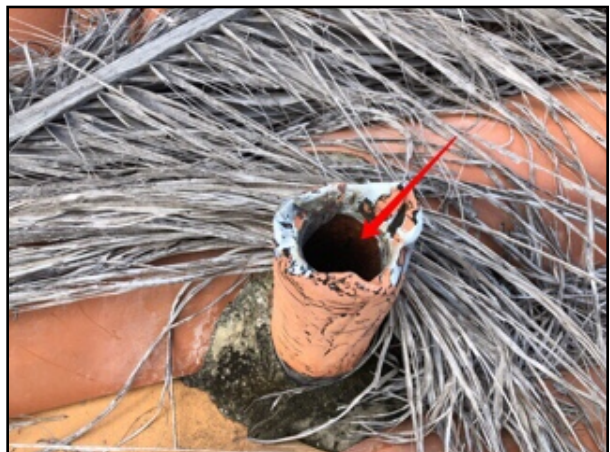
Plumbing drain lines visible from ventilation stacks on top of roof.

- Drain lines consist of aged cast iron & updated PVC piping.

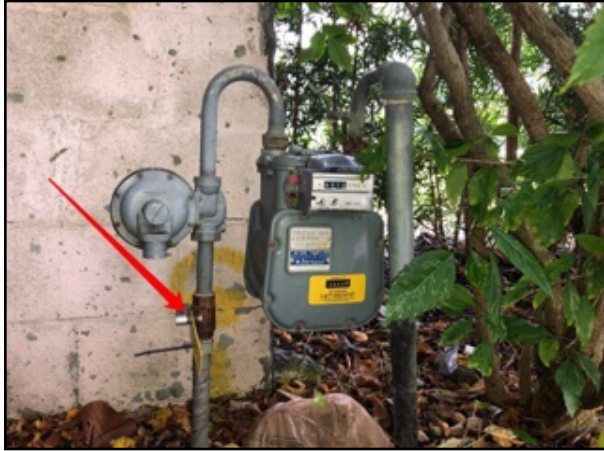
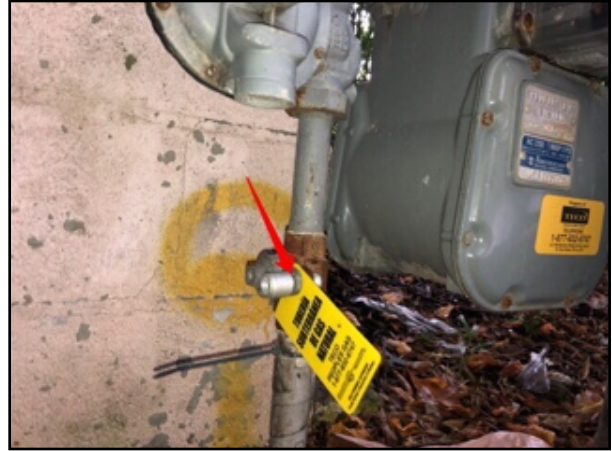
- Main fuel shut-off valve is located next to city meter.
- Gas service currently disconnected. Utility provider has placed a lock on the meter.
- Unable to test gas appliances.

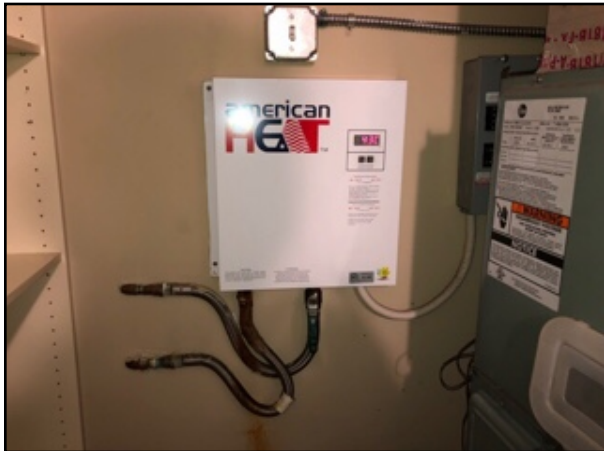
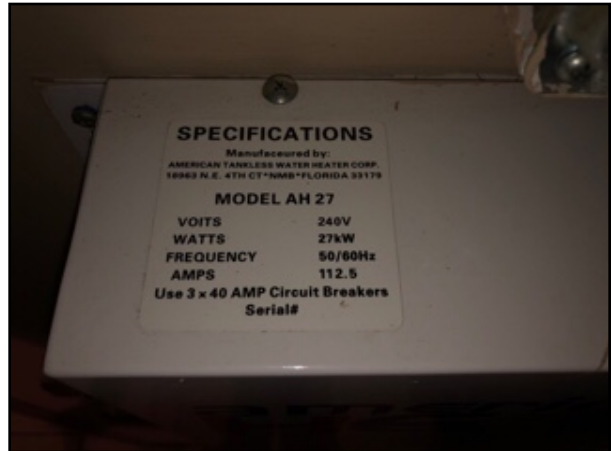
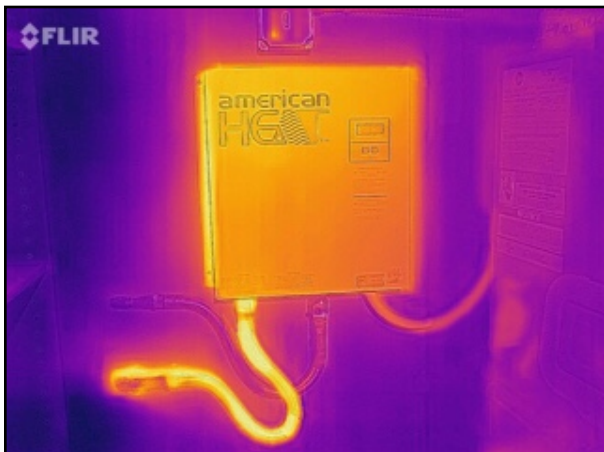
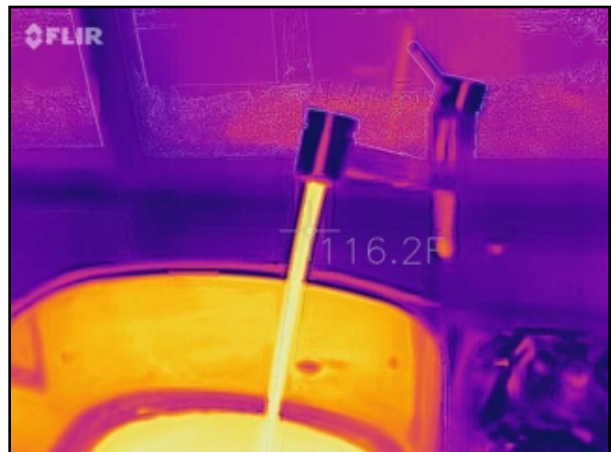
Hot water heater appears in good condition and functioning properly at the time of inspection.

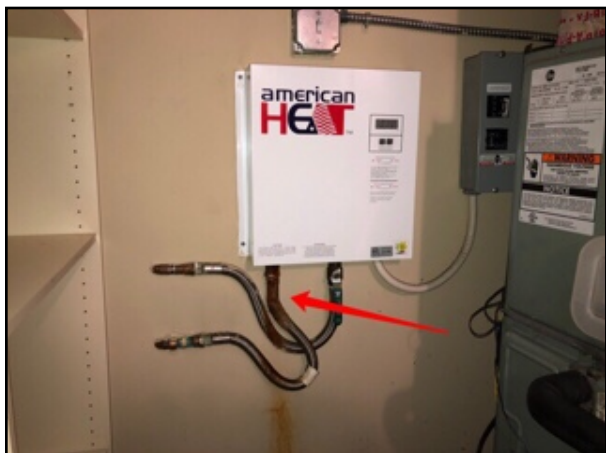
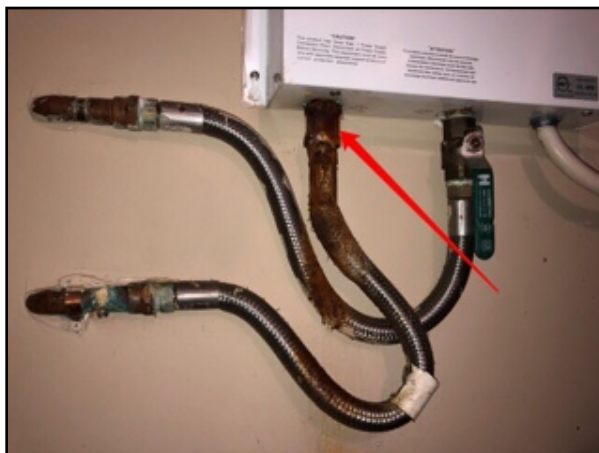
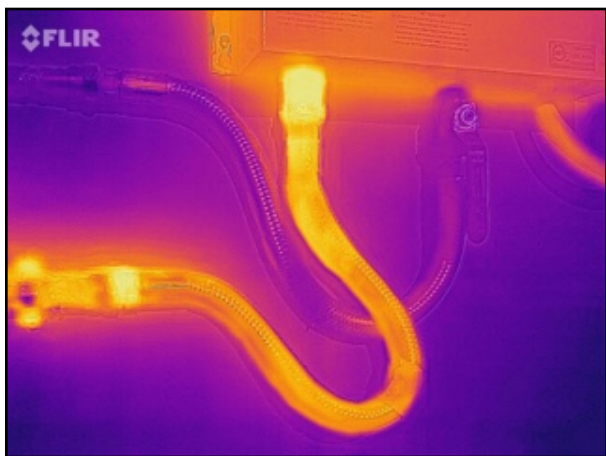
Heavily oxidation/rusting to plumbing hose connection to water heater.

- Indications of previous leaking. No active leaking noticed during the time of inspection.

Recommend having a licensed plumbing contractor replace connection & hose to hot water heater to prevent any possible leaking. (Estimate: \$200 - \$400)

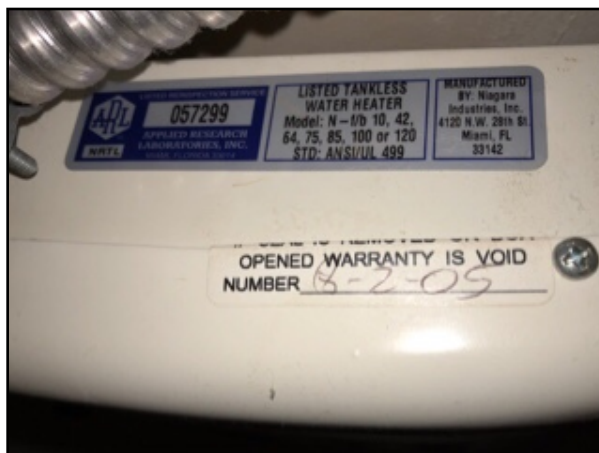
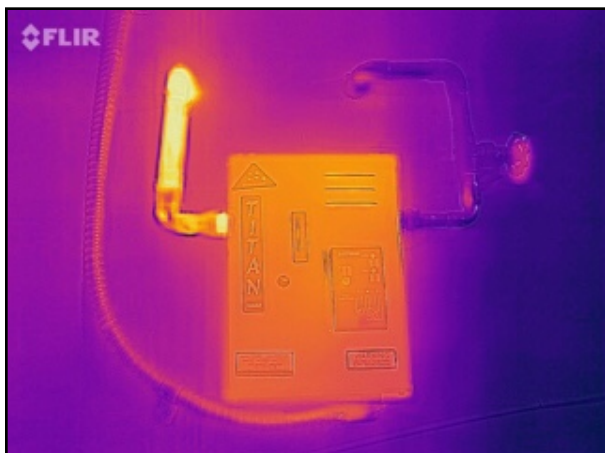
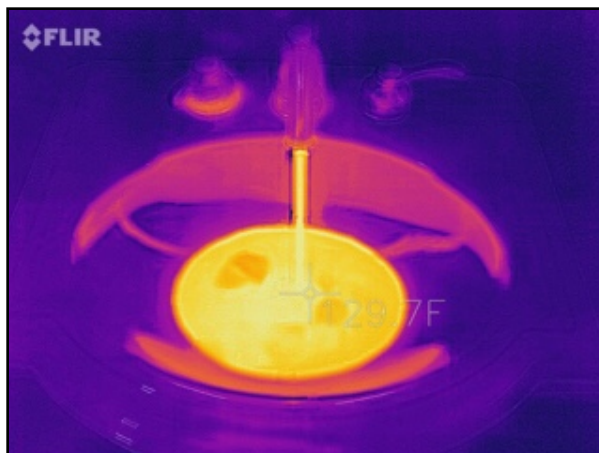
- Water heater currently 14 years old.
- Due to age of unit, water heater is nearing end of efficient life expectancy and may need to be replaced in near future. (Estimate: \$1,000 - \$1,500)

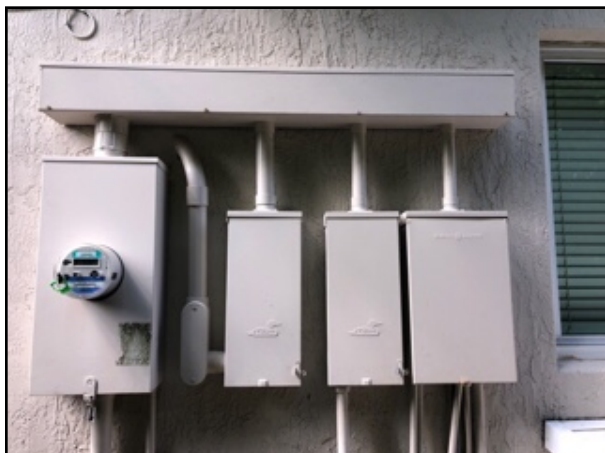
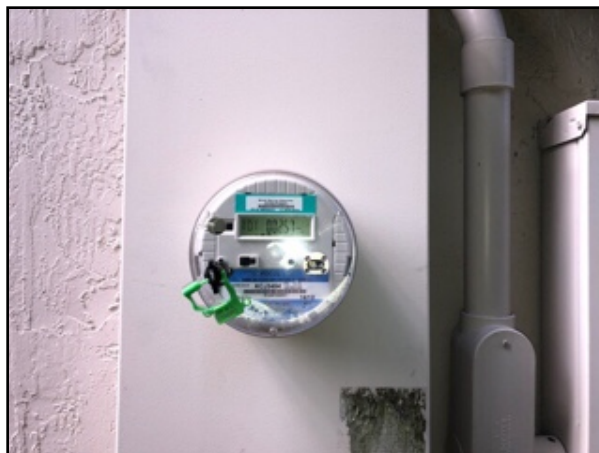
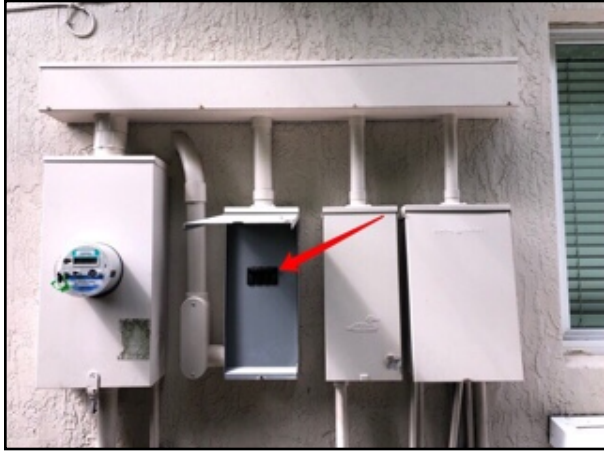
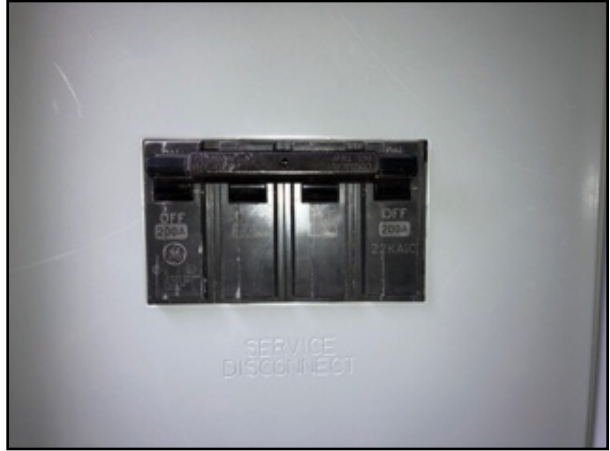
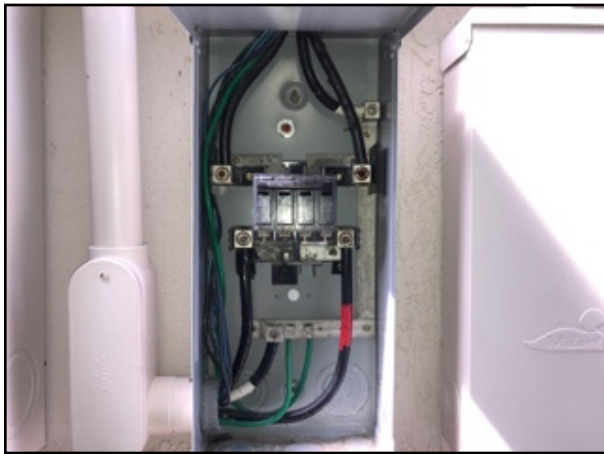
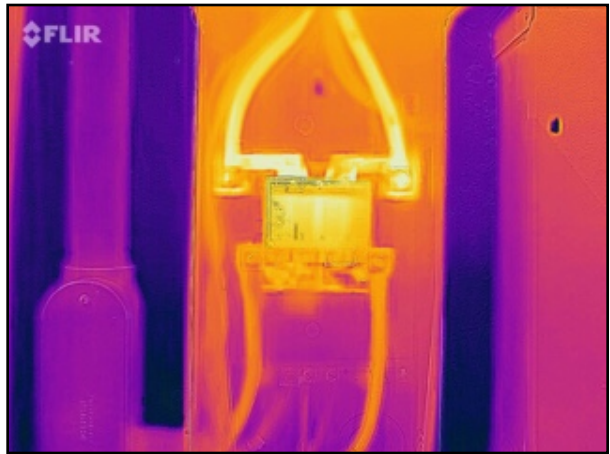
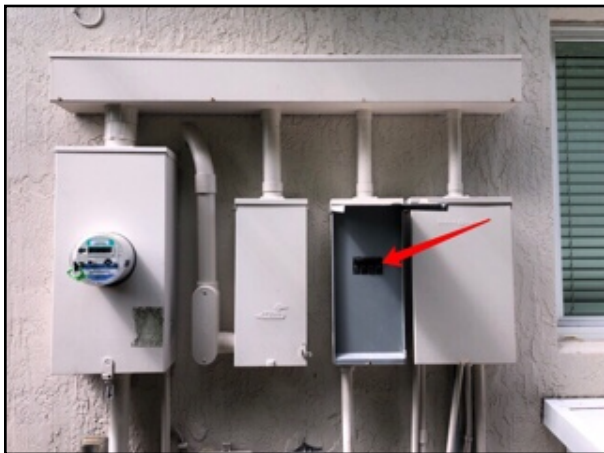
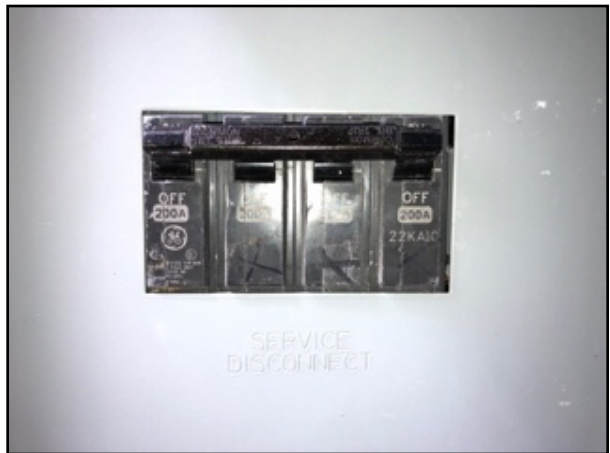
Electrical service entrance header & conductors located on east side of property.

- Electrical service entrance conductors are in good & working condition.
- Electrical service is properly grounded.
- Main service disconnect breaker A & B (200 AMPs each) are located next to main service meter.
- Service entrance conductors appear in good condition within service entrance panels A & B.
- Service entrance conductors appear in good condition within main distribution panels A & B.

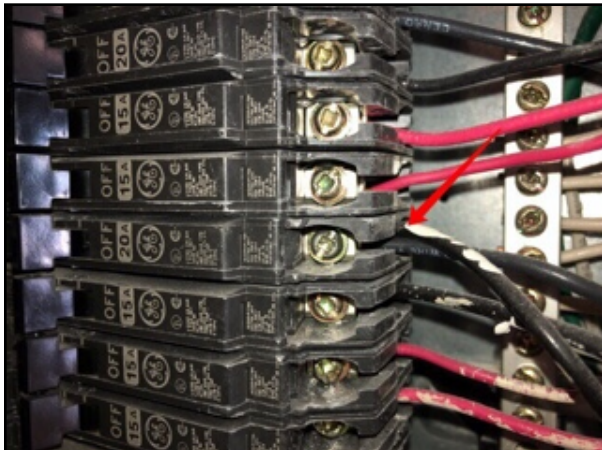
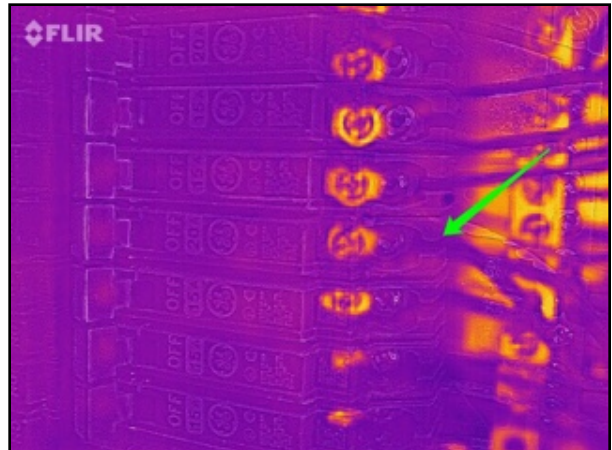
- Double-tapped 20 AMP breaker present with multiple circuits connected to a single circuit breaker within main distribution panel. (Breakers do not appear to be over heating or over loaded at the time of inspection.)

Recommend having a licensed electrician properly install additional circuit breakers to connect double-tapped circuits to their own individual circuit breaker within main distribution panel. (Estimate \$250 - \$500)

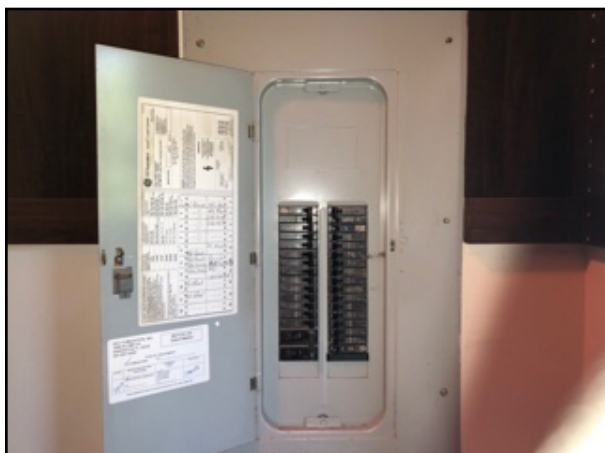
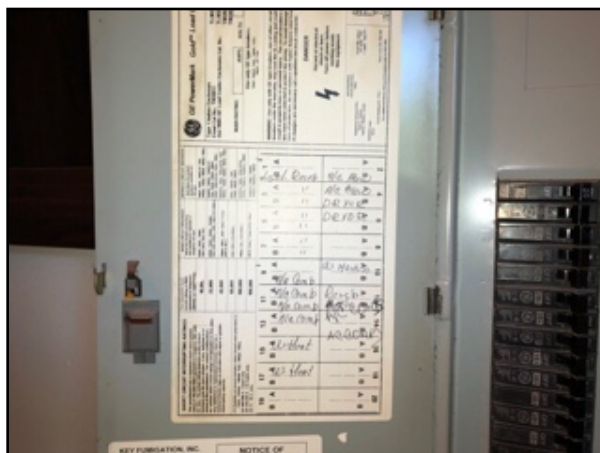
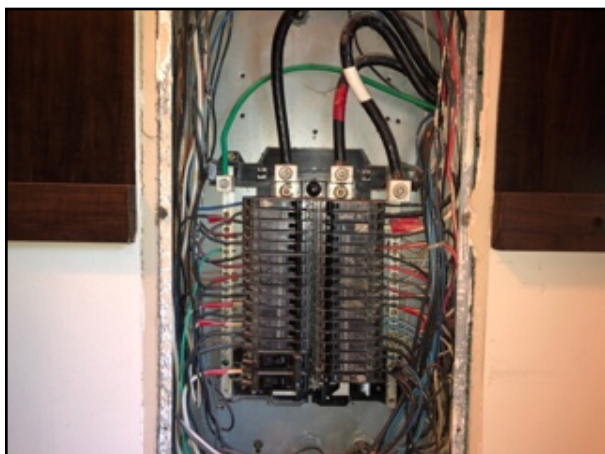
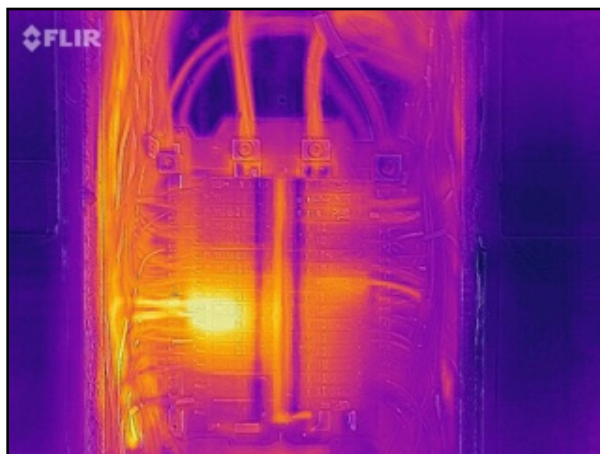
Main distribution panel B (200 AMPs) located next to main service meter within exterior north side of property.

- Distribution panel, circuit breakers, and branch wiring appear in good & working condition at the time of inspection.

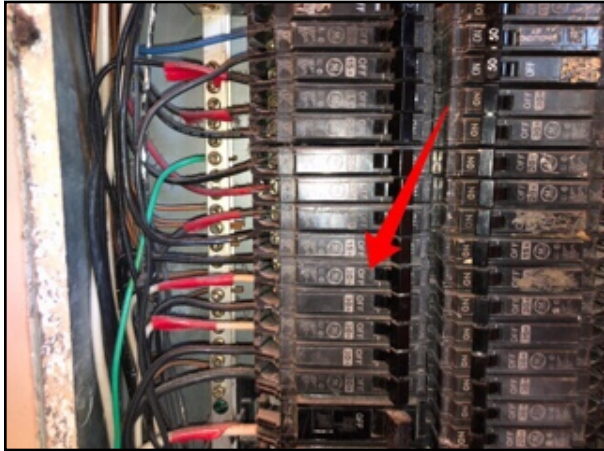
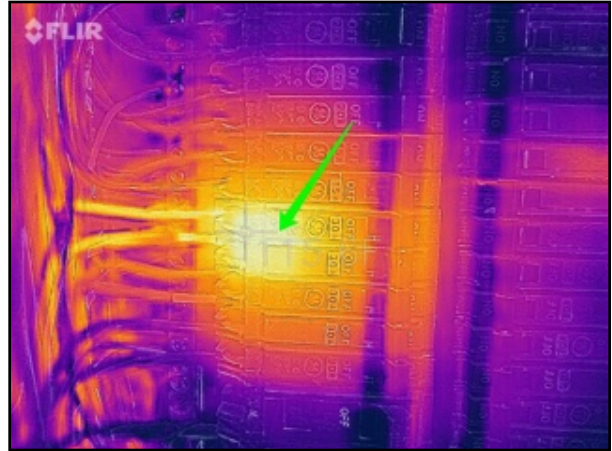
30 AMP circuit within main distribution panel appears to be overheating. (115.6 Degrees)

Recommend further evaluation of circuit and breaker by a licensed electrician to determine cause of over heating/over loading breaker and repair/replace accordingly. (Estimate: \$250 - \$500)

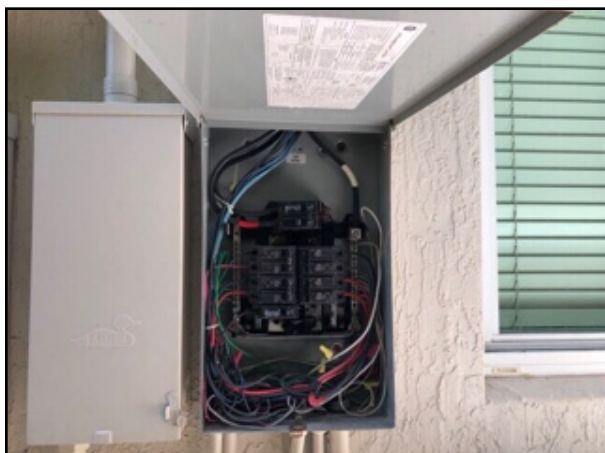
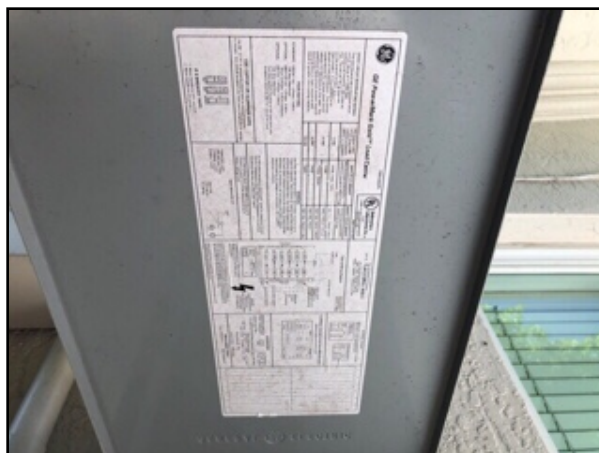
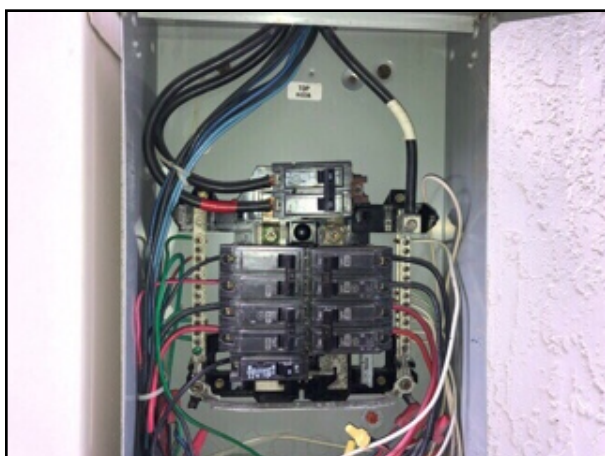
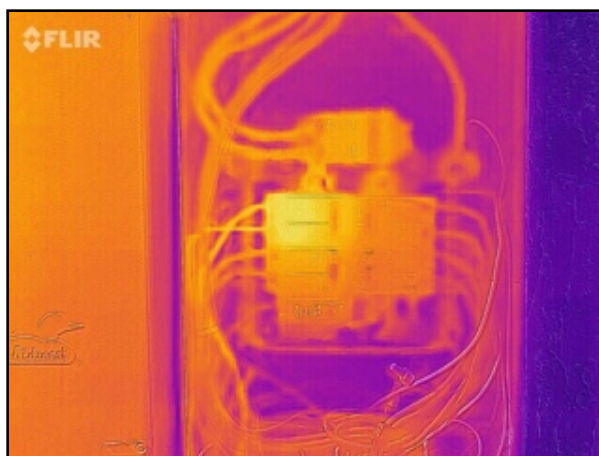
Sub-panel located next to main service meter within north side of property. (125 AMPs)

Sub-panel, circuit breakers and branch wiring are in good & working condition at the time of inspection.

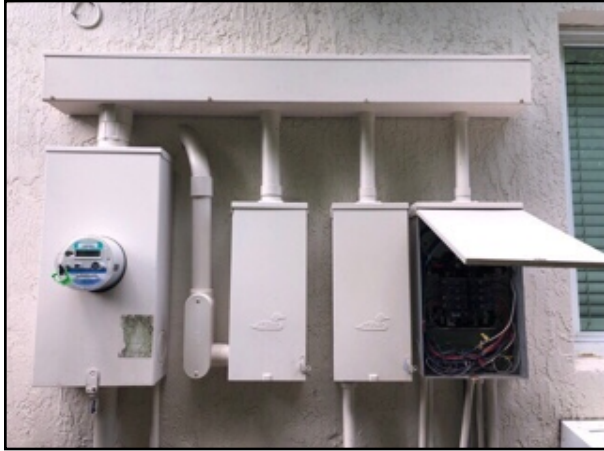
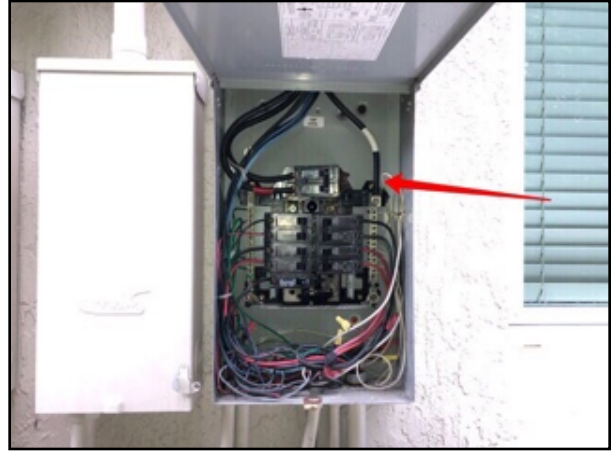
Electrical Sub-panel located next to service meter missing cover plate at time of inspection.

Recommend replacing missing cover plate within Sub-panel. (Estimate: \$50 - \$150)

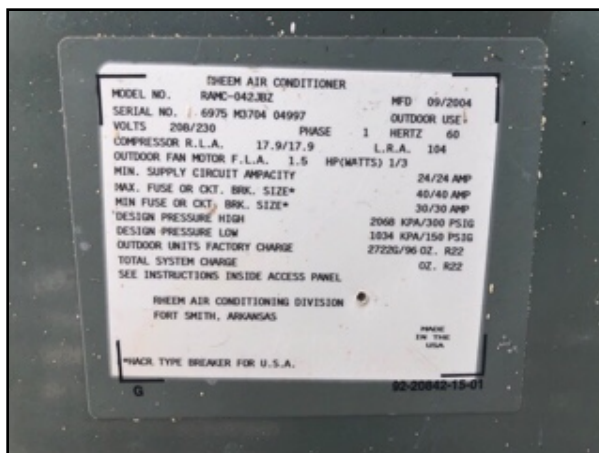
Figure 42-2

- HVAC currently 15 years old.
- HVAC system does not appear to be compressing or cooling refrigerant line properly at the time of the inspection. As HVAC system unit is nearing end off efficient life expectancy, estimate system may need to be replaced. (Estimate: \$2,000 - \$4,000)

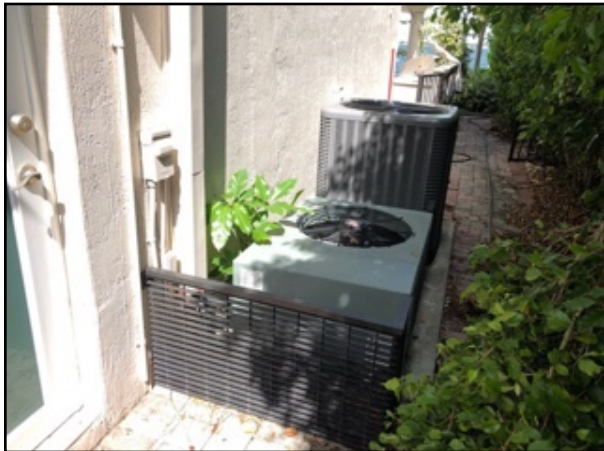
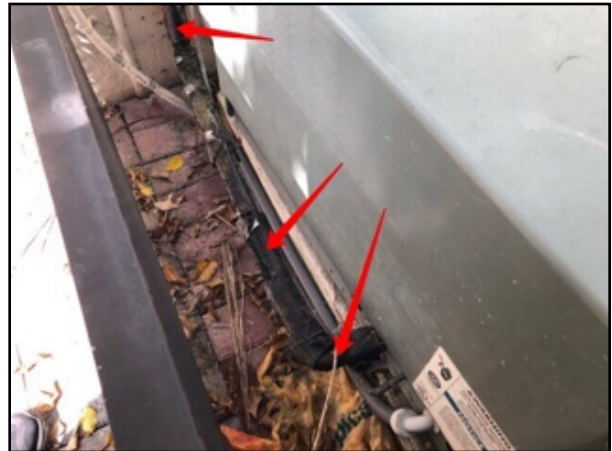
Insulation weathered/worn away around refrigerant line to exterior compressor unit.

- Missing insulation may cause refrigerant line to condensate and cause water damage to surrounding areas.

Recommend replacing insulation around refrigerant line to exterior compressor unit. (Estimate: \$100 - \$200)

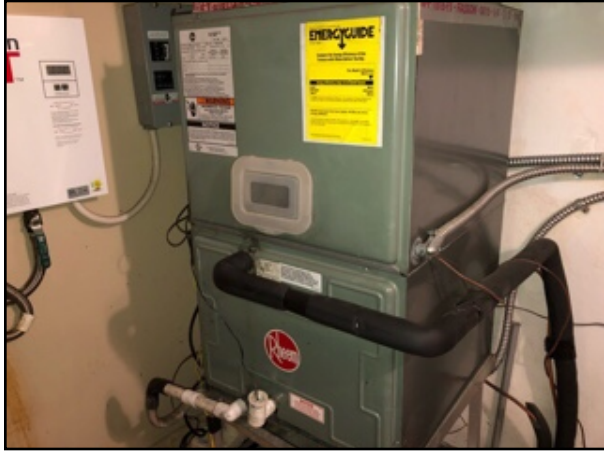
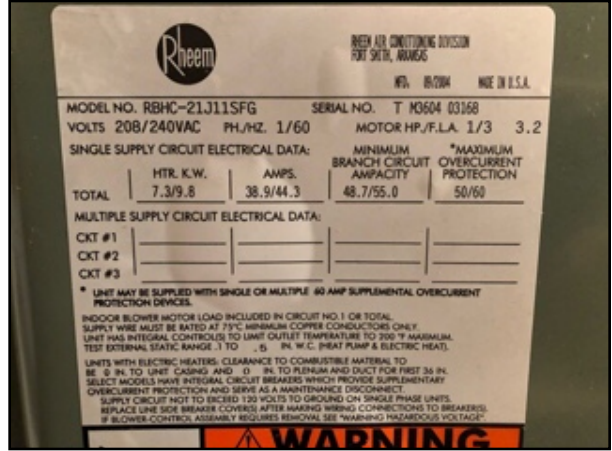
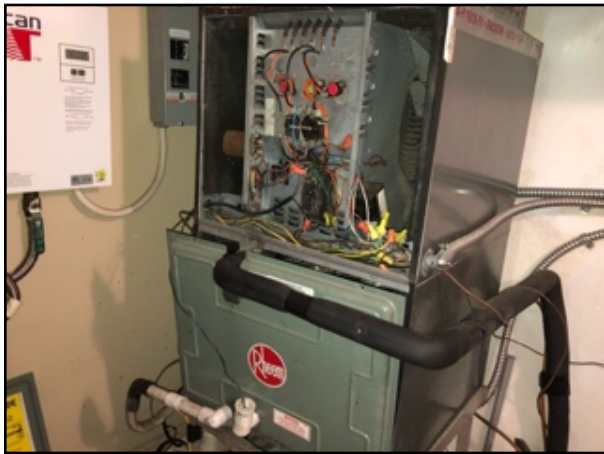
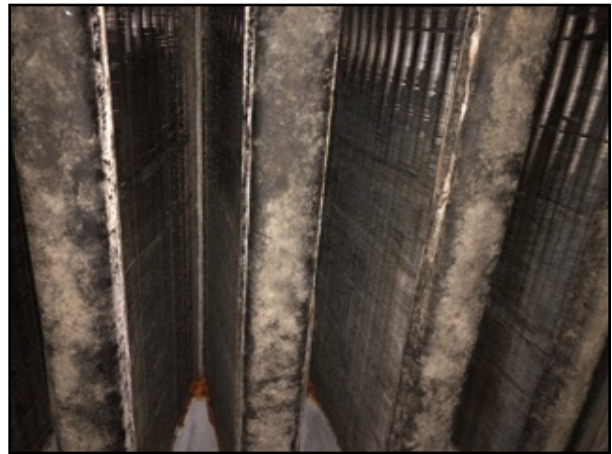
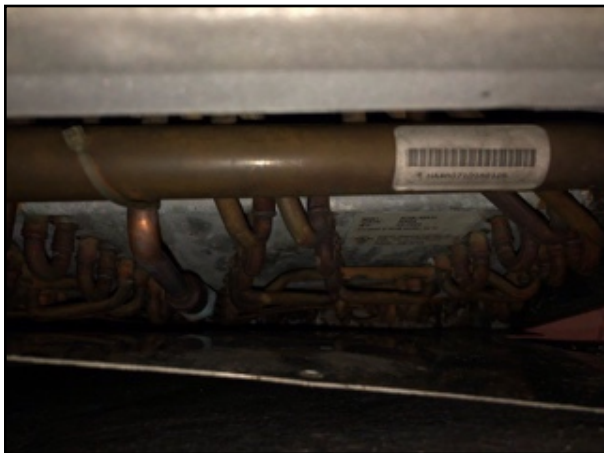
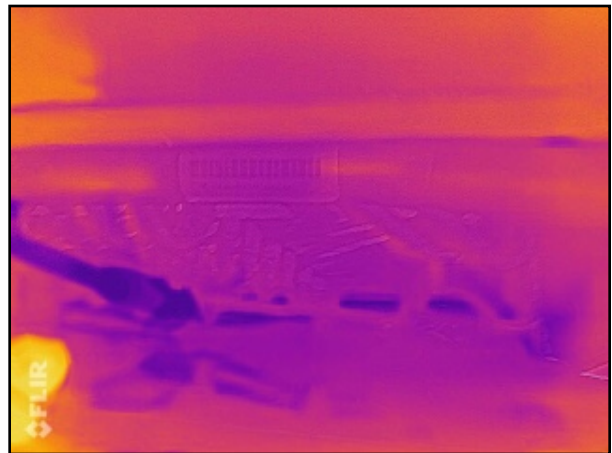
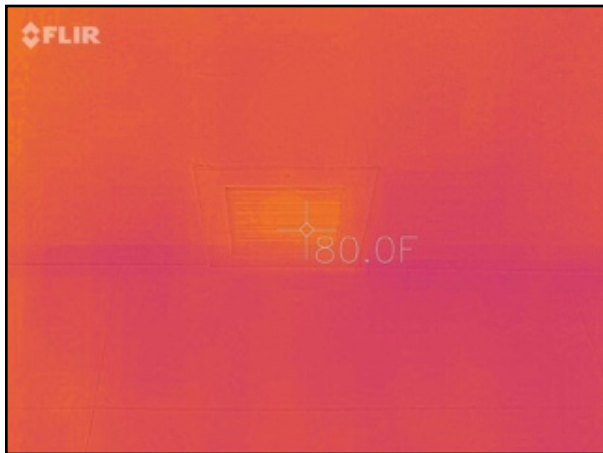
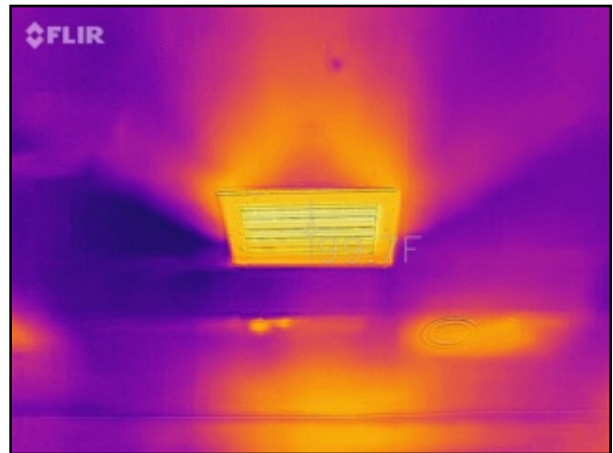
- HVAC system in fair condition at the time of inspection.

- A/C radiator & coils appear in fair condition at the time of inspection.

Recommend further evaluation by a licensed HVAC technician and repair or replace accordingly. (Estimate \$2,000 - \$4,000)

Recommend having HVAC system serviced/cleaned periodically by a licensed HVAC technician for better maintenance.

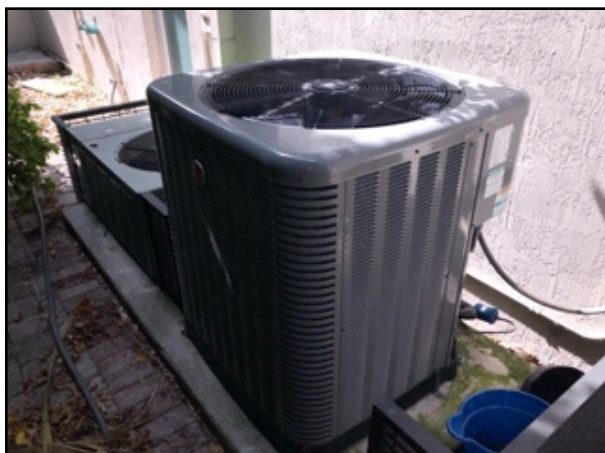
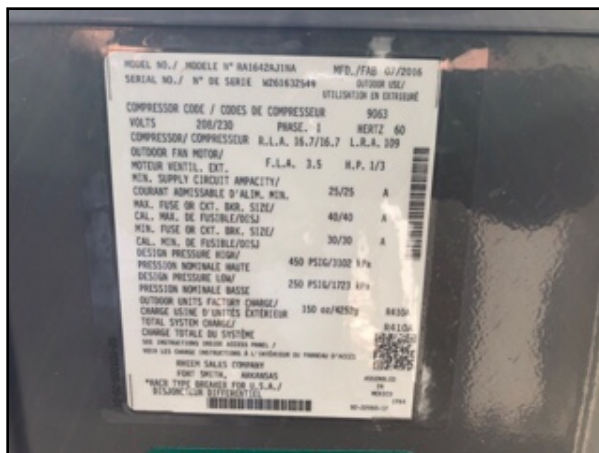
Comment 45:
HVAC system exterior compressor unit.
