Home Pro Miami

Home Inspection Report

1175 Sample Dr

Inspected on Thu, Aug 29 2019 at 10:00 AM

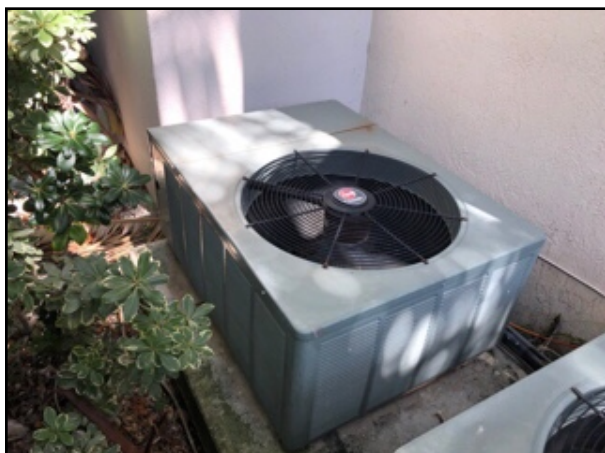
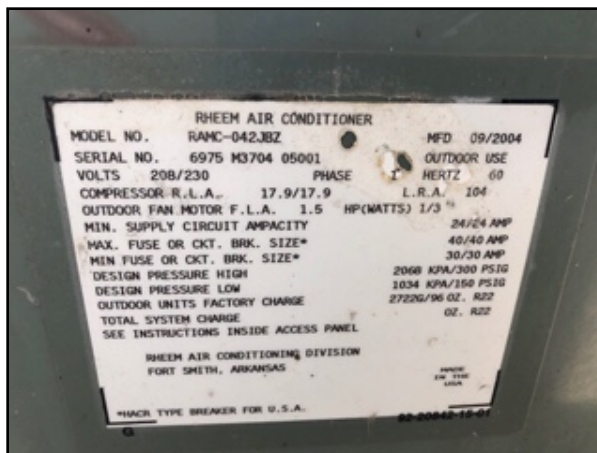
HVAC system exterior compressor unit.

- HVAC currently 15 years old.
- HVAC system functioning properly at the time of inspection, but unit is nearing end off efficient life expectancy. HVAC system may need to be replaced in near future. (Estimate: \$2,000 - \$4,000)

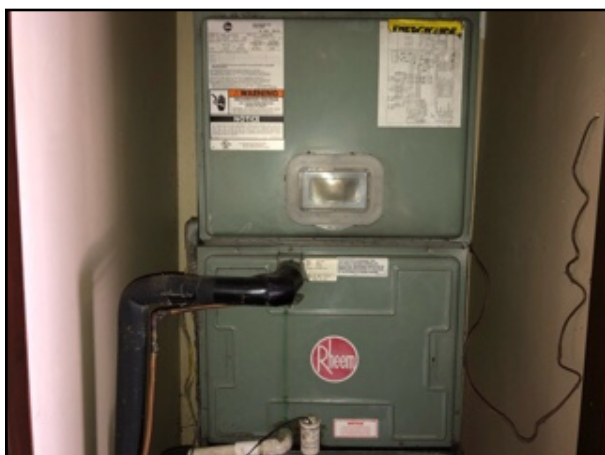
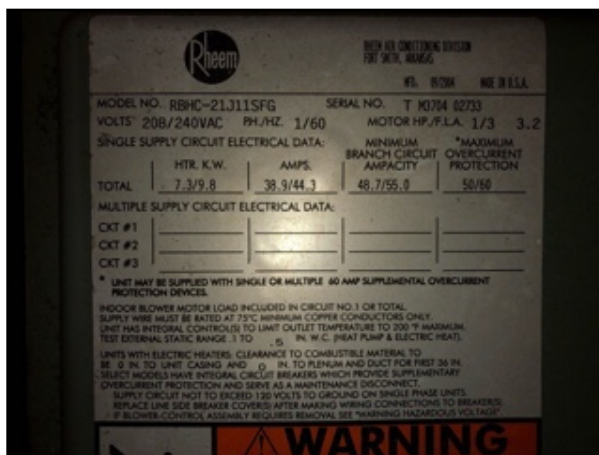
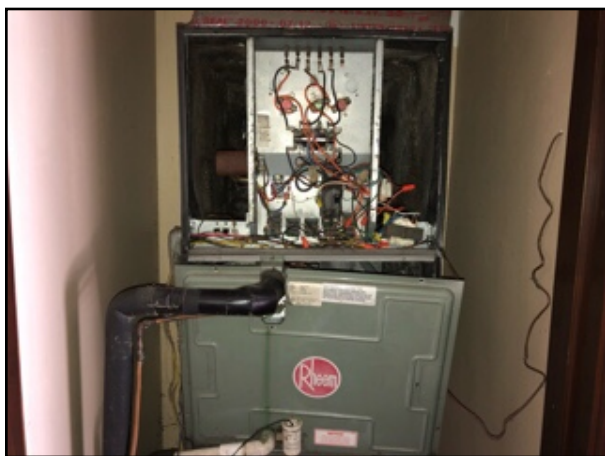
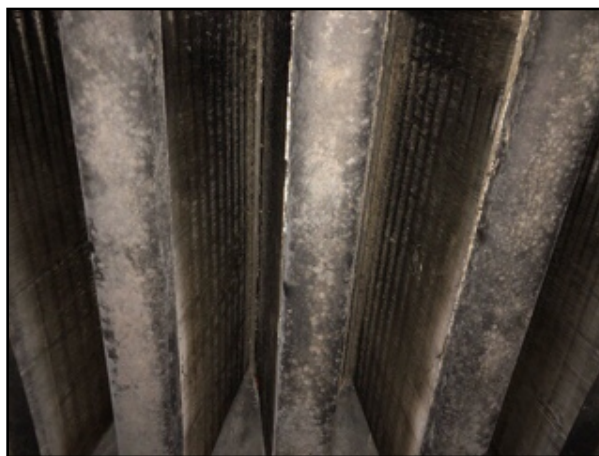
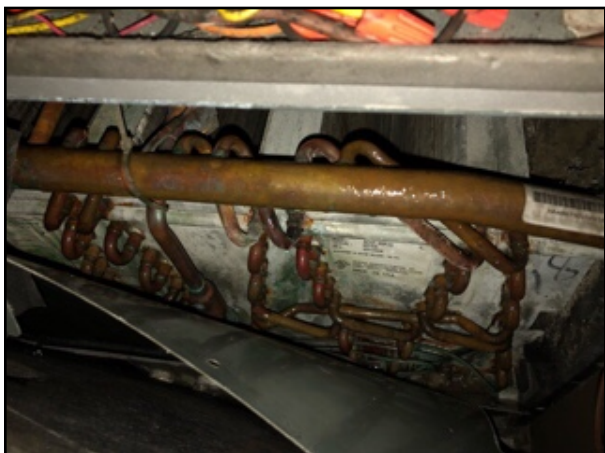
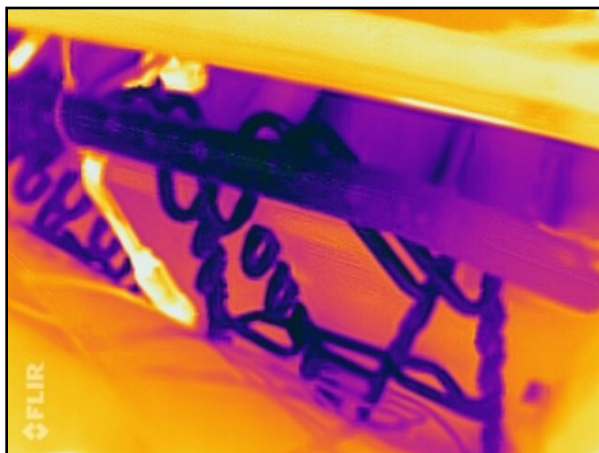
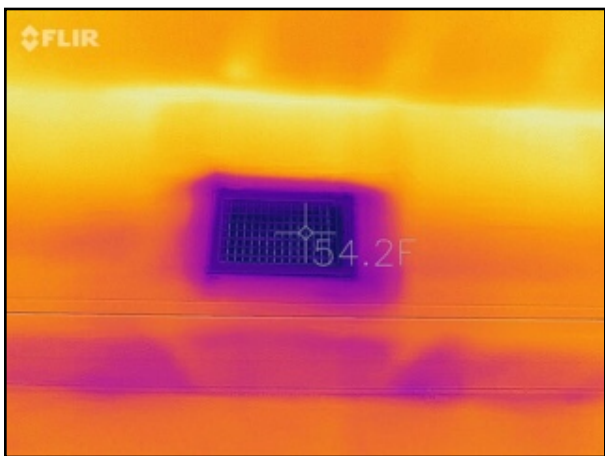
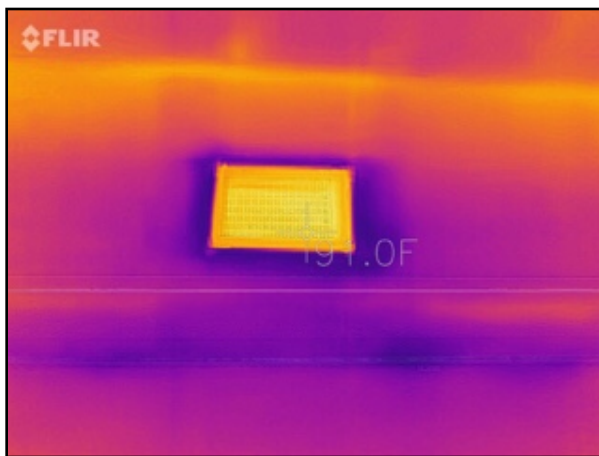
- HVAC system controlling master bedroom.
- HVAC system in good & working condition at the time of inspection.
- A/C radiator & coils appear in good condition at the time of inspection.
- Minor debris build up along exterior of radiator.
- HVAC currently 15 years old, and nearing end of efficient life expectancy. HVAC system may need to be replaced in near future. (Estimate: \$2,000 - \$4,000)

Recommend having HVAC system serviced/cleaned periodically by a licensed HVAC technician for better maintenance.

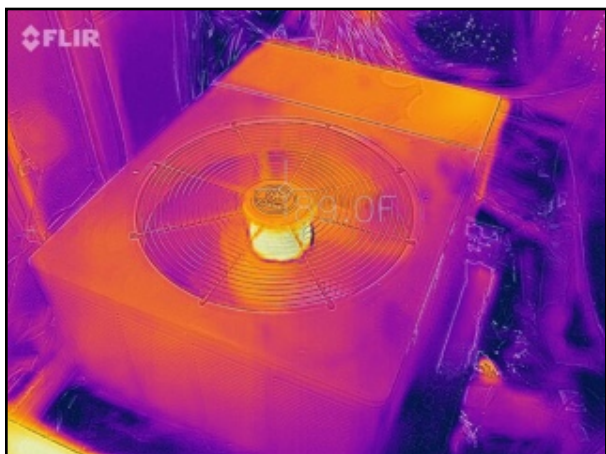
Figure 51-3

- HVAC currently 15 years old.
- HVAC system does not appear to be compressing or cooling refrigerant line properly at the time of the inspection. As HVAC system unit is nearing end of efficient life expectancy, estimate system may need to be replaced. (Estimate: \$2,000 - \$4,000)

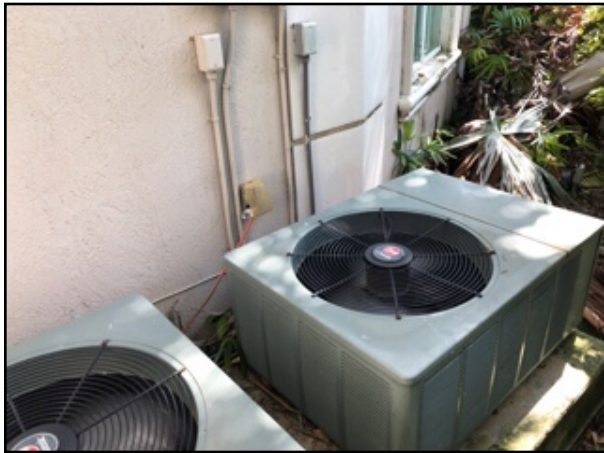
Figure 52-1

Insulation weathered/worn away around refrigerant line to exterior compressor unit.

- Missing insulation may cause refrigerant line to condensate and cause water damage to surrounding areas.

Recommend replacing insulation around refrigerant line to exterior compressor unit. (Estimate: \$100 - \$200)

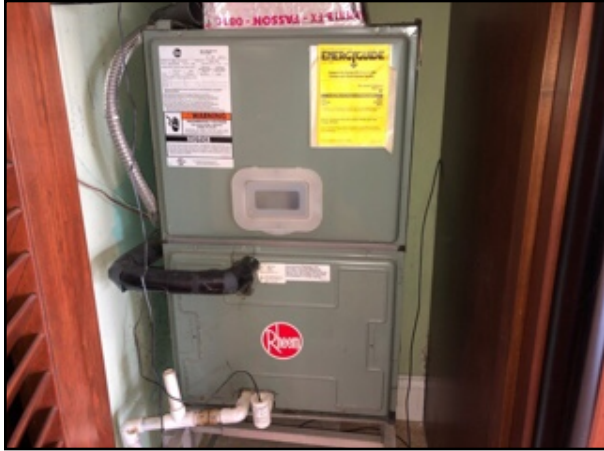
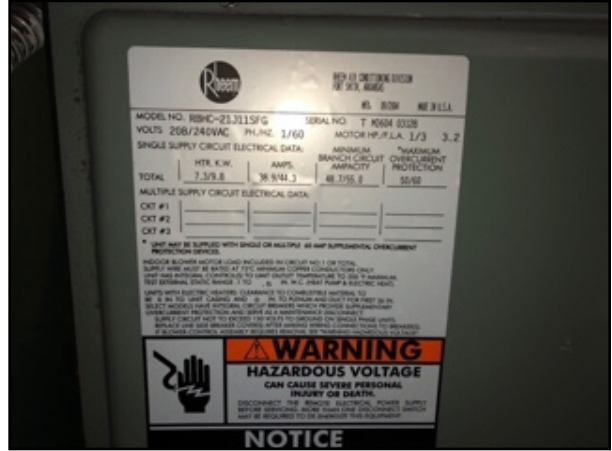
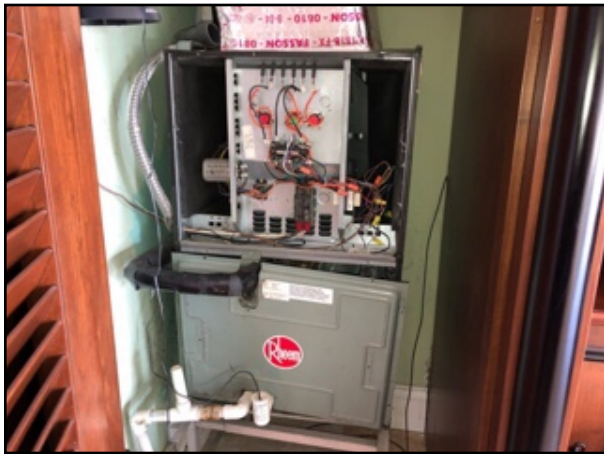
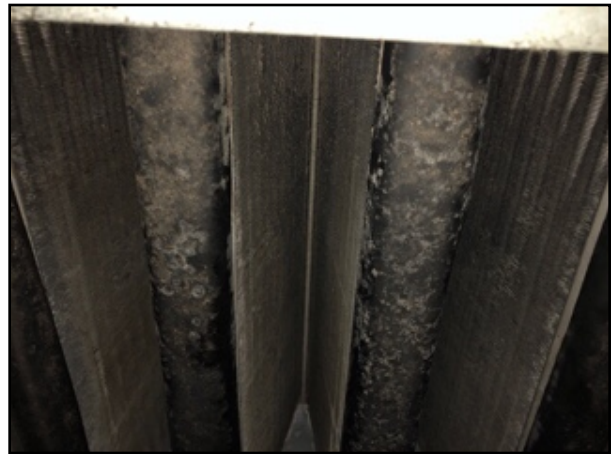
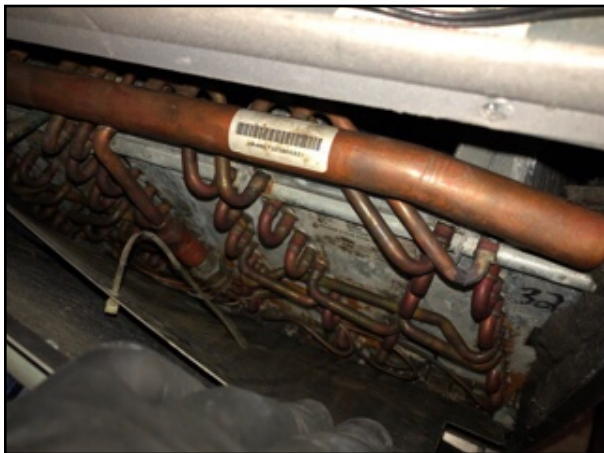
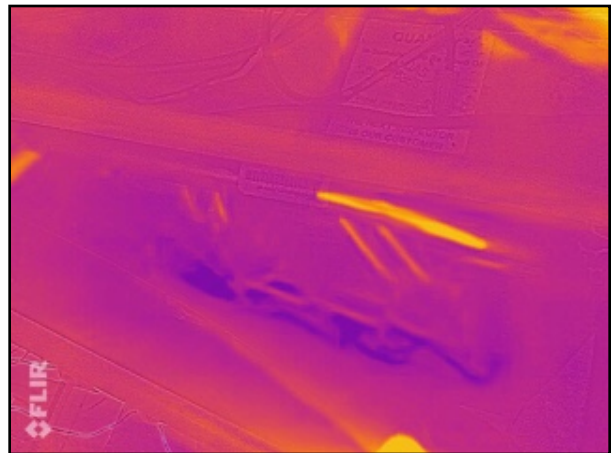
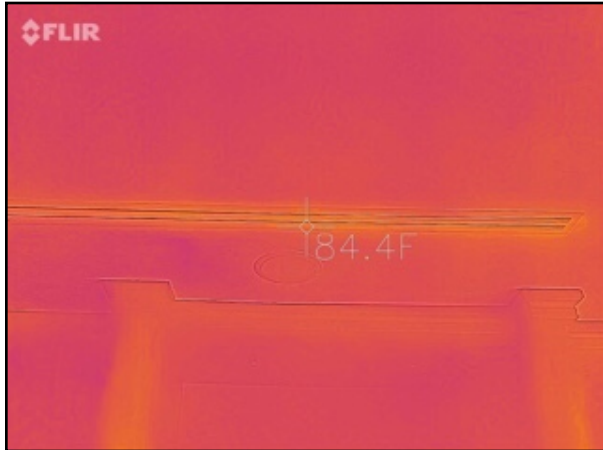
- HVAC system controlling living room & dining room.
 - HVAC system in fair condition at the time of inspection.
 - A/C radiator & coils appear in fair condition at the time of inspection.
 - Minor debris build up along exterior of radiator.
 - HVAC system not heating at the time of the inspection.
 - HVAC system coils do not appear to be cooling properly. Estimate due to compressor unit not functioning properly.
 - HVAC currently 15 years old and nearing end of efficient life expectancy.
- Recommend further evaluation by a licensed HVAC technician and repair or replace accordingly. (Estimate \$2,000 - \$4,000)

Recommend having HVAC system serviced/cleaned periodically by a licensed HVAC technician for better maintenance.

HVAC systems over 10 years old should be checked, cleaned and serviced yearly by a licensed HVAC technician.

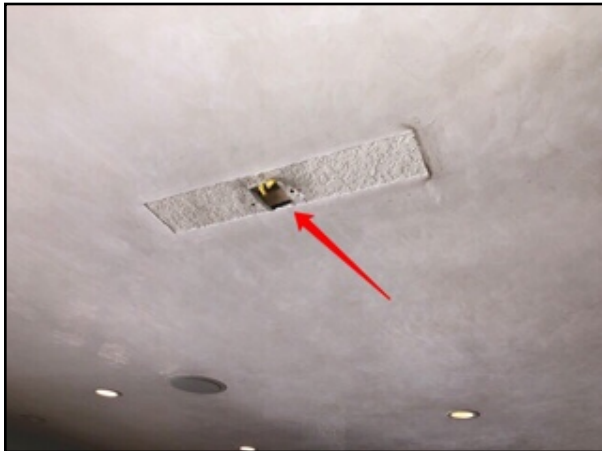
Figure 55-1

Missing lighting fixtures throughout kitchen leaving exposed wiring. Replace missing lighting fixtures. (Detailed quotation required)

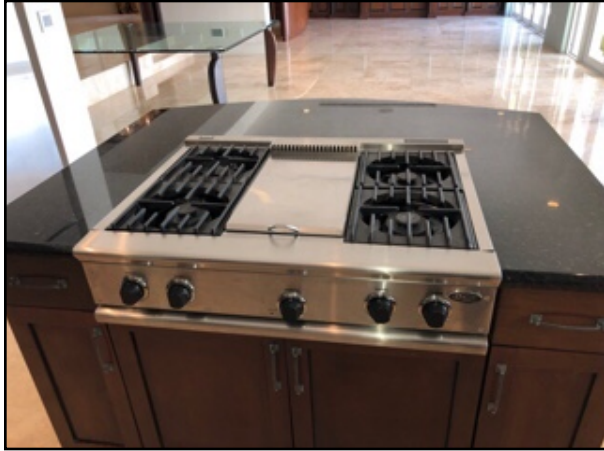
Figure 57-1

Range cooktop appears in good & working condition.

- Unable to properly test as gas service is disconnected from property at the time of inspection.

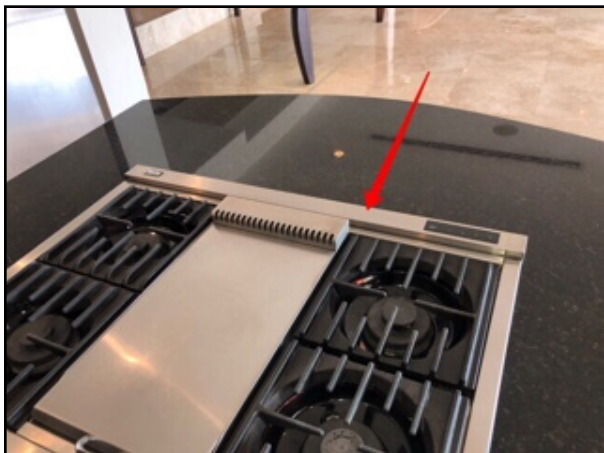
Figure 58-1

Retractable range hood over cooktop not functioning properly at the time of inspection.

Recommend further evaluation by a licensed technician and repair/replace accordingly. (Estimate: \$500 - \$1,000)

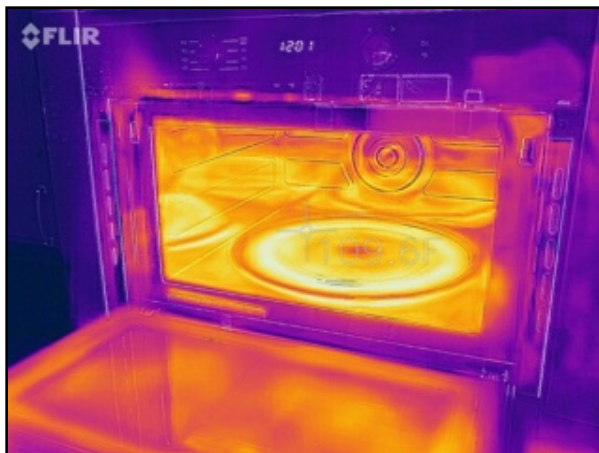
Figure 60-2

Comment 60:
Microwave functioning properly at the time of inspection.
- Control panel is currently broken/loose.
Recommend further evaluation by a licensed technician and repair/replace accordingly. (Estimate: \$100 - \$250)

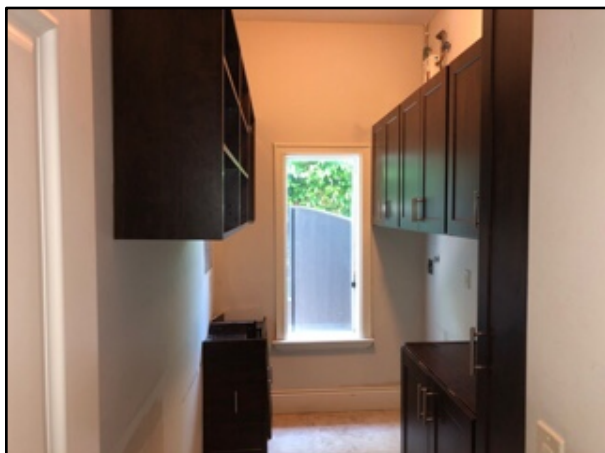
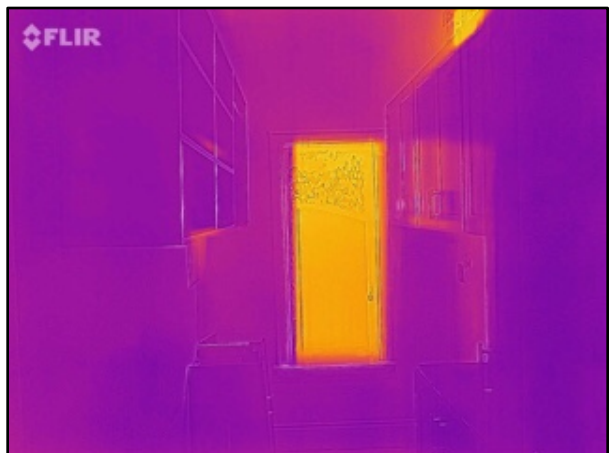
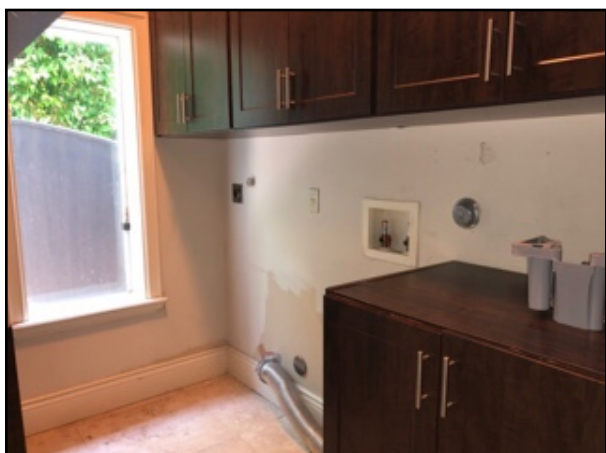
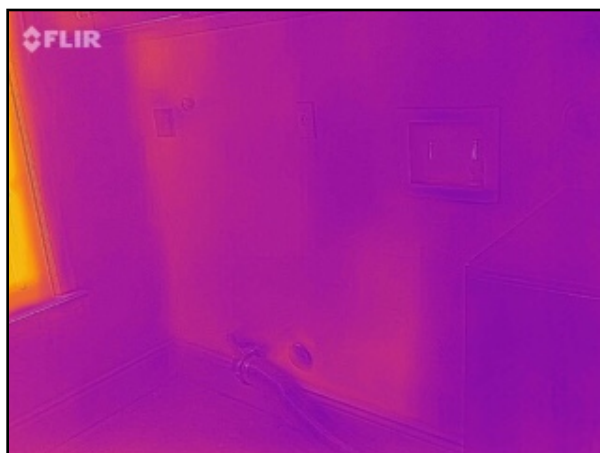
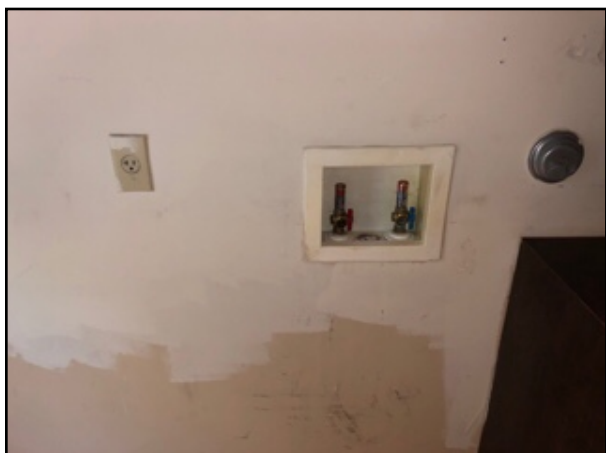
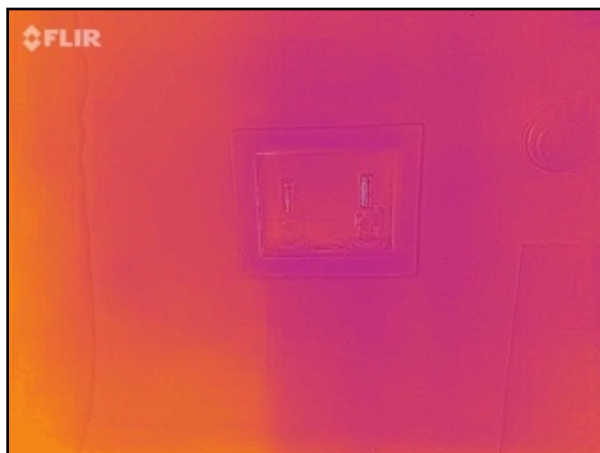
Laundry Room Photos.

- Washer & dryer not installed at the time of inspection.
- No indications of water damage or leaking at the time of inspection.

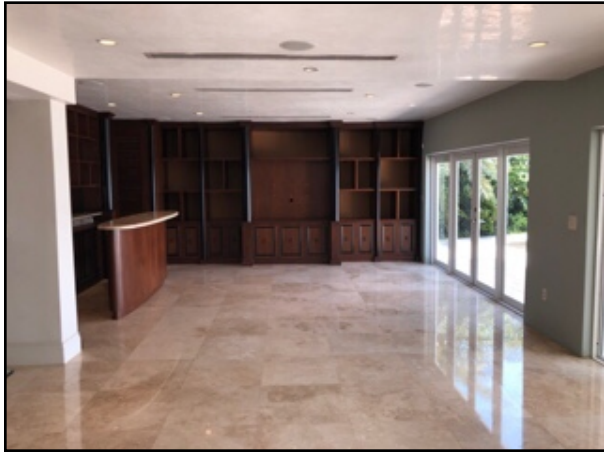
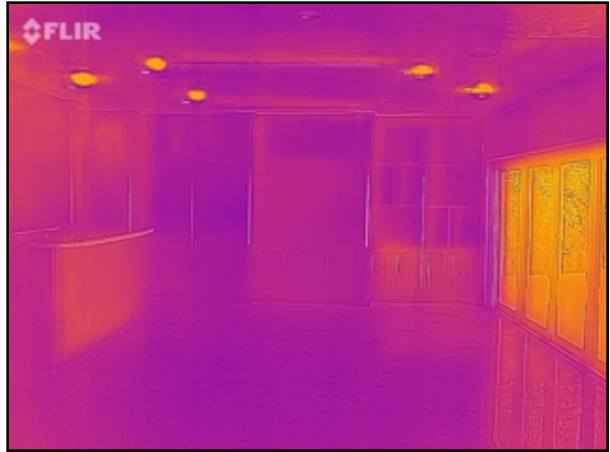
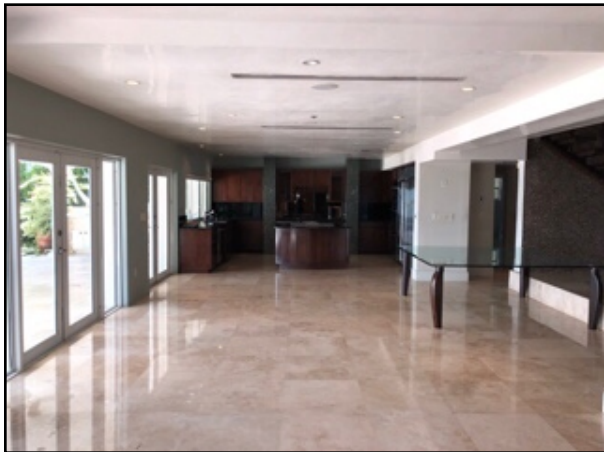
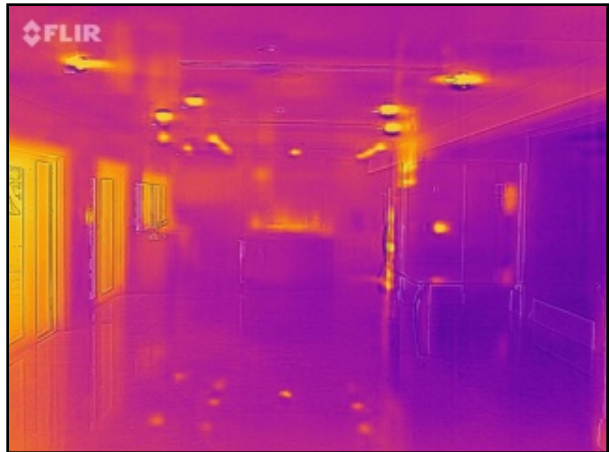
Comment 67:
Living Room Photos.

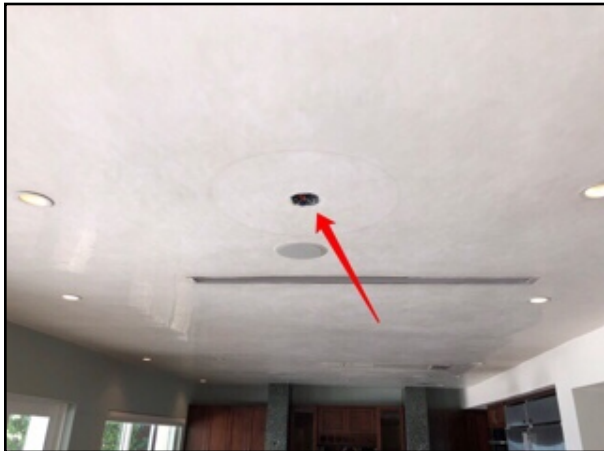
Figure 68-1

**Comment 68:**
Missing overhead lighting fixture in living room leaving exposed wiring.
Replace missing lighting fixture. (Detailed quotation required)

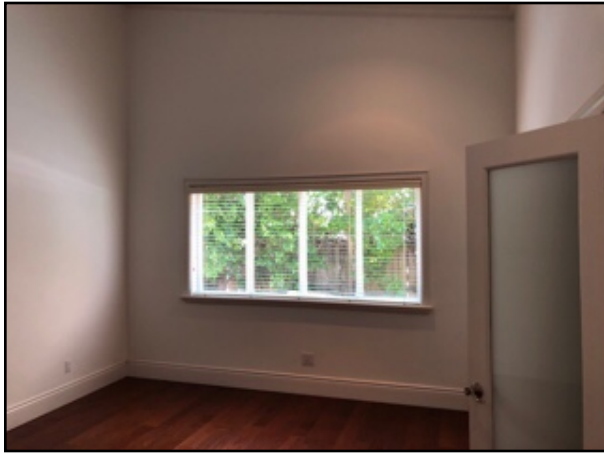
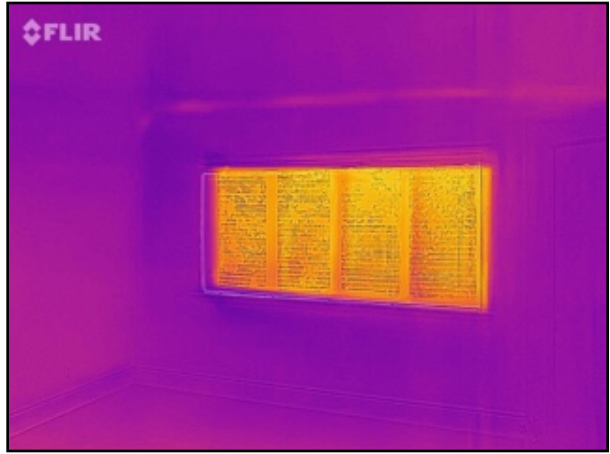
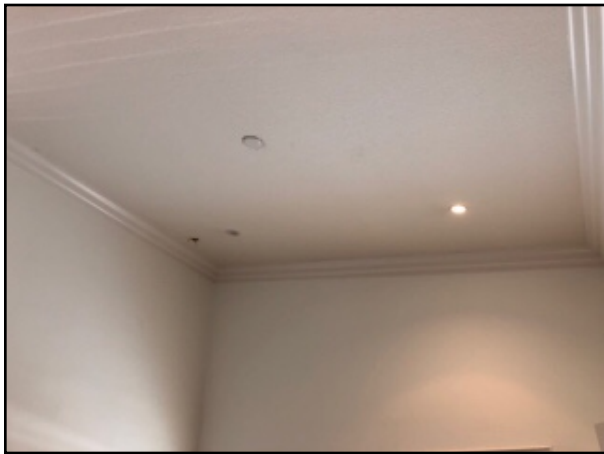
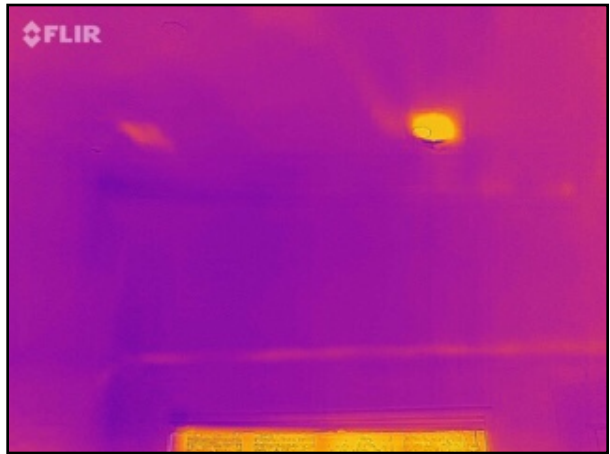
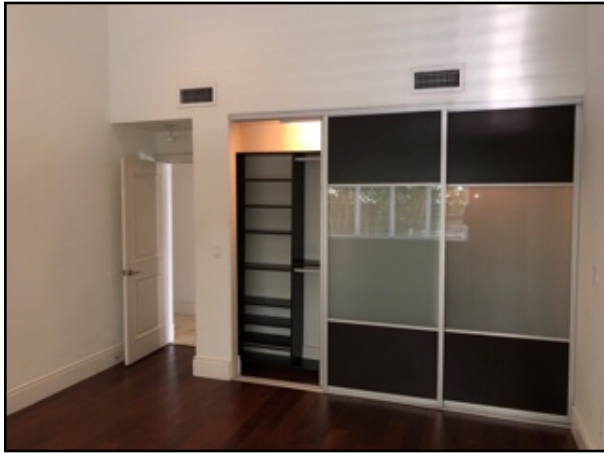
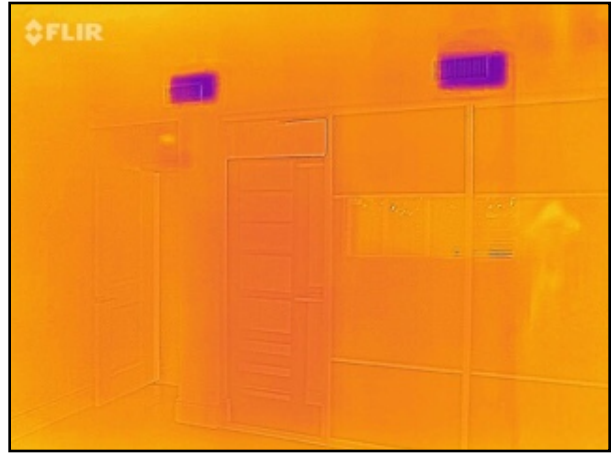
Comment 69:
Downstairs Bedroom #1 Photos.

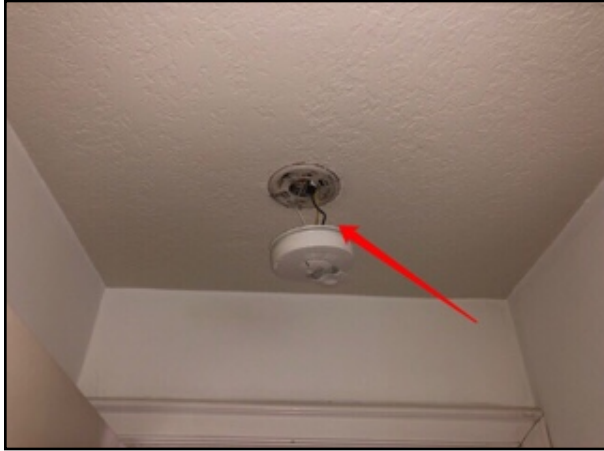
Figure 70-1

Smoke detector not properly installed & missing battery within downstairs bedroom #1.

Properly connect smoke detector, and replace missing 9V battery. (Estimate: \$25 - \$50)

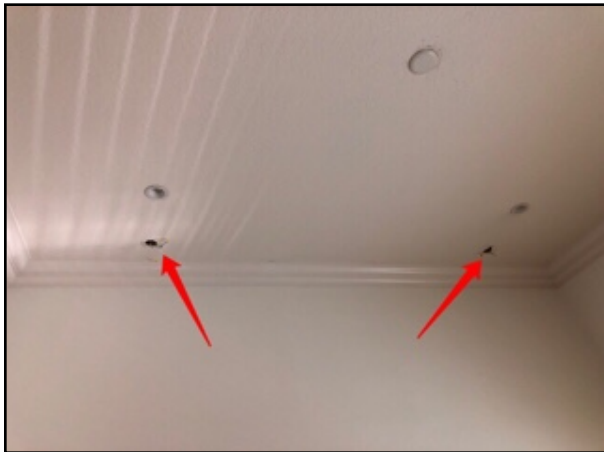
Figure 71-1

Missing overhead lighting fixtures within downstairs bedroom #1 leaving exposed wiring.

Replace missing lighting fixtures. (Detailed quotation required)

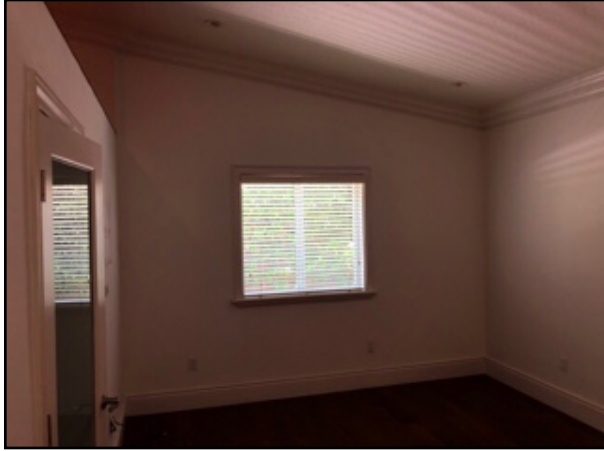
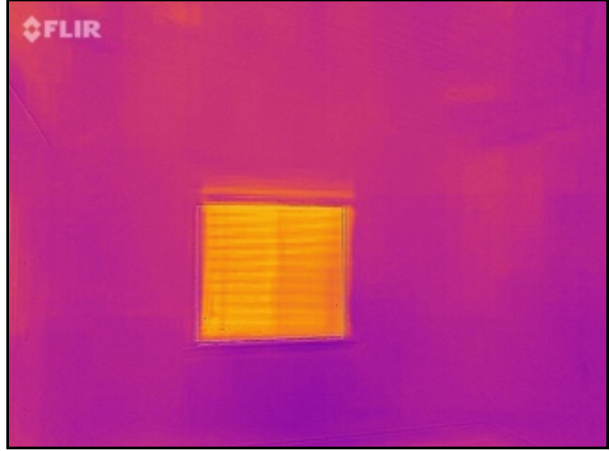
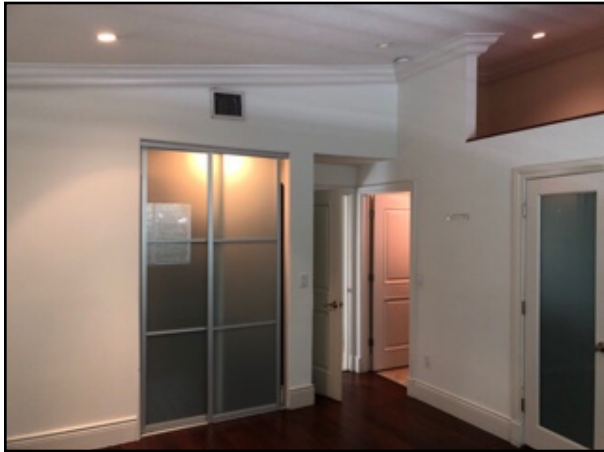
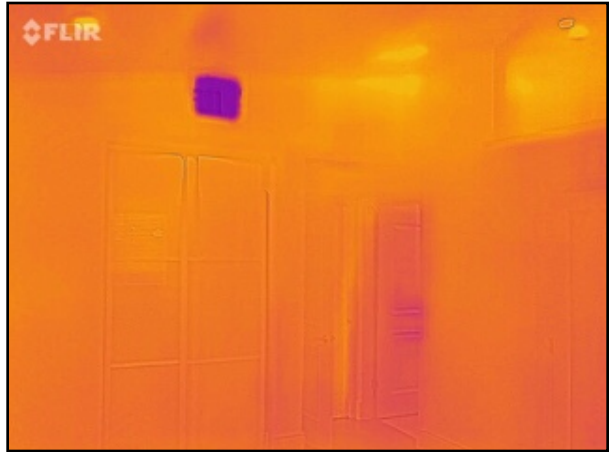
Comment 72:
Downstairs Bedroom #2 Photos.

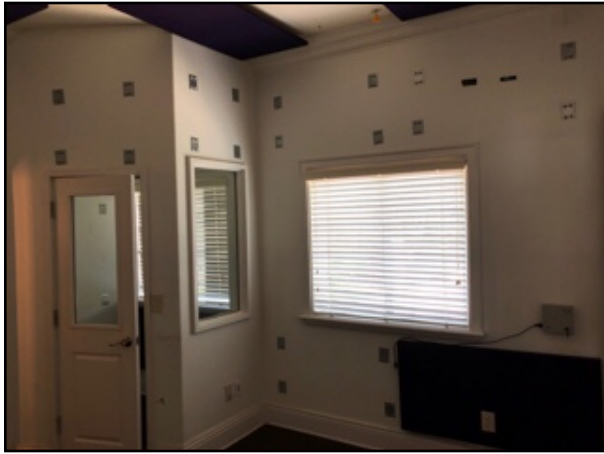
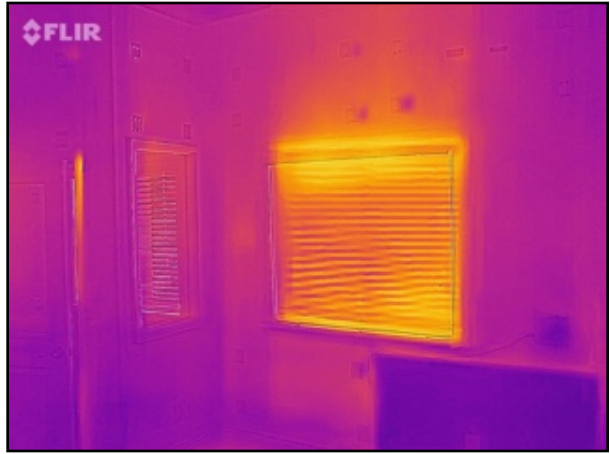
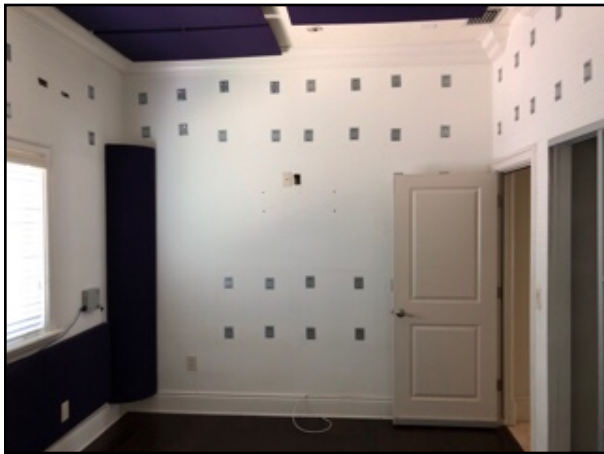
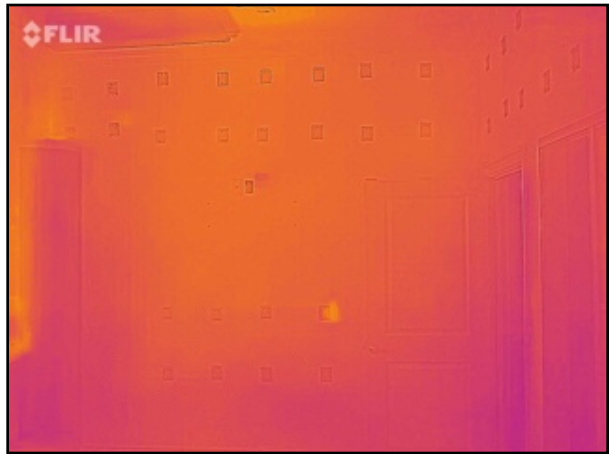
Comment 73:
Downstairs Bedroom #3 Photos.

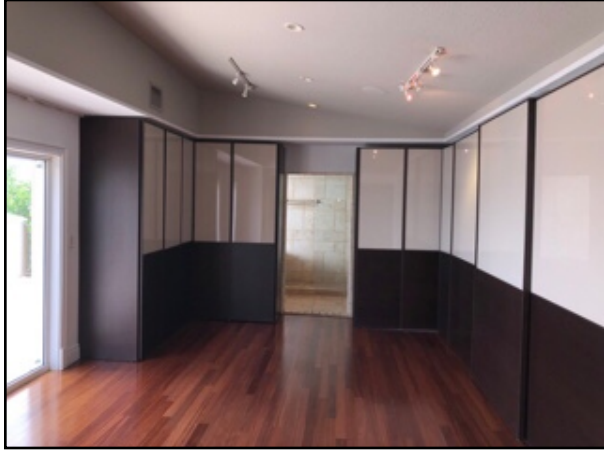
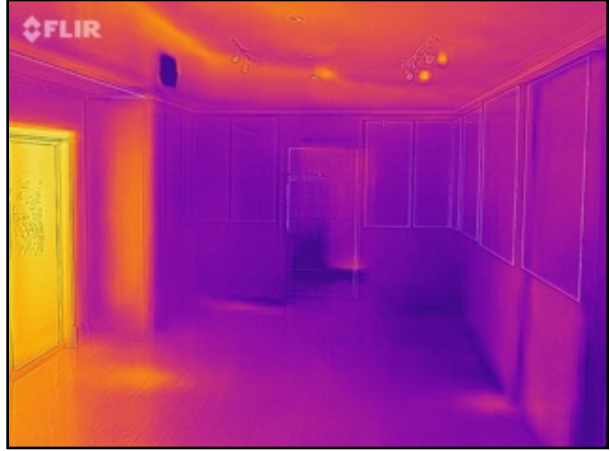
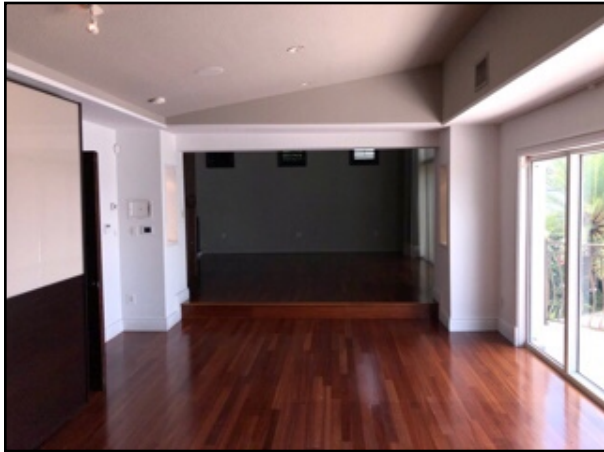
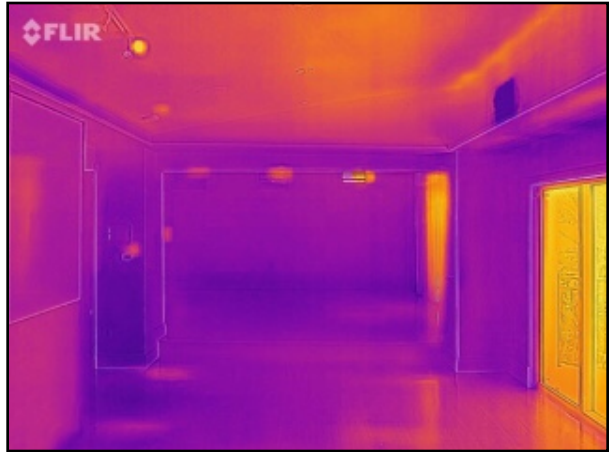
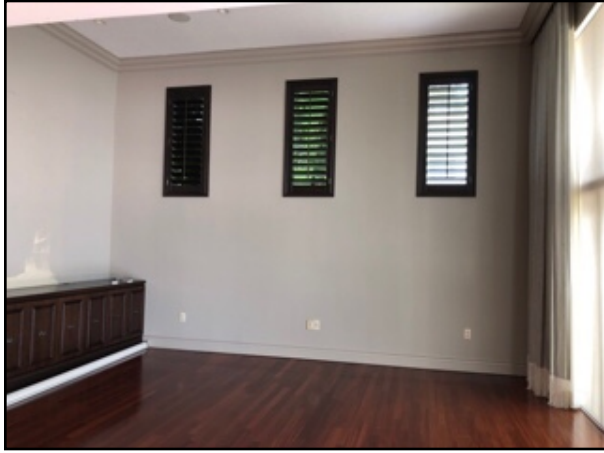
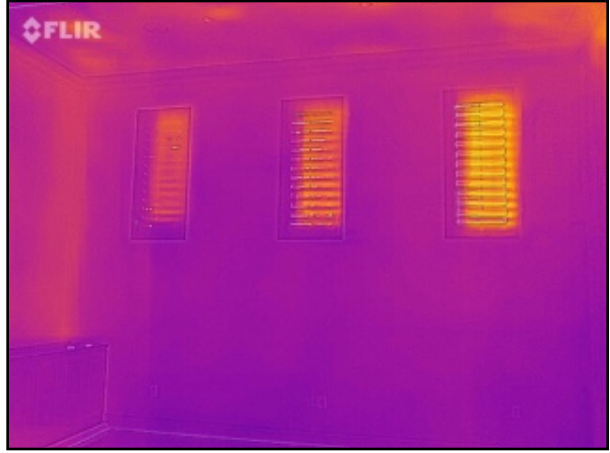
Comment 74:
Upstairs Master Bedroom Photos.

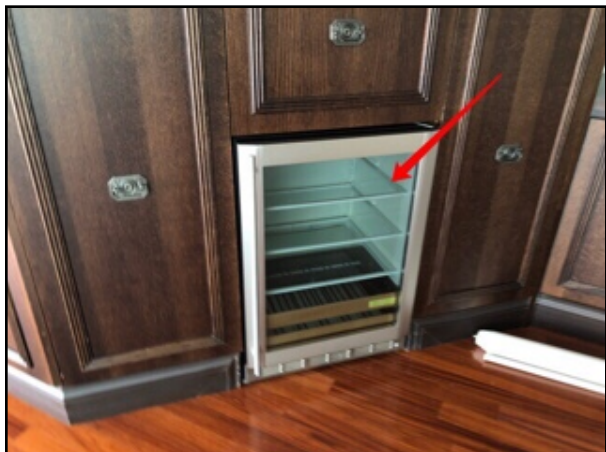
Figure 75-1

Built-in mini wine refrigerator within upstairs master bedroom not functioning properly at the time of inspection.

Repair or replace mini wine refrigerator. (Estimate: \$400 - \$800)

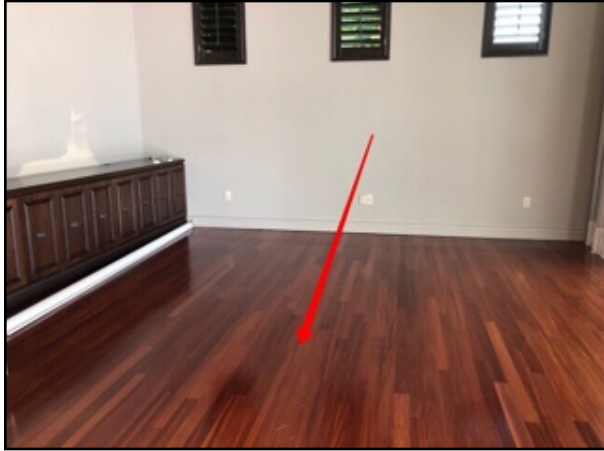
Figure 76-1

Loose wood flooring within master bedroom popping when pressure is applied. Recommend further evaluation of sub-flooring below and repair/replace accordingly. (Estimate: \$250 - \$500)

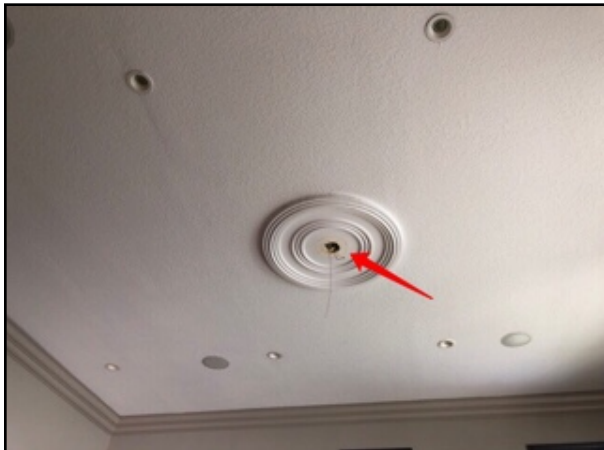
Figure 77-1

Missing overhead lighting fixture in upstairs master bedroom leaving exposed wiring.

Replace missing lighting fixture. (Detailed quotation required)

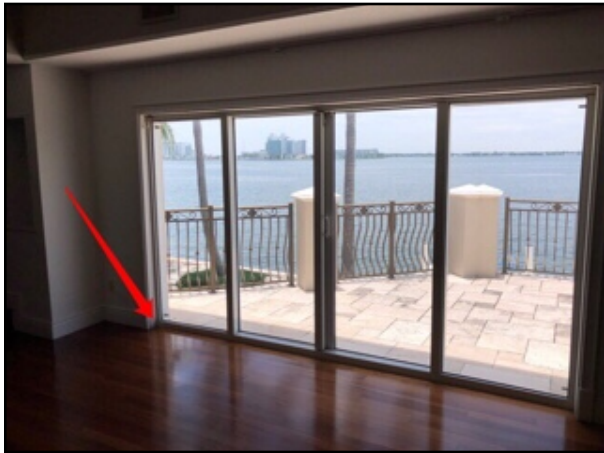
Figure 78-1

Minor water damage found around corner rear sliding glass door/window frame in master bedroom to exterior terrace.

- Indications of minor moisture intrusion along interior walls around door/window frame at the time of inspection.

Recommend repairing/re-sealing around exterior of window framing to prevent possible moisture intrusion or water damage in the future. (Estimate: \$150 - \$300)

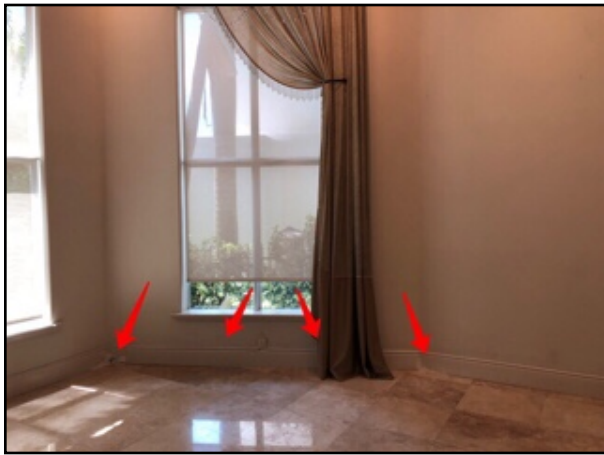
Figure 80-1

Apparent water damage to drywall around base of wall & baseboards below dining room window.

- Indications of current moisture intrusion detected in wall. Estimate leaking from window frame above.

Recommend re-sealing window above to prevent further leaking & water damage.

Replace water damaged drywall & baseboards. (Estimate: \$250 - \$500)

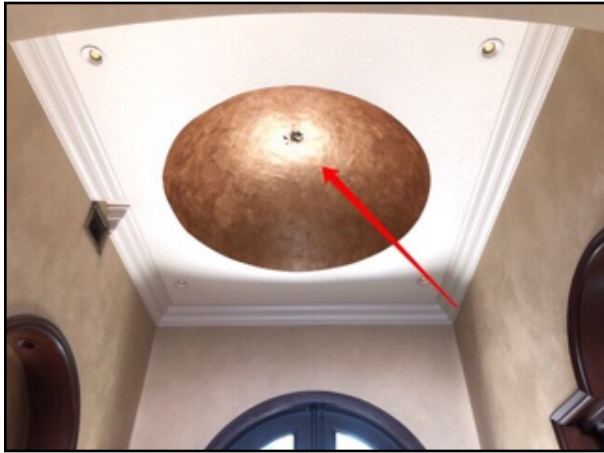
Figure 82-1

Missing overhead lighting fixture/chandelier in over front entrance/foyer leaving exposed wiring.

Replace missing lighting fixture/chandelier. (Detailed quotation required)

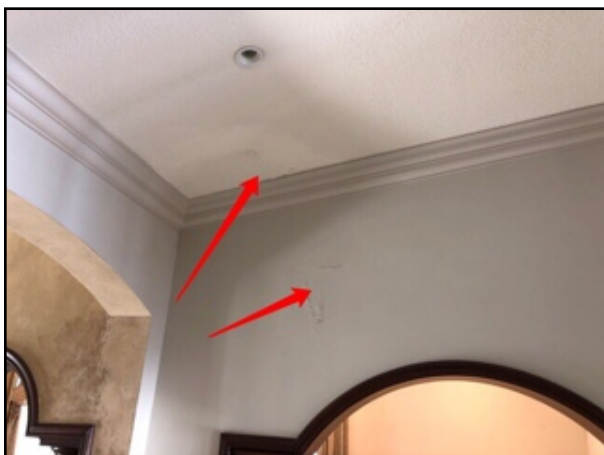
Figure 83-1

Water damage/active moisture intrusion detected along ceiling & wall over front entrance hallway adjacent to dining room.

- Estimate active roof leak from above currently causing moisture intrusion & water damage.

Recommend having a licensed roofer further evaluate roof coverings above & repair accordingly to prevent further moisture intrusion or water damage.

Recommend replacing water damaged drywall over front entrance hallway adjacent to dining room. (Estimate: \$1,000 - \$2,000)

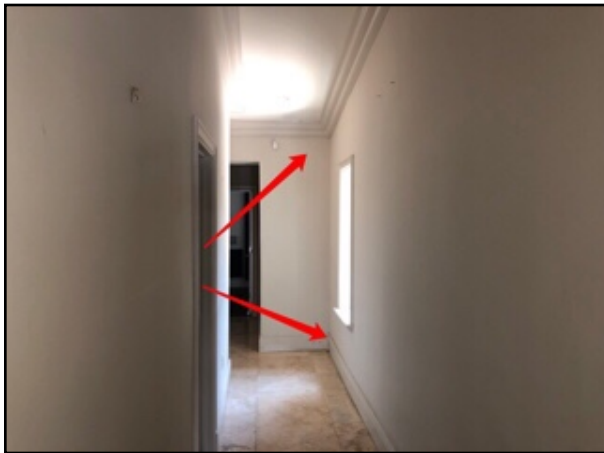
Figure 84-1

Water damage/active moisture intrusion detected along ceiling & wall over downstairs bedroom hallway.

- Estimate active roof leak from above currently causing moisture intrusion & water damage.

Recommend having a licensed roofer further evaluate roof coverings above & repair accordingly to prevent further moisture intrusion or water damage.

Recommend replacing water damaged drywall & baseboards in downstairs hallway. (Estimate: \$1,000 - \$2,000)

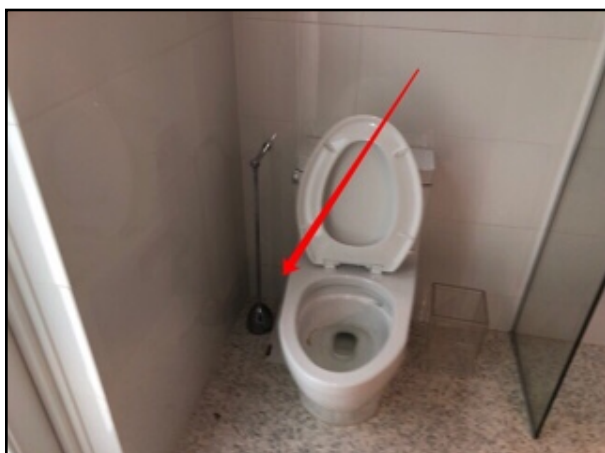
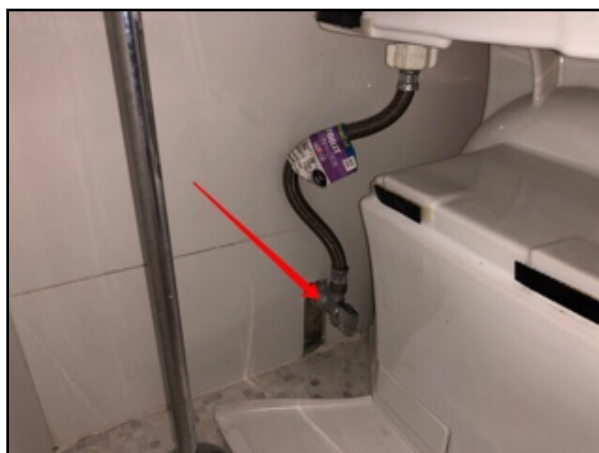
**Comment 86:**
Water supply turn-stop valve to toilet fixture leaking at the time of inspection.
Replace water supply turn-stop valve to toilet fixture. (Estimate: \$150 - \$300)

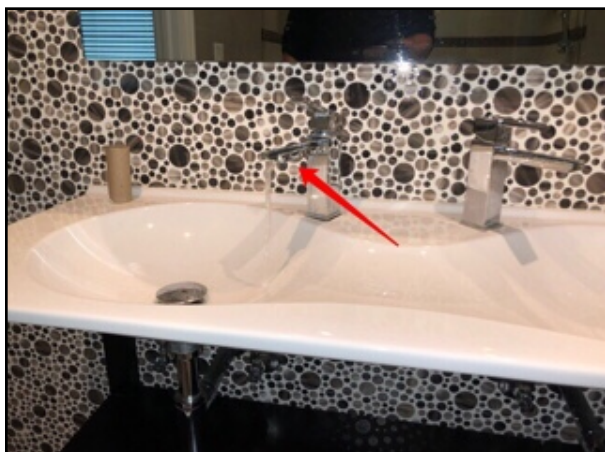
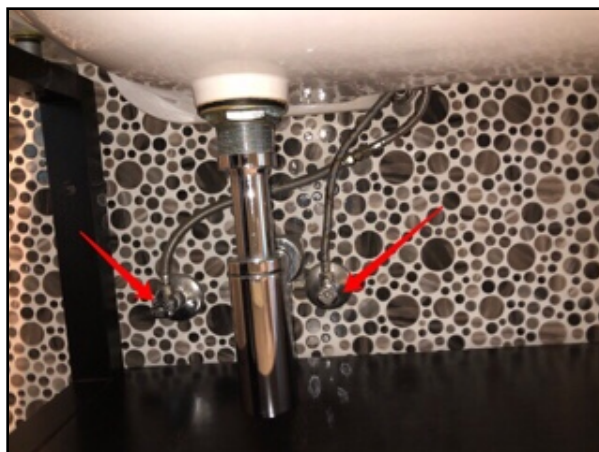
Low water pressure from left-hand sink fixture. Estimate possible blockage in water supply turn-stop valves below sink.

Recommend replacing hot & cold water supply turn-stop valves below sink fixture. (Estimate: \$200 - \$400)

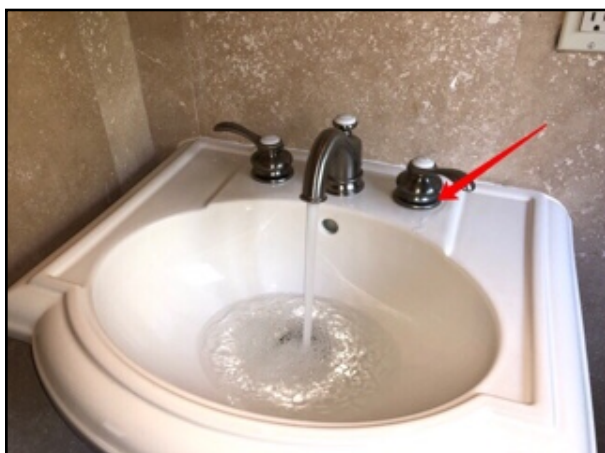
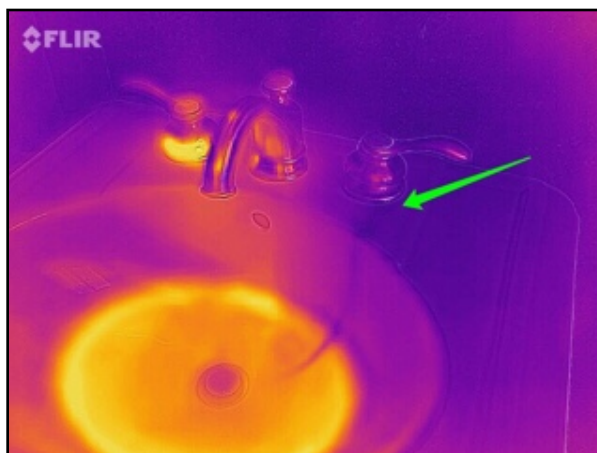
Sink fixture cold water valve handle leaking above sink.

Repair/replace cold water valve handle to sink faucet fixture. (Estimate: \$100 - \$200)

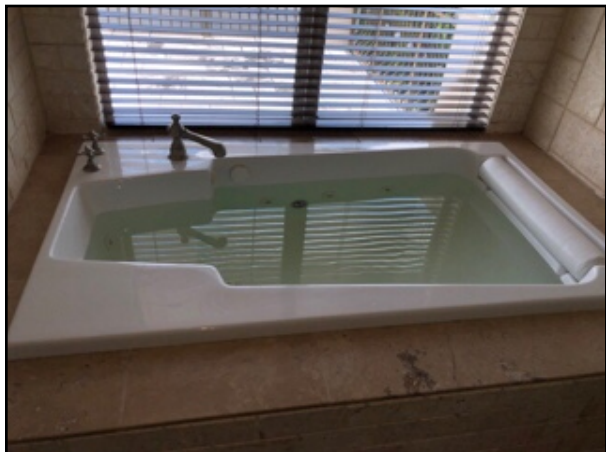
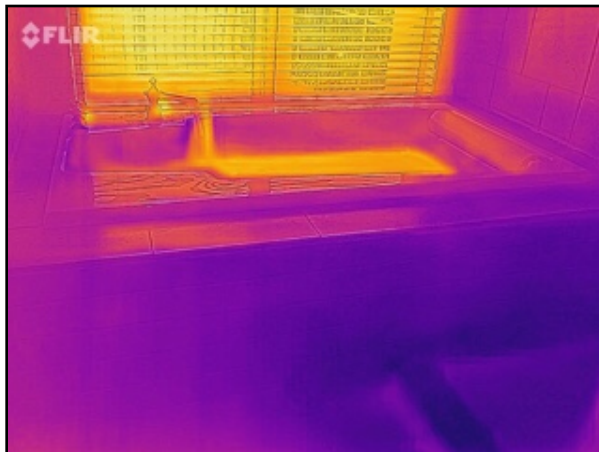
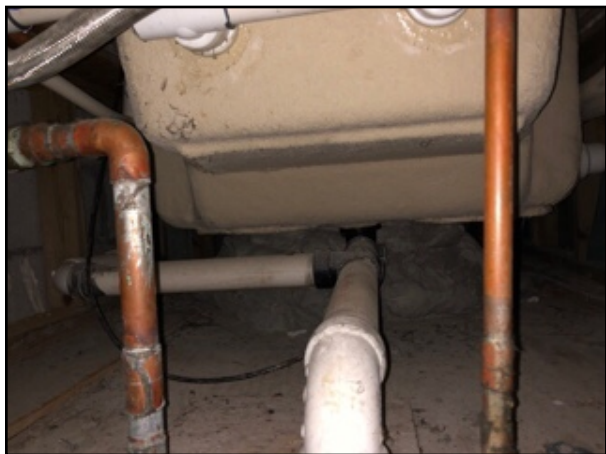
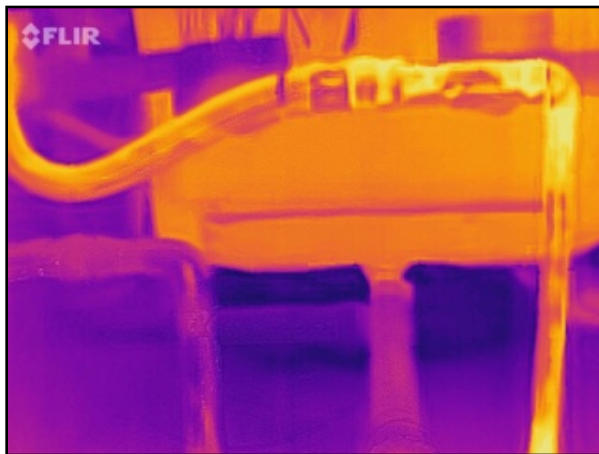
- No indications of leaking from around jacuzzi tub at the time of inspection.
- Jacuzzi motor does not activate with control panel.

Recommend further evaluation by a professional contractor and repair/replace accordingly. (Estimate: \$500 - \$1,000)

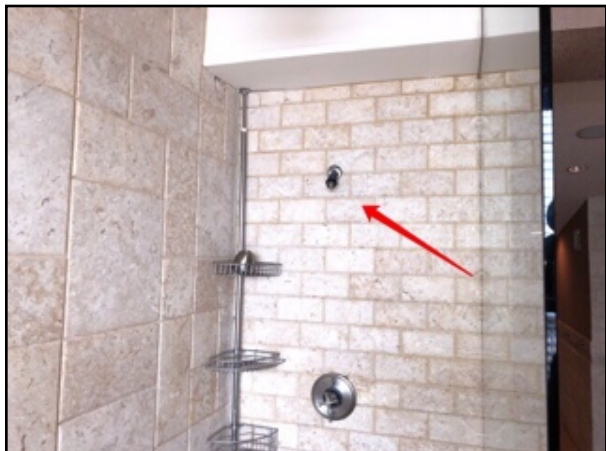
Figure 94-1

**Comment 94:**
Wall mounted shower head fixture removed within stand-up shower fixture.
Replace shower head fixture. (Estimate: \$150 - \$300)

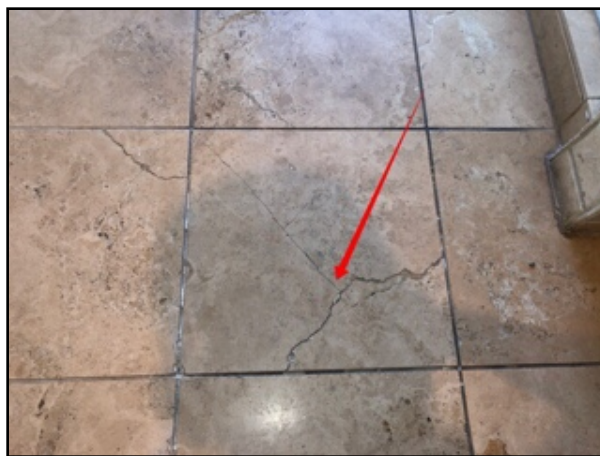
Figure 95-2

**Comment 95:**
Broken flooring tile within master bathroom.
Replace broken flooring tile. (Estimate: \$150 - \$300)
