Home Pro Miami

Home Inspection Report

1175 Sample Dr

Inspected on Thu, Aug 29 2019 at 10:00 AM

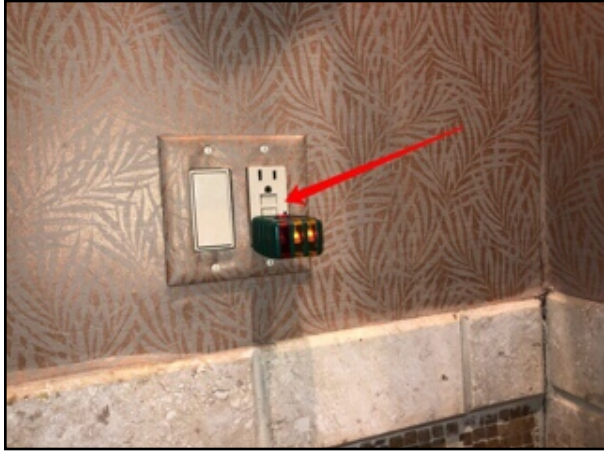
Figure 96-1

Bathroom GFCI outlet functioning properly, but does not trip when electrical surge is detected.

Recommend replacing GFCI outlet. (Estimate: \$50 - \$100)

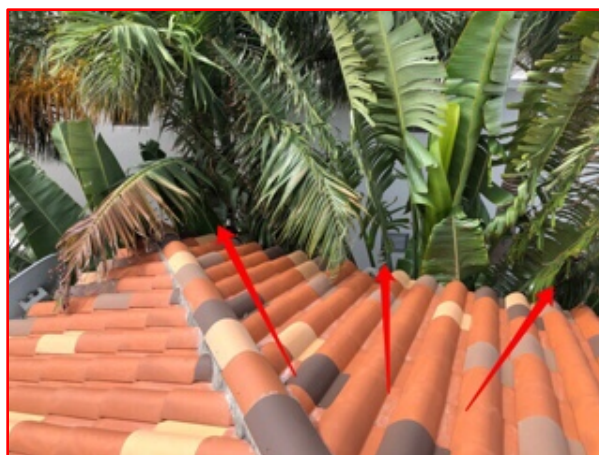
Figure 1-2

1) Comment 1: Vegetation/trees growing along siding & roof.
Recommend cutting back vegetation/trees from side of home and roof to prevent damage to home siding & roof coverings. (Estimate: \$500 - \$1,000)

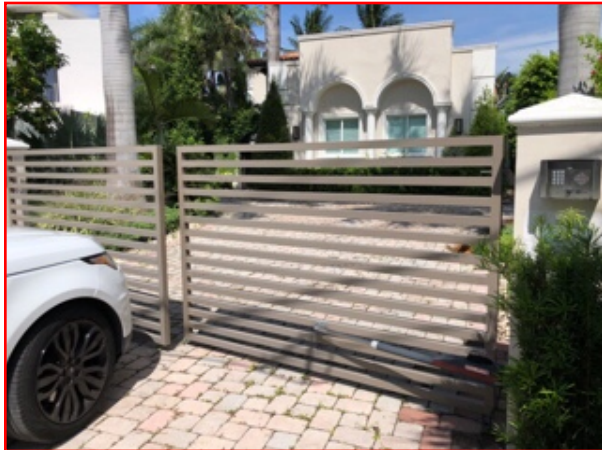
Figure 2-1

2) Comment 2: Automatic privacy gate for driveway not functioning at the time of inspection.

- System attempted to be reset by reset switch, but continues to be non-functional.
Recommend further evaluation by a professional installer or LiftMaster technician and repair or replace accordingly. (Estimate: \$250 - \$500)

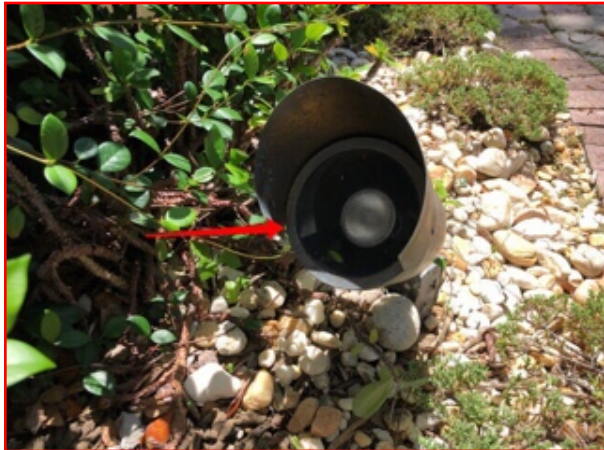
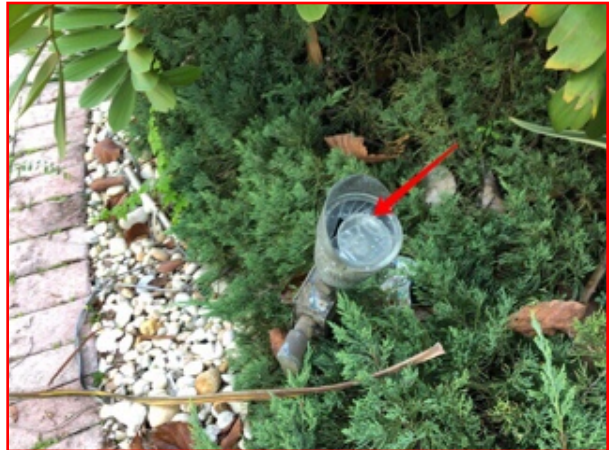
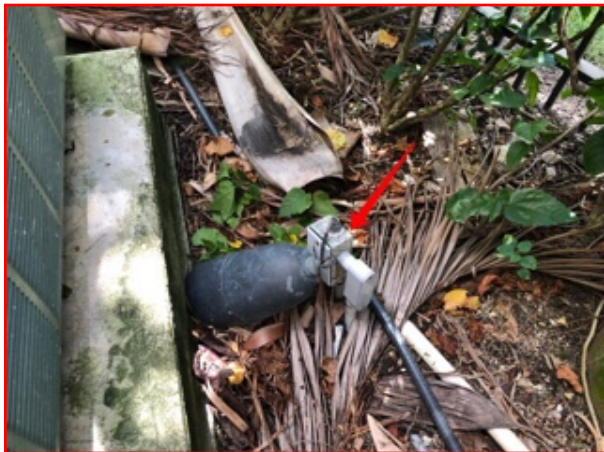
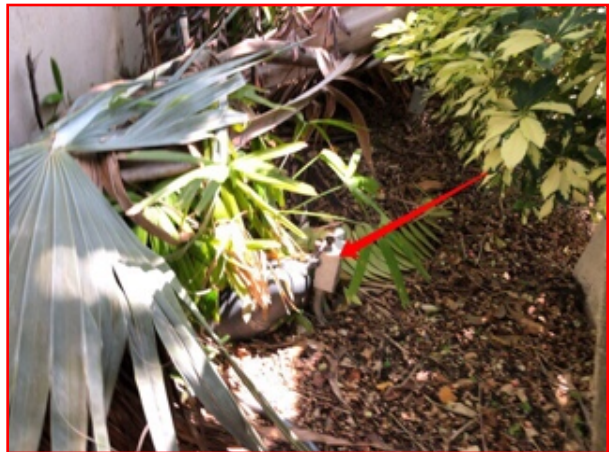
3) Comment 3: Landscaping lighting around exterior of property currently appears in poor condition, and does not appear to be functional.

- Multiple damaged & broken exterior landscape lighting at the time of inspection. Recommend further evaluation by a licensed contractor and repair/replace landscape lighting accordingly. (Estimate: \$500 - \$1,000)

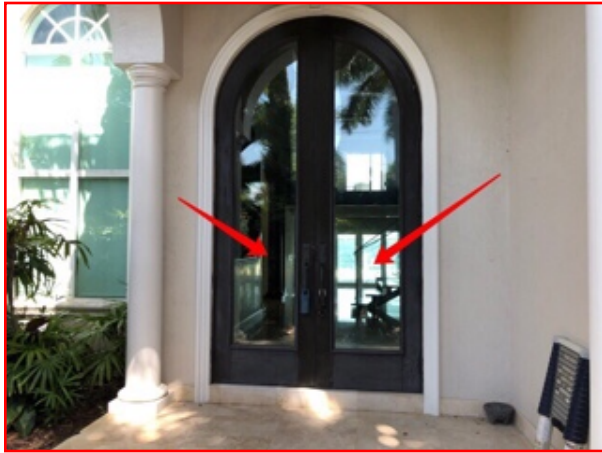
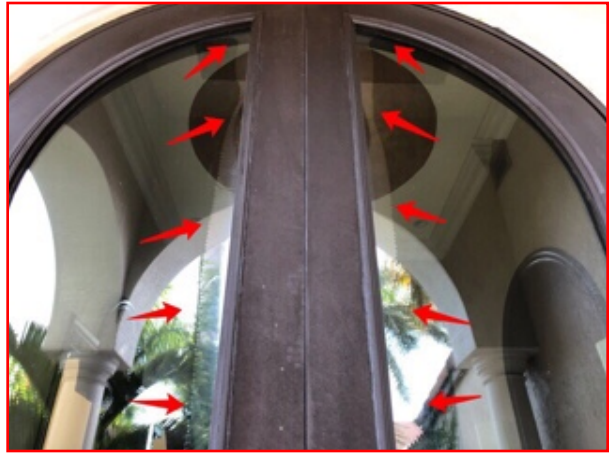
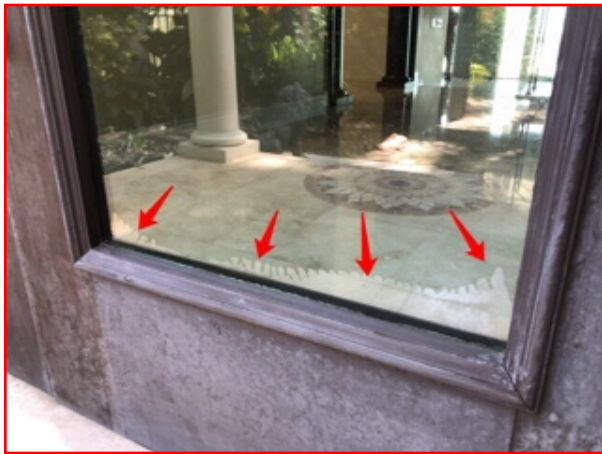
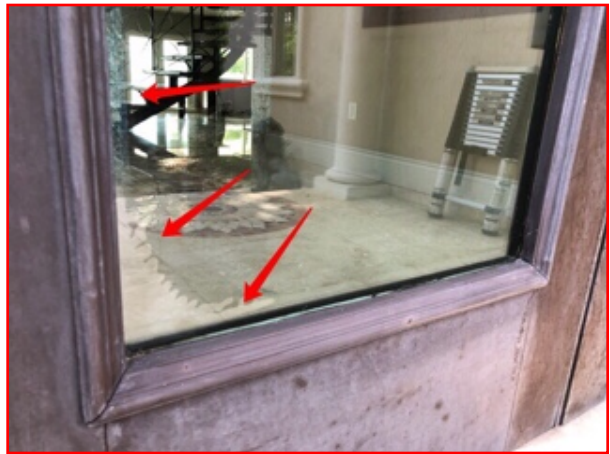
- Estimate over time the double-pane window seal may have failed allowing the inert gas within the window to leak out and moisture from outside air to seep into the space between window panes.

Recommend replacing damaged glazing within doors, or entire front entrance door.
(Estimate \$5,000 - \$10,000)

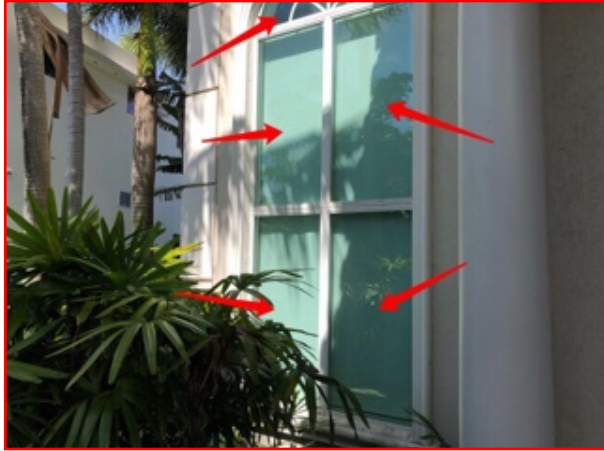
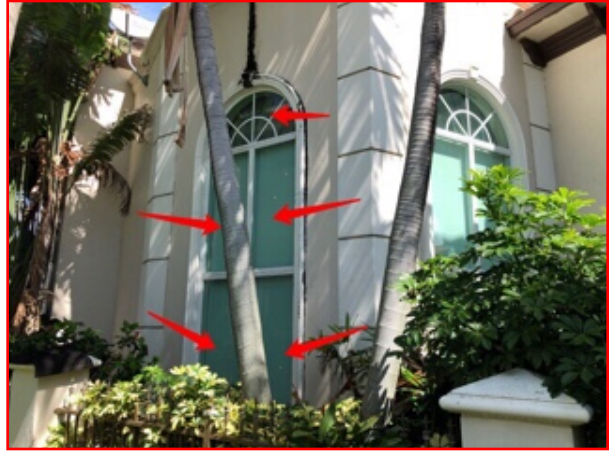
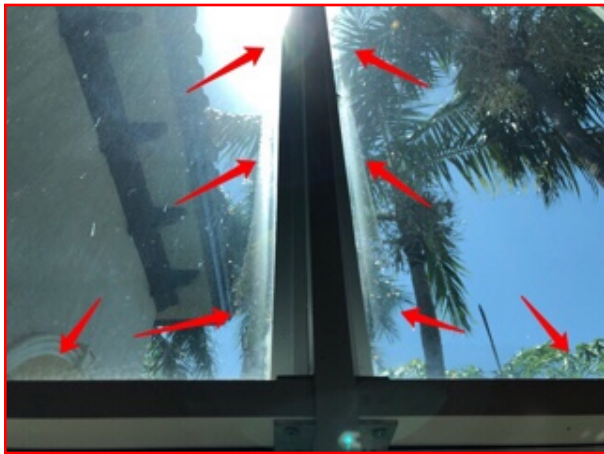
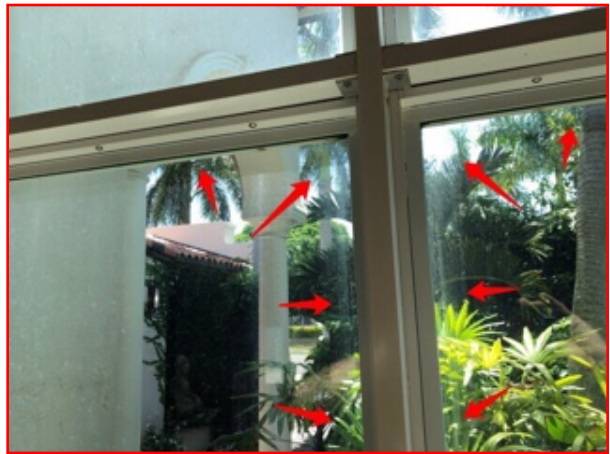
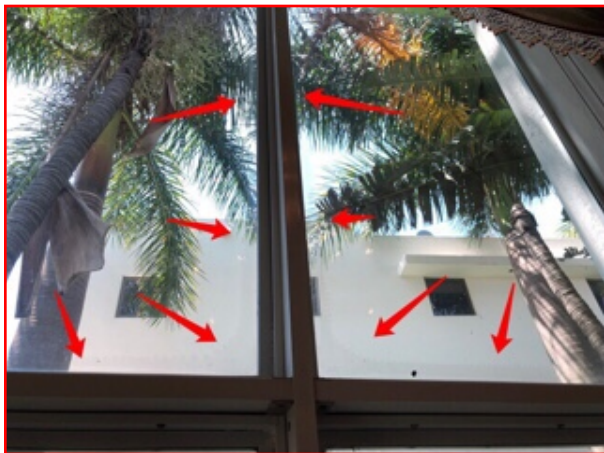
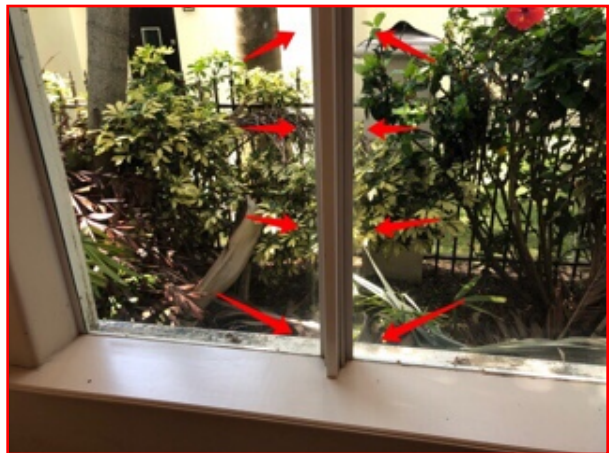
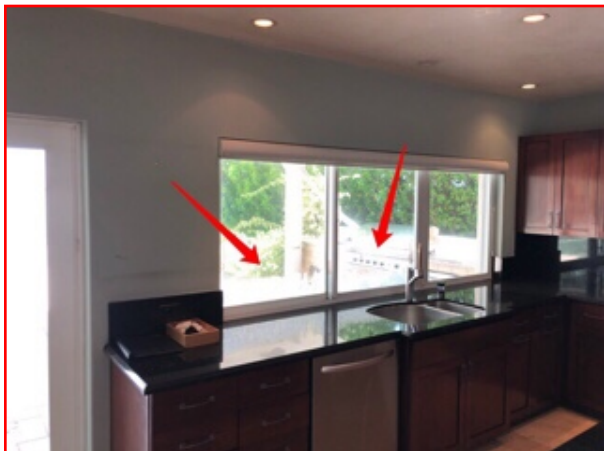
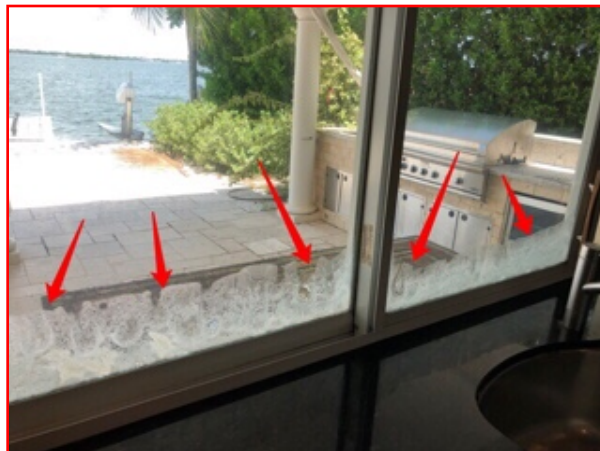
5) Comment 7: Multiple exterior windows within property have faulty double-pane glazing at the time of inspection.

- Estimate over time the double-pane window seal may have failed allowing the inert gas within the window to leak out and moisture from outside air to seep into the space between window panes.

Recommend replacing all damaged exterior windows. (Estimate \$15,000 - \$20,000)

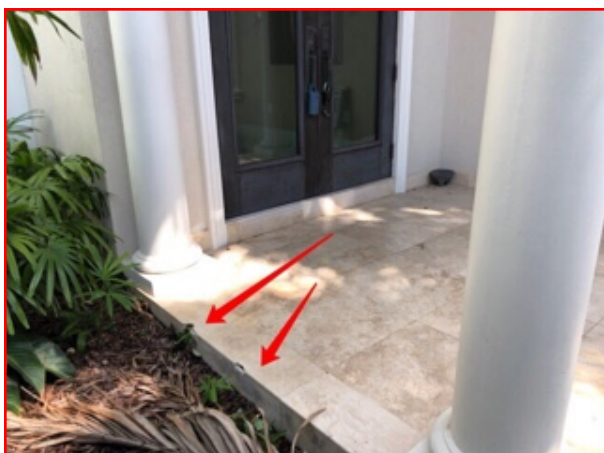
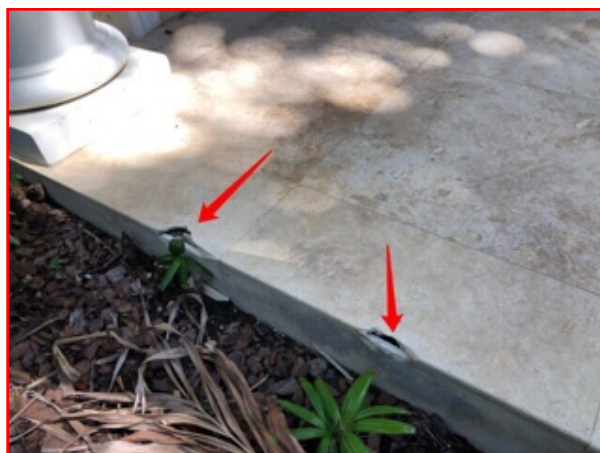
6) Comment 8: Broken exterior tile along front porch.

Replace broken exterior tiles along front porch. (Estimate: \$250 - \$500)

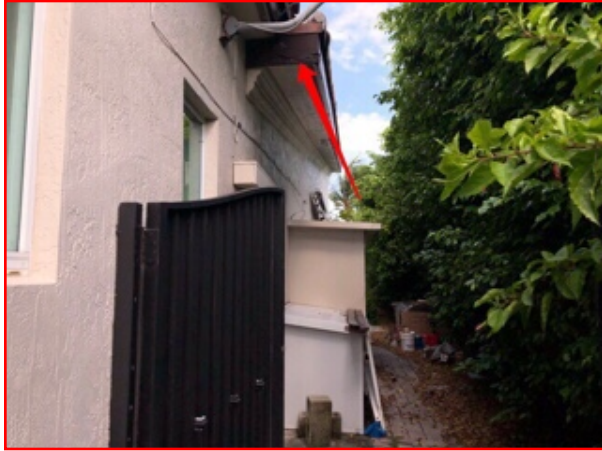
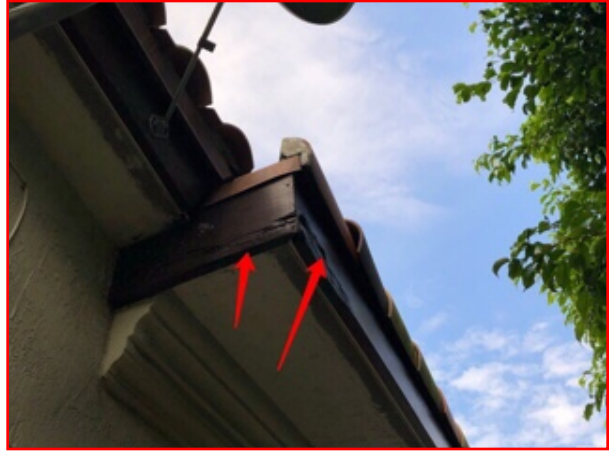
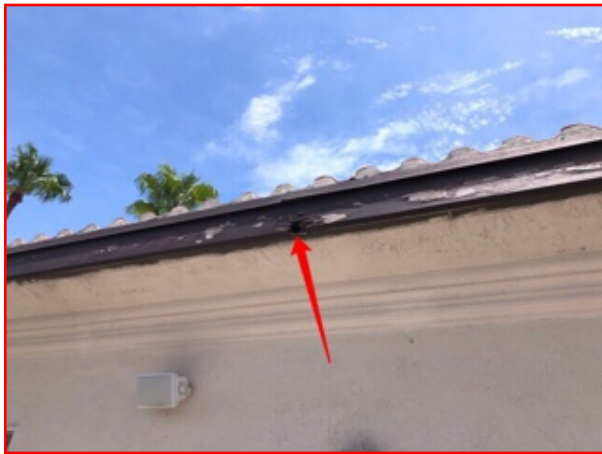
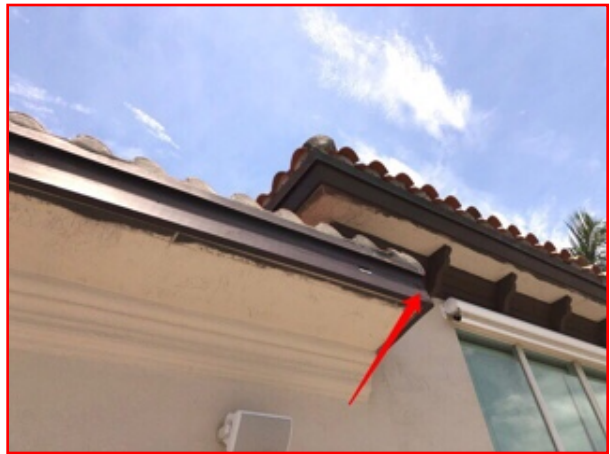
7) Comment 9: Apparent water damage/wood-rot to fascia within north & back sides of property.

Recommend repairing/replacing damaged fascia boards. (Estimate: \$1,000 - \$2,000)

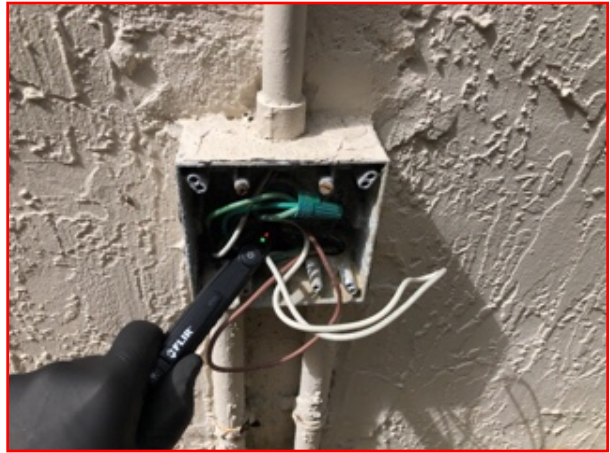
Figure 10-2

8) Comment 10: Electrical junction box left open within exterior wall on north side of property exposing live wiring. Recommend enclosing electrical junction box within exterior wall to properly conceal live wiring. (Estimate: \$50 - \$100)

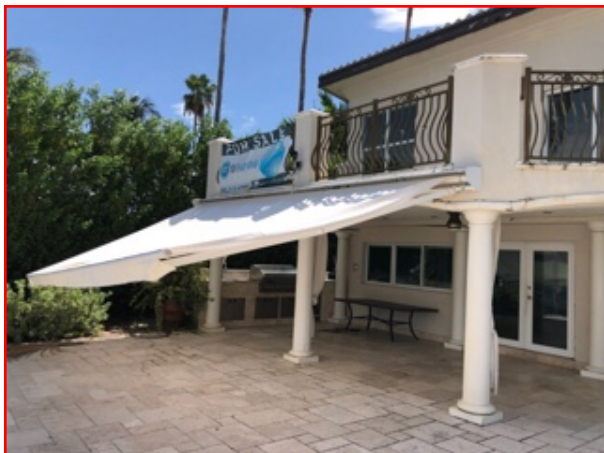
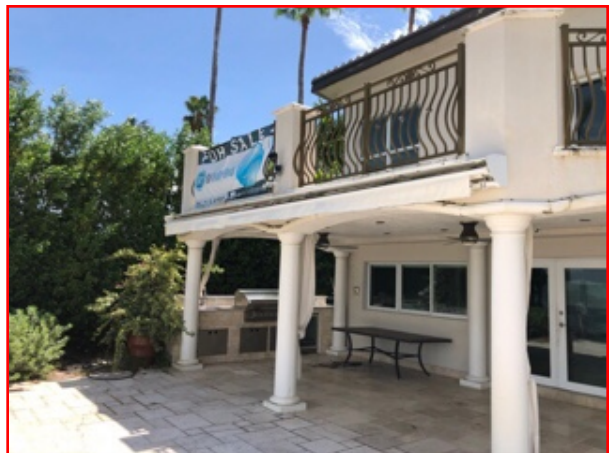
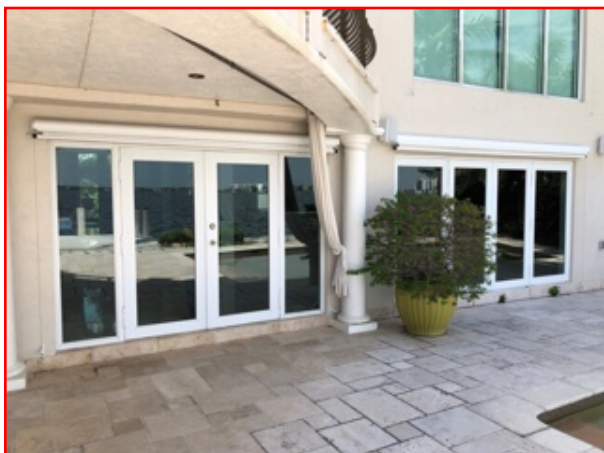
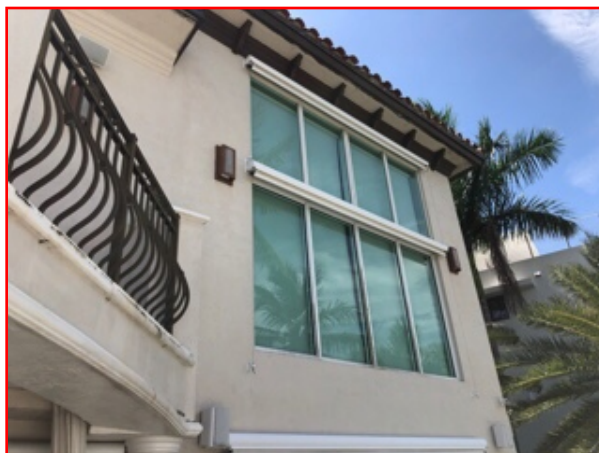
9) Comment 11: Automatic screen covering around back of property not functioning at the time of inspection.

- Remaining screens over exterior windows and doors do not appear to be functional.

Recommend adjusting to open out & close properly.

Recommend further evaluation by a professional technician or contractor, and repair/replace accordingly. (Estimate: \$500 - \$2,500)

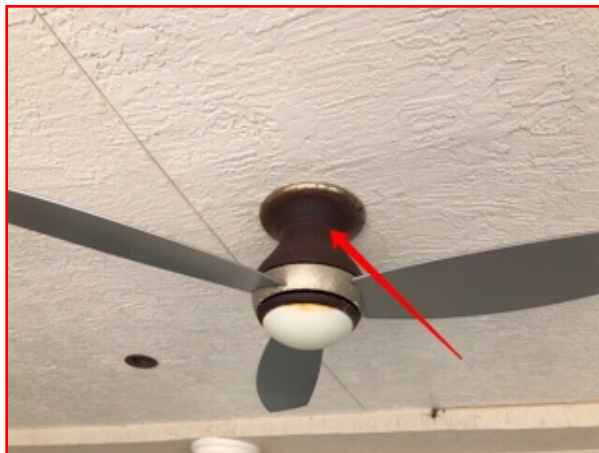
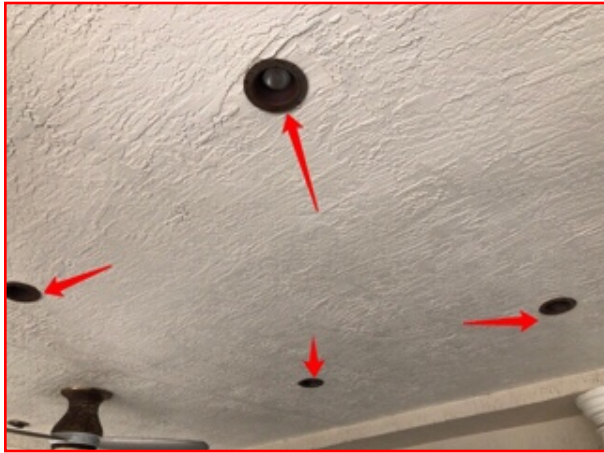
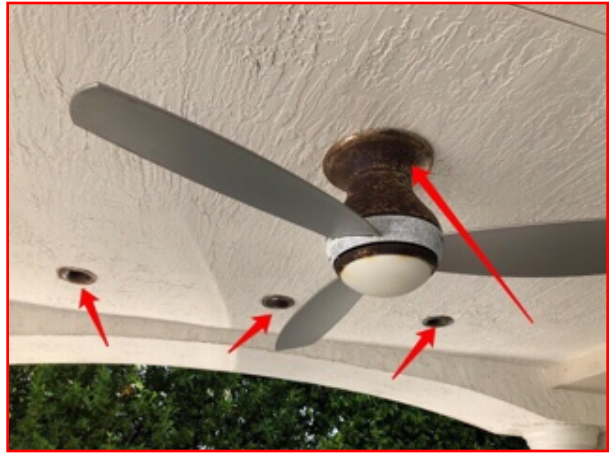
10) Comment 12: Heavily oxidized/rusted exterior lighting & fan fixtures over rear patio. Recommend replacing fixtures with proper outdoor fixtures to prevent excessive oxidation/rusting. (Estimate: \$500 - \$1,500)

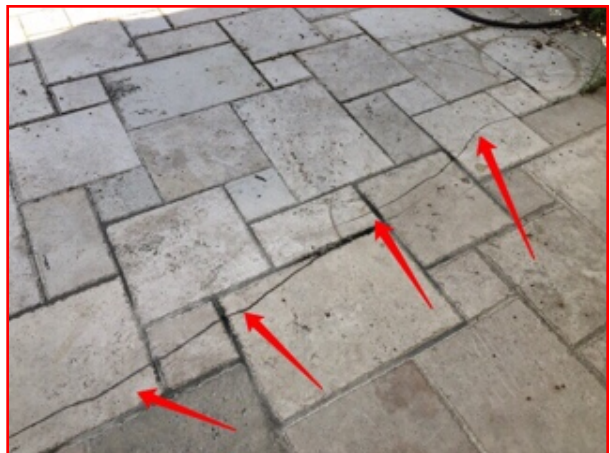
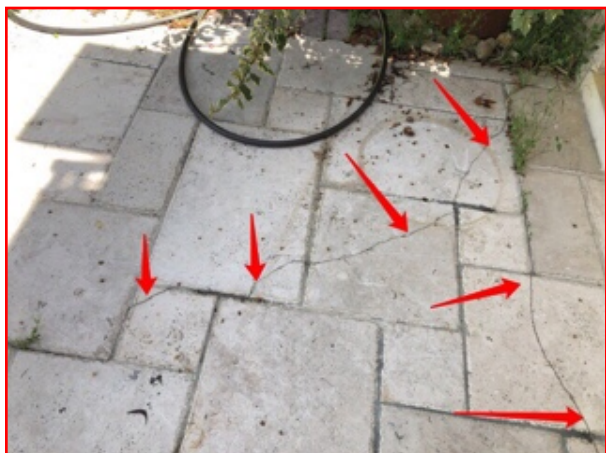
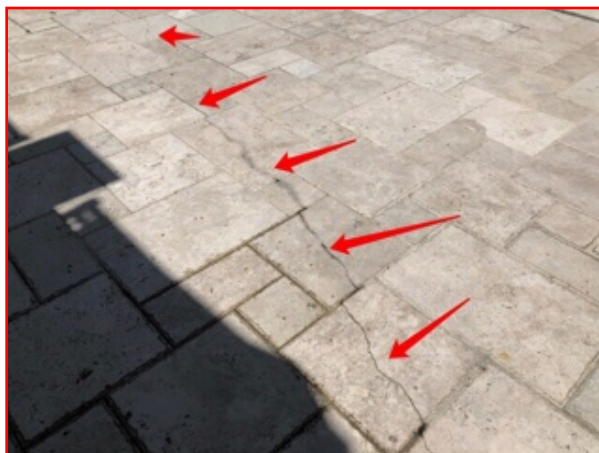
11) Comment 14: Apparent settlement cracking along exterior tiling/pavers in back of property.
Replace cracked/broken tile/pavers to remove settlement cracking. (Estimate: \$1,000 - \$2,500)

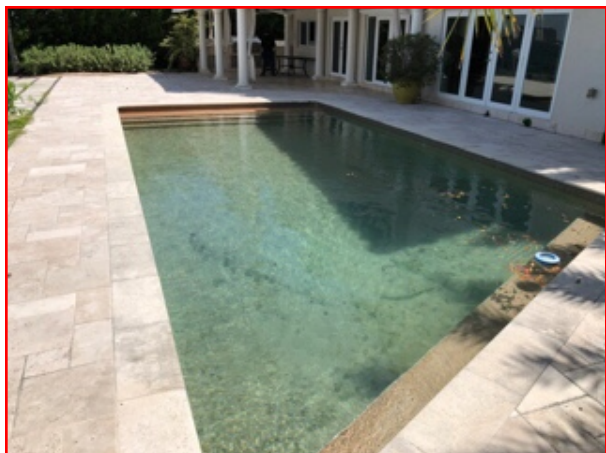
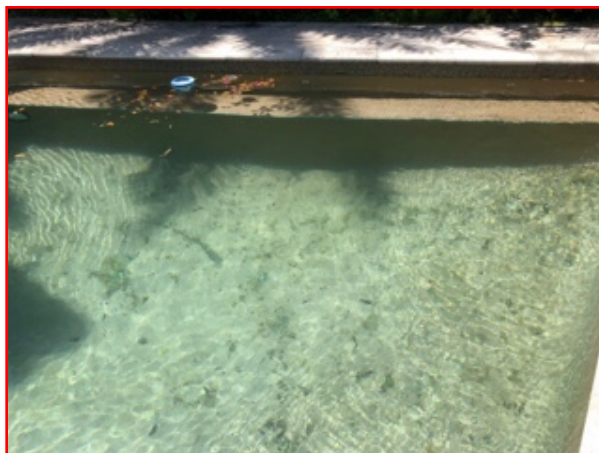
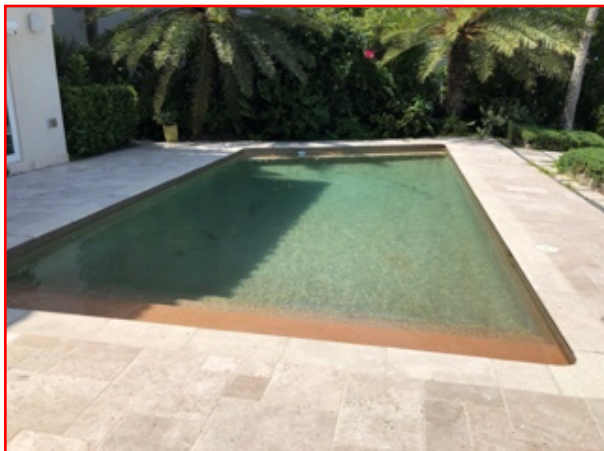
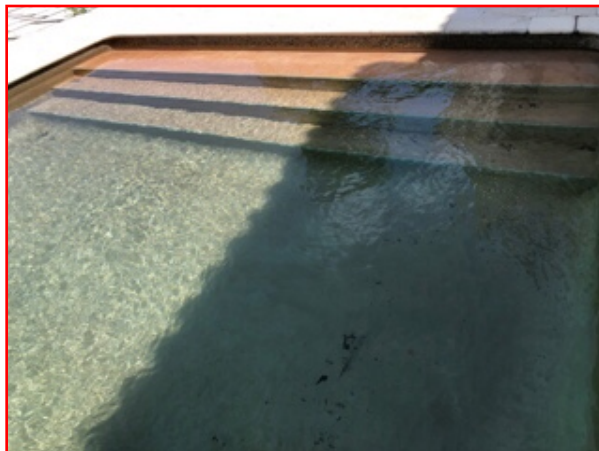
12) Comment 15: Pool and pool lining appears in fair condition.

- Pool appears to have not been properly maintained and currently full with debris. Recommend having a licensed professional drain pool & properly clean/acid wash pool lining. (Estimate: \$750 - \$1,500)

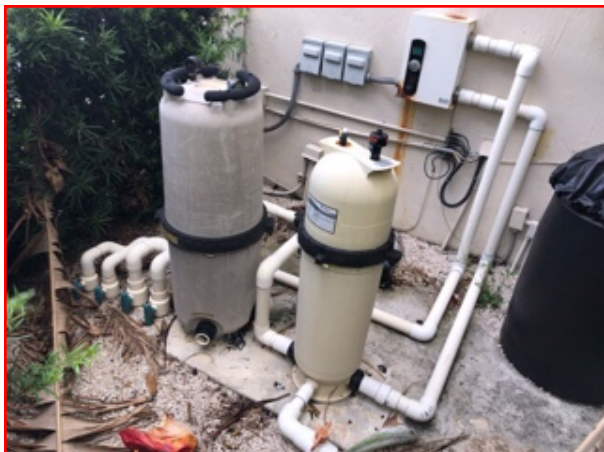
Figure 16-1

13) Comment 16: Pool pump & filtration equipment appears to be functioning properly at the time of inspection.

- Minor leaking apparent from connecting pipe fitting to pool pump & filtration equipment at the time of the inspection.

Recommend repair/replace damaged & leaking piping to pump & filtration equipment to prevent further leaking. (Estimate: \$100 - \$250)

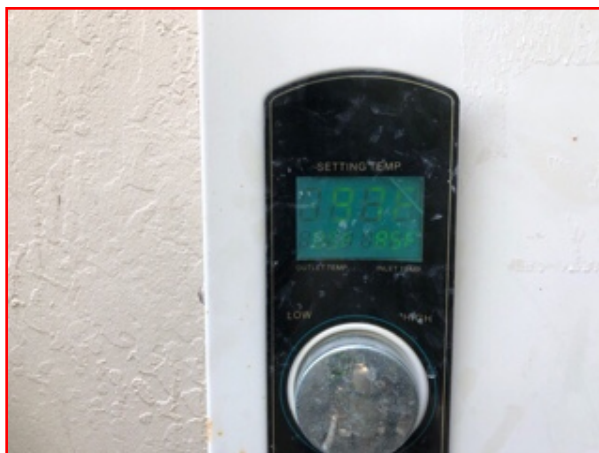
Figure 17-2

14) Comment 17: Pool heater appears in poor condition, and does not appear to be functioning properly at time of inspection. Recommend further evaluating by a licensed professional and repair or replace accordingly. (Estimate: \$2,000 - \$3,500)

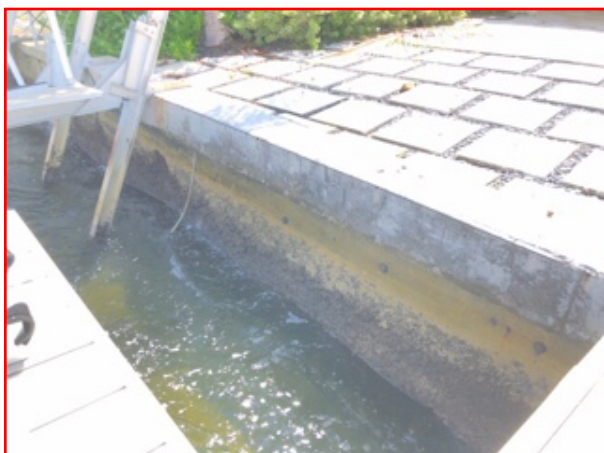
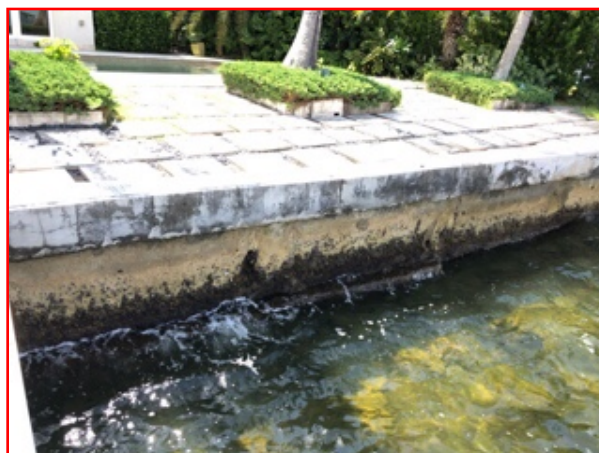
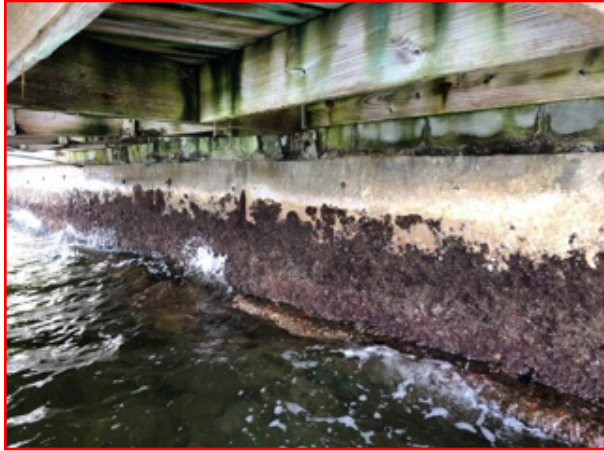
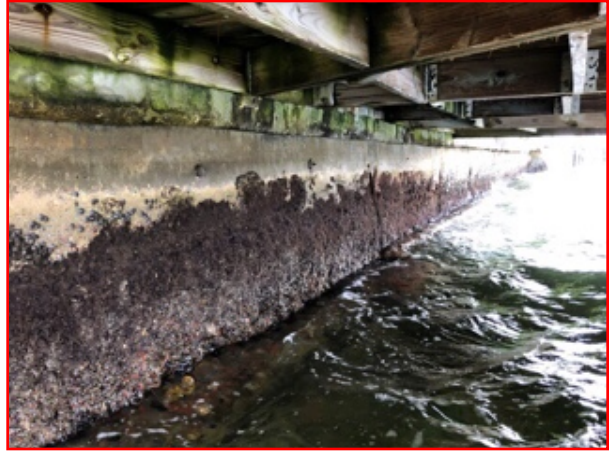
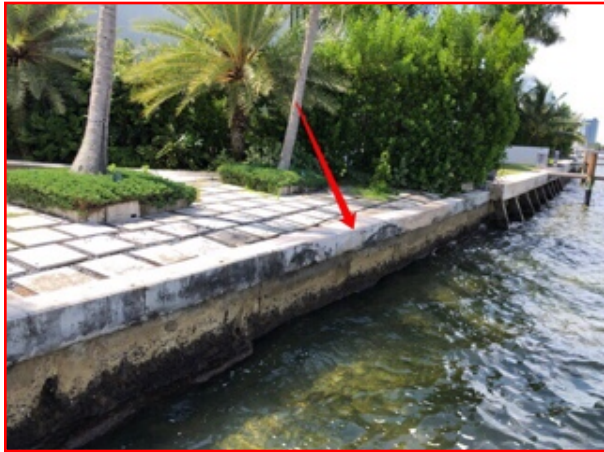
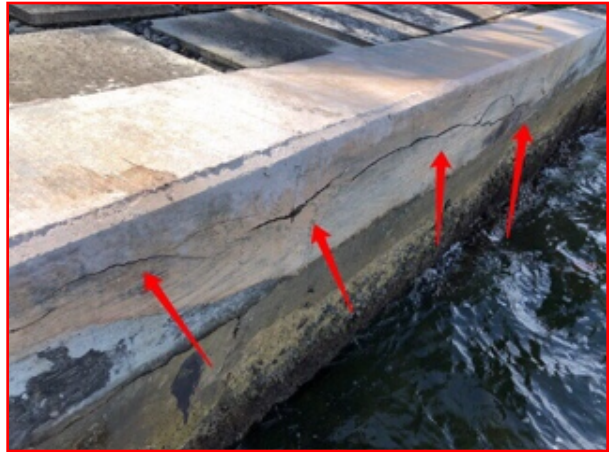
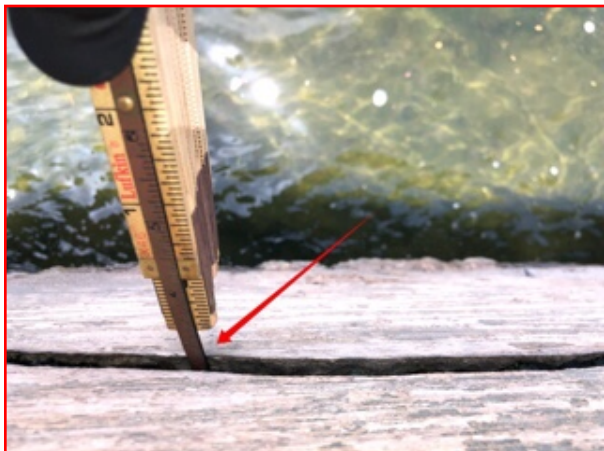
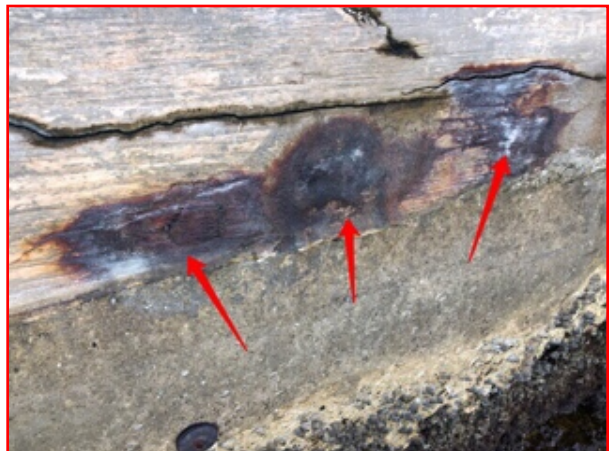
- Seawall appears to be in overall fair condition at time of inspection.
 - Apparent structurally cracking & spalling along concrete seawall/bulkhead on south side of seawall.
 - Spalling/deterioration appears to be exposing rebar reinforcement from within structure due to apparent oxidation/rusting around cracking.
- Recommend having a structural engineer or seawall contractor further evaluate spalling, and advise for proper repairs. (Detailed quotation required)

As we can only check for visual deficiencies above water level, we recommend further evaluation of dock & seawall by a licensed structural engineer or seawall contractor for proper structural evaluation of seawall.

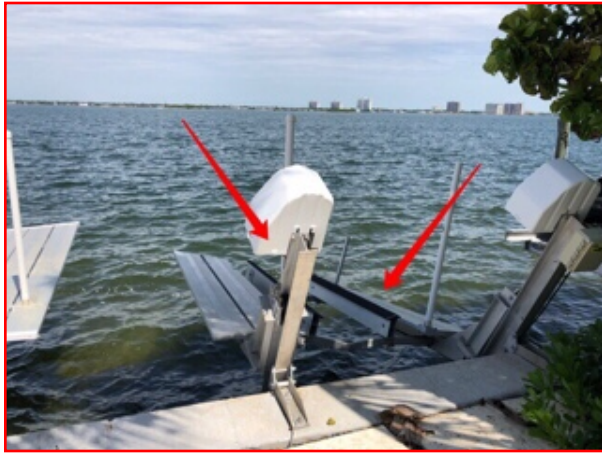
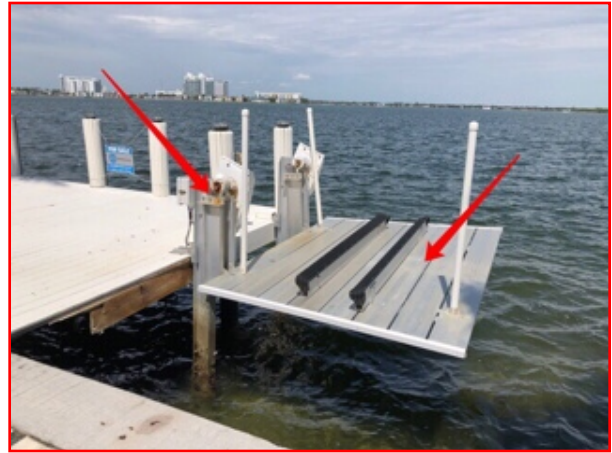
17) Comment 21: Dry-dock boat lifts appear to be damaged & not functional at the time of inspection.

Recommend further evaluation by a licensed contractor, and repair or replace dry-dock boat lifts accordingly. (Detailed quotation required)

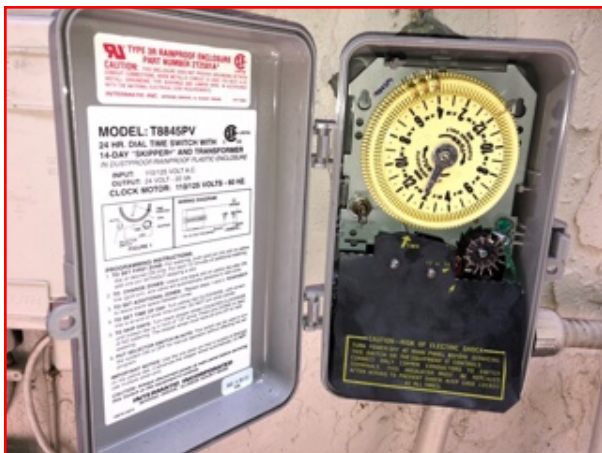
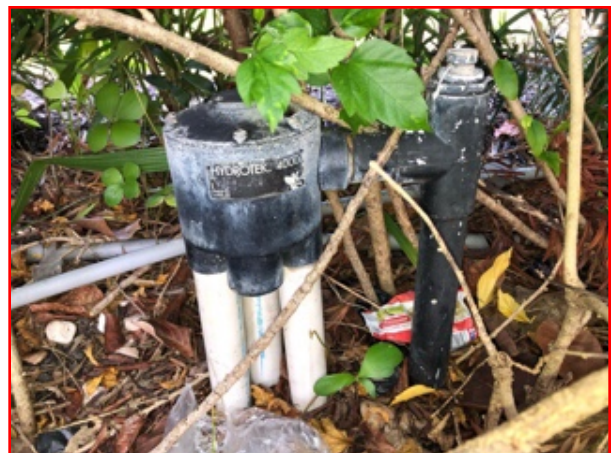
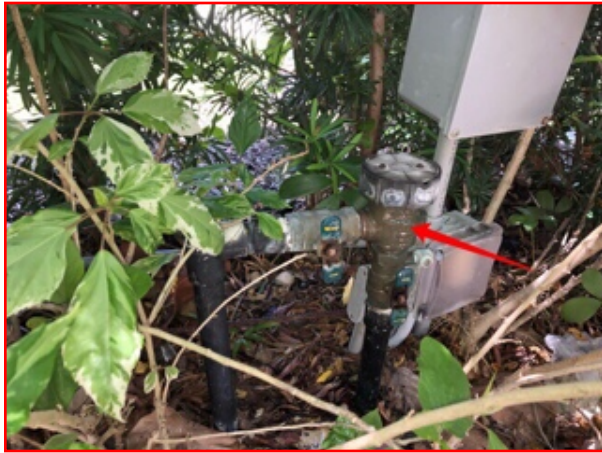
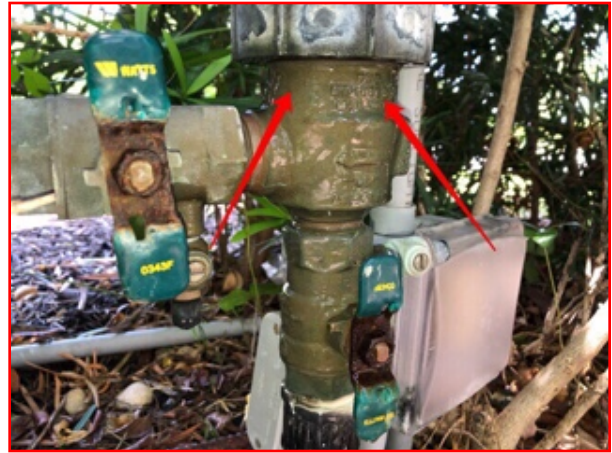
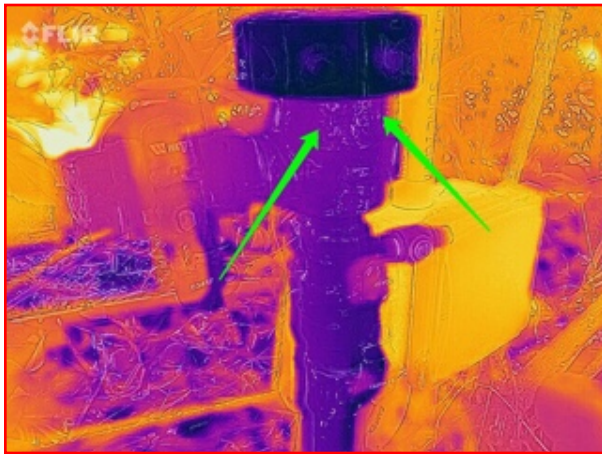
- Mechanical valves for irrigation system are buried around property.
- Sprinkler system does not appear to be functioning properly at the time of inspection.
- Excessive leaking apparent from irrigation system incoming water line in front corner of property.

Recommend further evaluation by a licensed contractor and repair or replace accordingly.
(Estimate: \$500 - \$1,000)

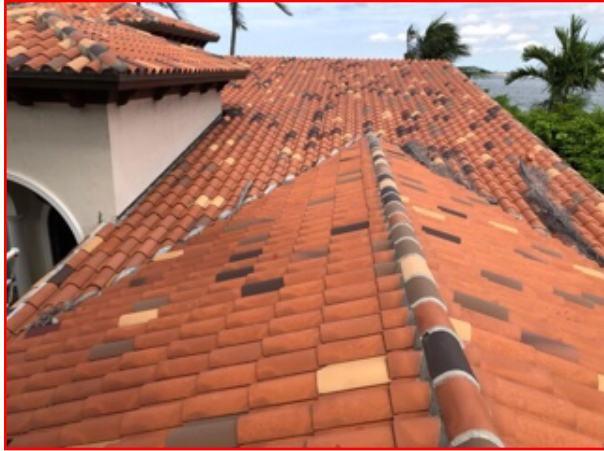
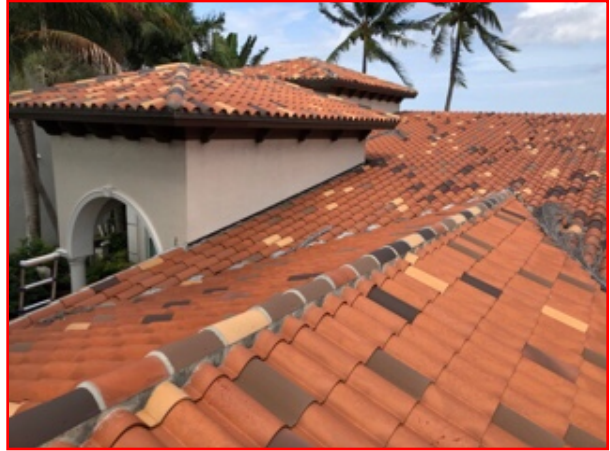
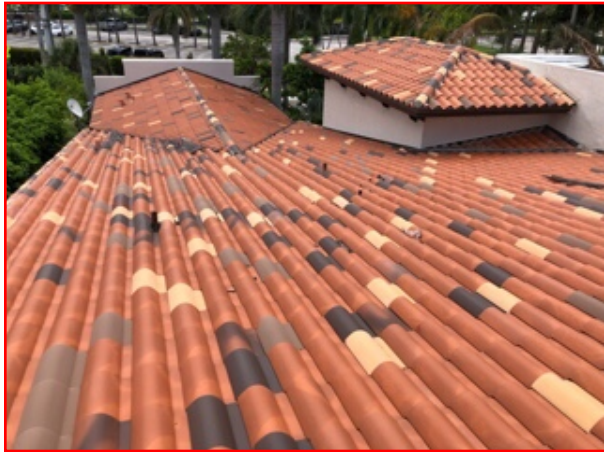
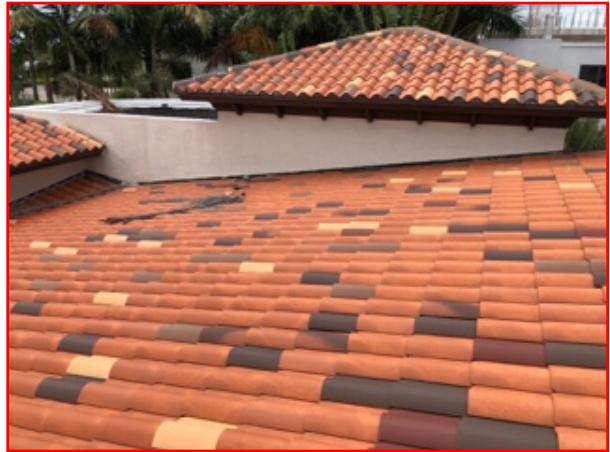
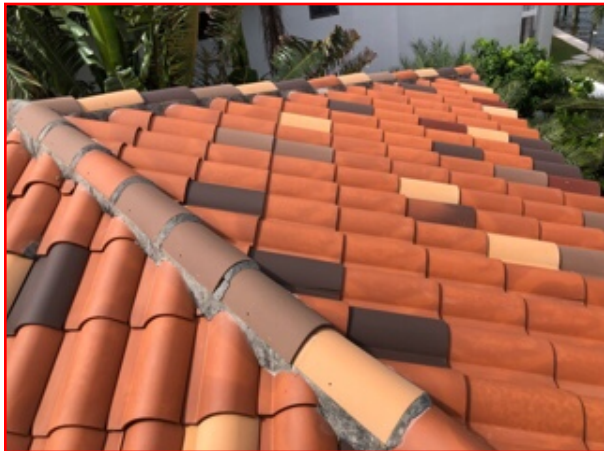
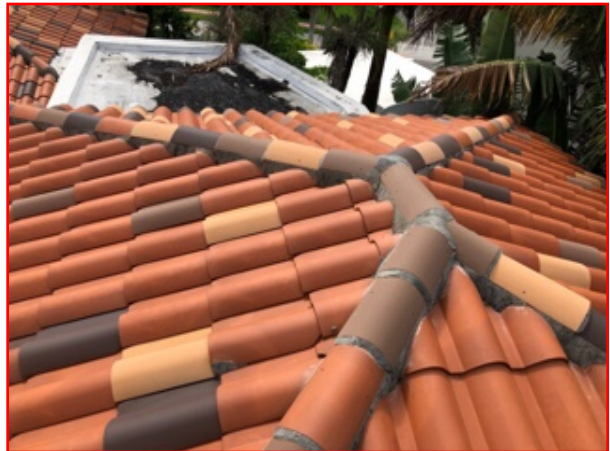
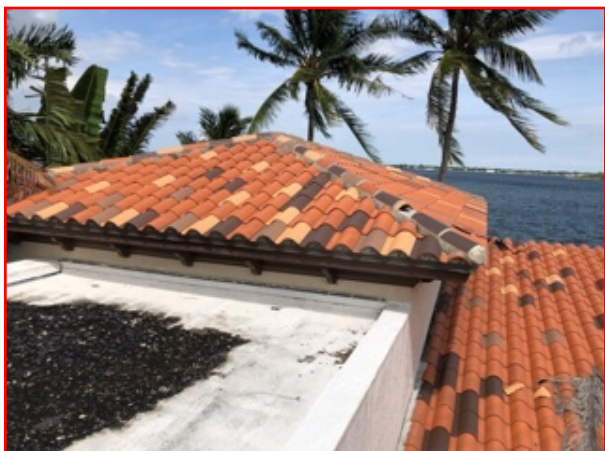
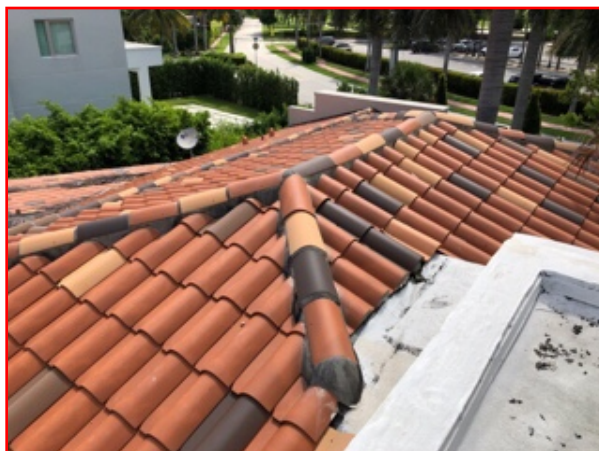
- Roof coverings replaced in 2004 (Permit #04-00089325), and currently appear in overall fair condition.

- Multiple indications of damage as well as active leaking from roof at the time of inspection.

Recommend further evaluation by a licensed contractor, and repair or replace roof coverings accordingly. (Estimate: \$10,000 - \$15,000)

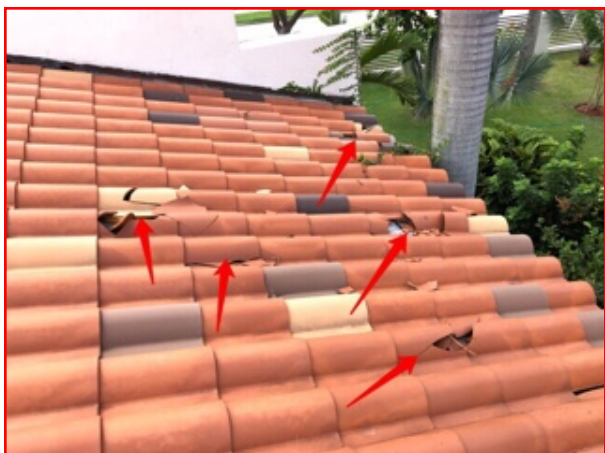
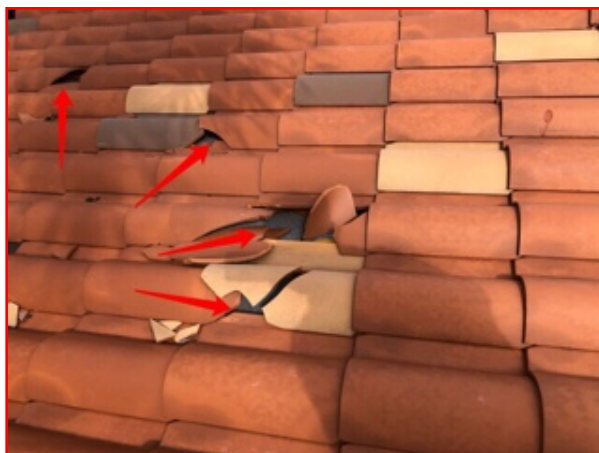
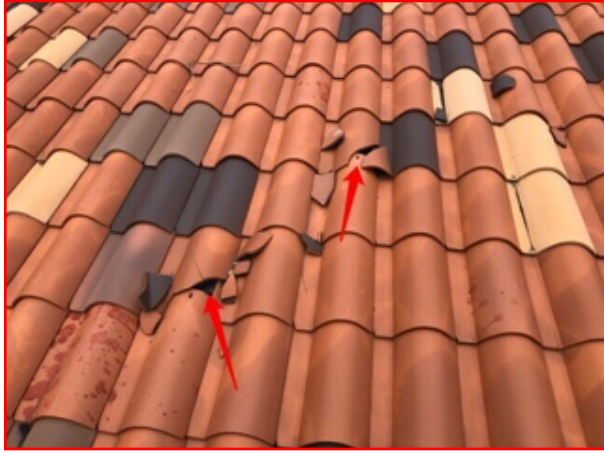
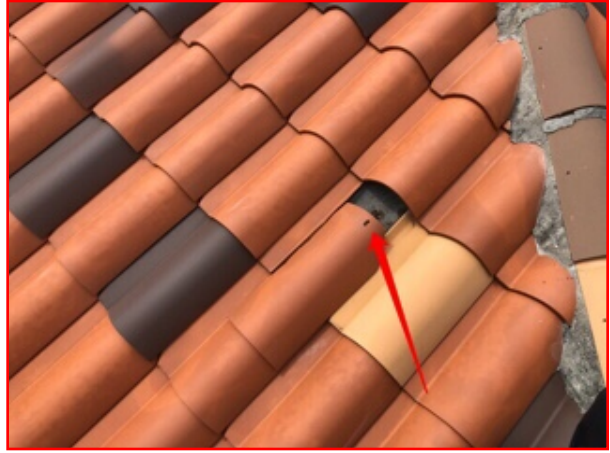
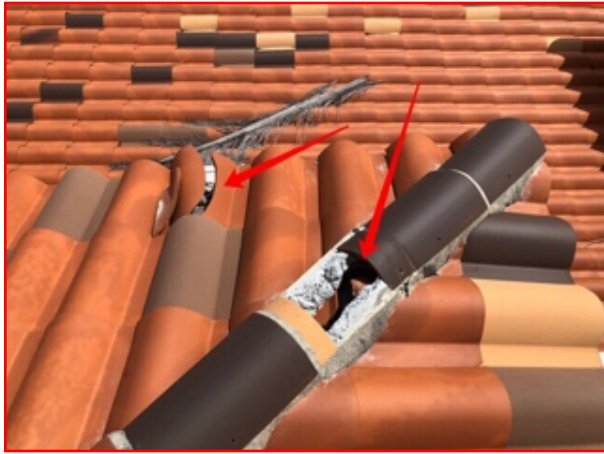
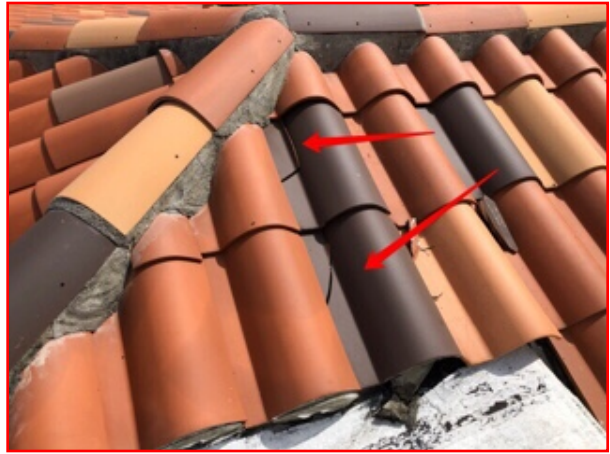
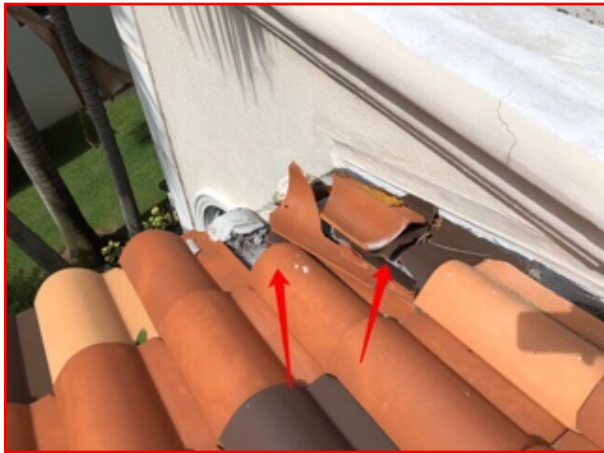
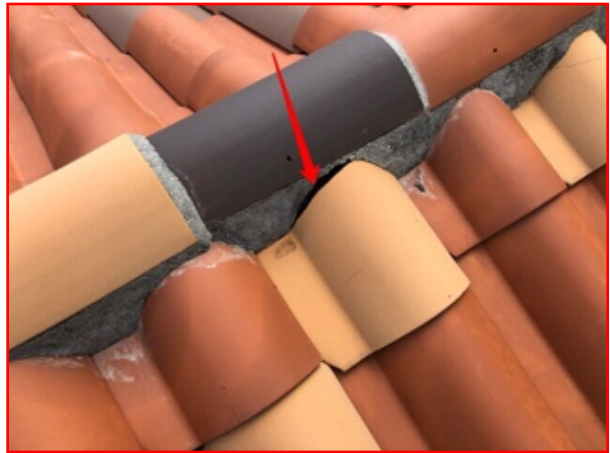
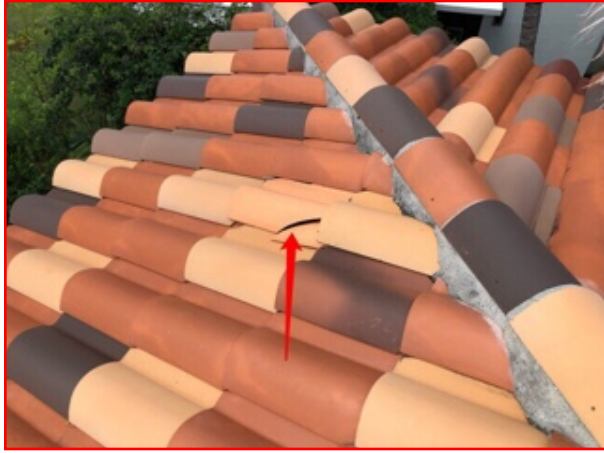
20) Comment 24: Multiple cracked broken tiles present along roof.

- Roughly 45 - 60 cracked/broken, loose, or missing clay barrel tiles found at the time of inspection.

Repair/replace cracked/broken roofing tiles.

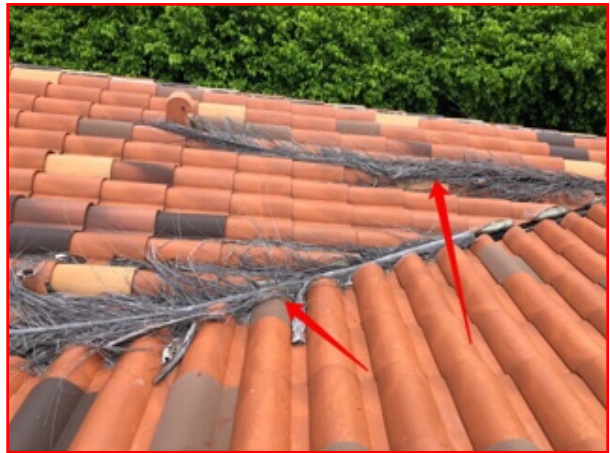
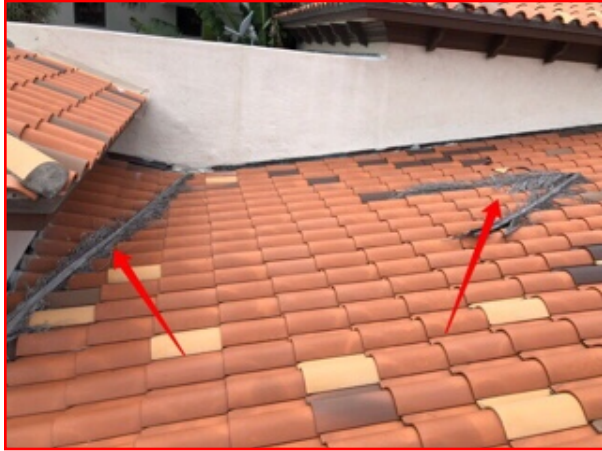
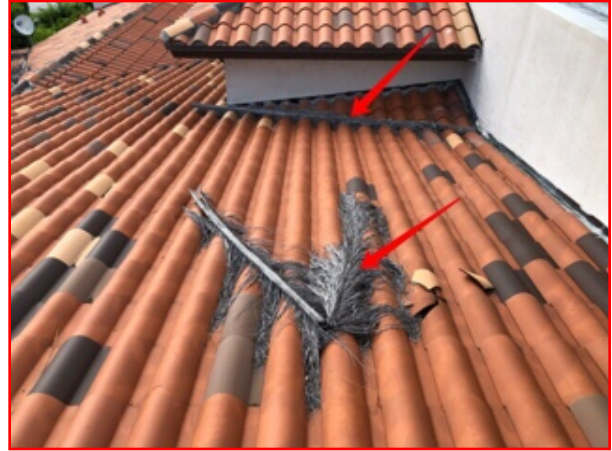
21) Comment 25: Heavy debris from surrounding vegetation collecting along roof. Recommend removing debris from roof to prevent damage to roof coverings. (Estimate: \$200 - \$400)
