Home Pro Miami

Home Inspection Report

1175 Sample Dr

Inspected on Thu, Aug 29 2019 at 10:00 AM

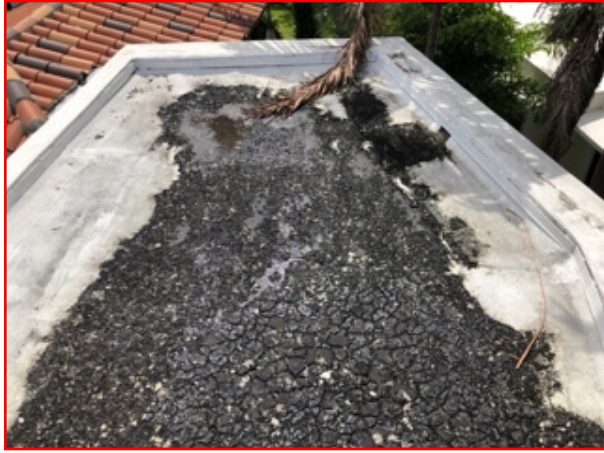
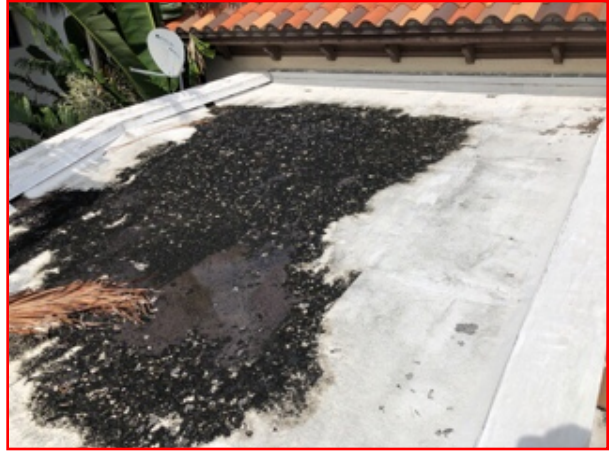
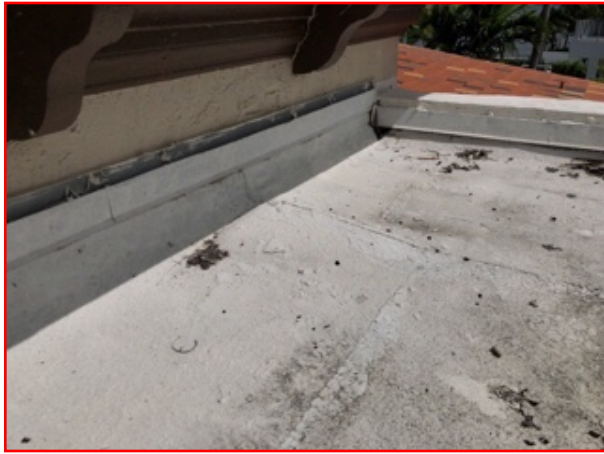
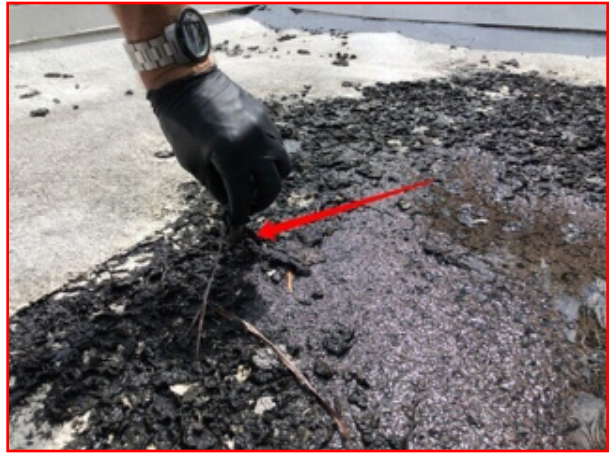
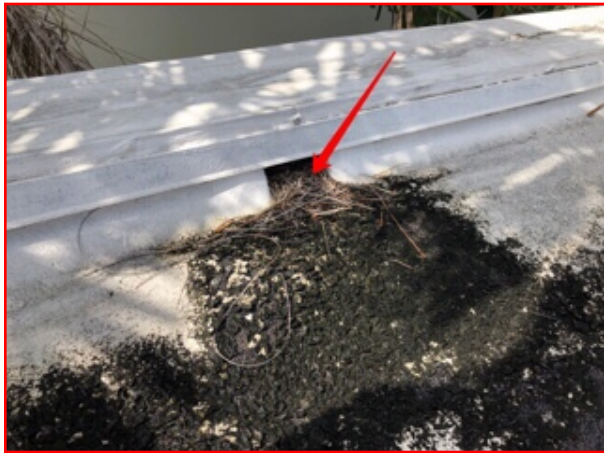
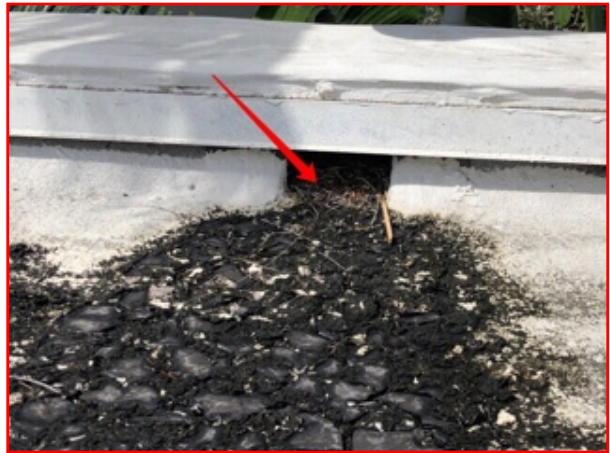
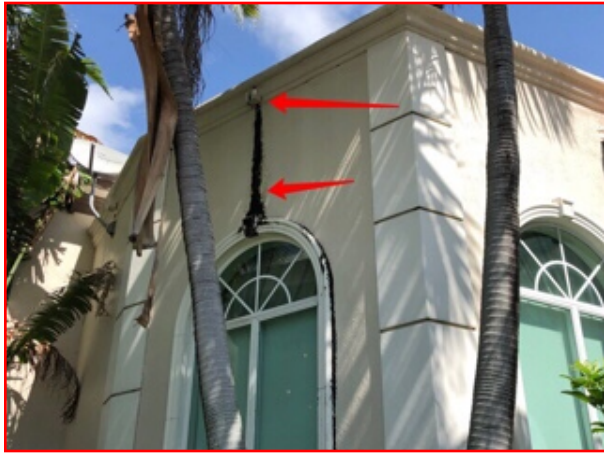
22) Comment 26: Secondary Flat Roof:

- Flat roof coverings last replaced along with primary roof coverings in 2004 (Permit #04-00089325), and currently appear weathered & worn condition at the time of inspection.
- Weather-seal coating appears to have been previously applied, but is currently worn, peeling-up, and in poor condition.
- Debris from surrounding vegetation currently clogging scupper drains from flat roof covering preventing proper drainage from flat roof.
- No indications of leaking from flat roof coverings at the time of inspection, but flat roof coverings are nearing end of efficient life expectancy, and due to current condition recommend to be replaced in near future. (Estimate: \$8,000 - \$10,000)

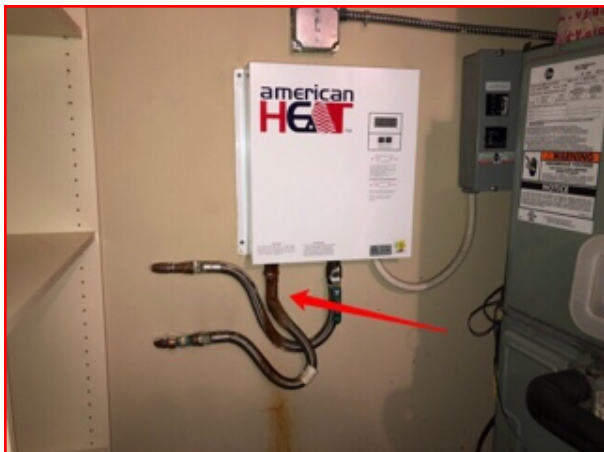
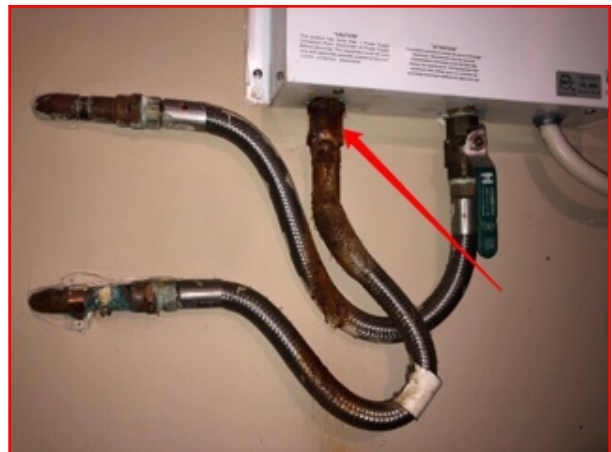
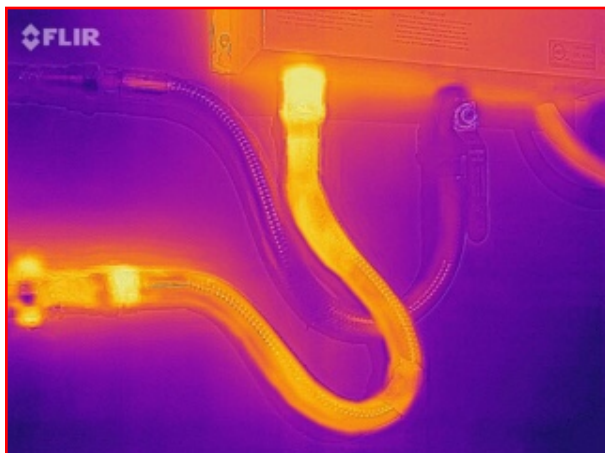
23) Comment 32: Heavily oxidation/rusting to plumbing hose connection to water heater.
- Indications of previous leaking. No active leaking noticed during the time of inspection.

Recommend having a licensed plumbing contractor replace connection & hose to hot water heater to prevent any possible leaking. (Estimate: \$200 - \$400)

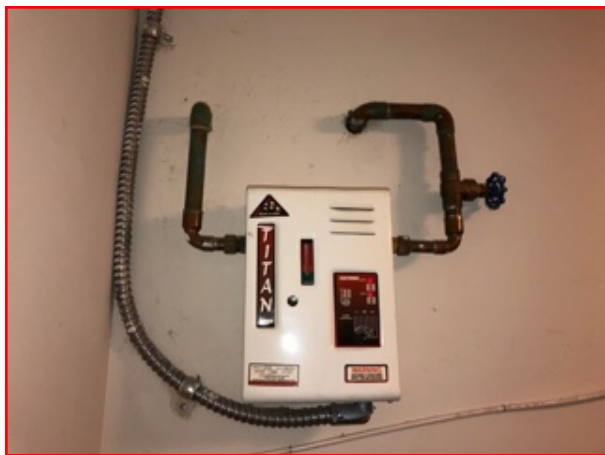
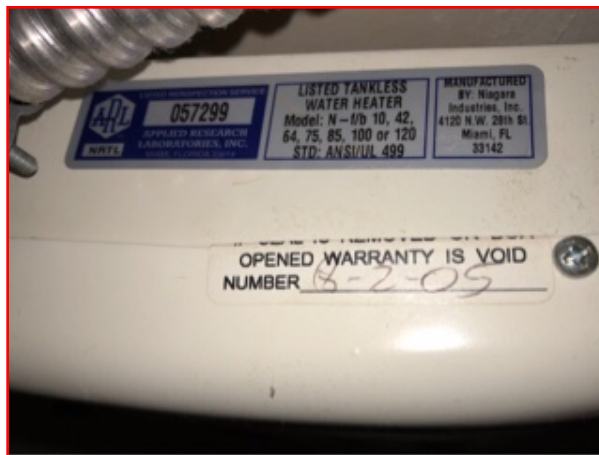
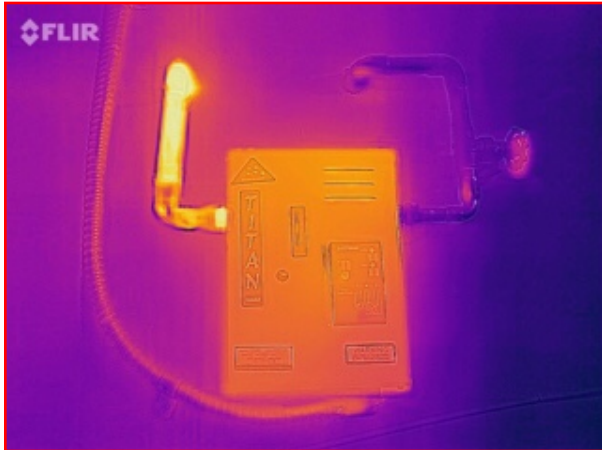
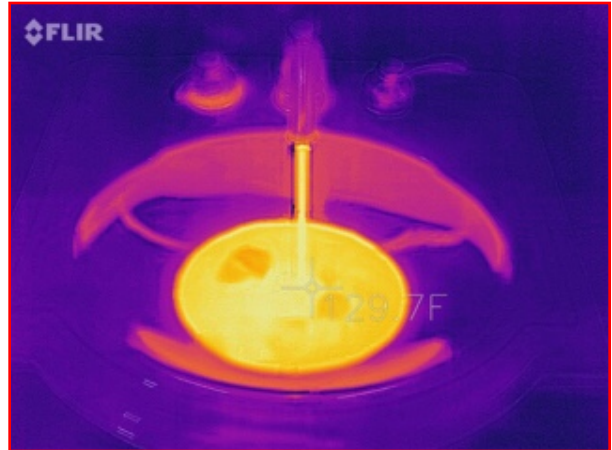
24) Comment 33: Hot water heater functioning properly at the time of inspection.

- Water heater currently 14 years old.
- Due to age of unit, water heater is nearing end of efficient life expectancy and may need to be replaced in near future. (Estimate: \$1,000 - \$1,500)

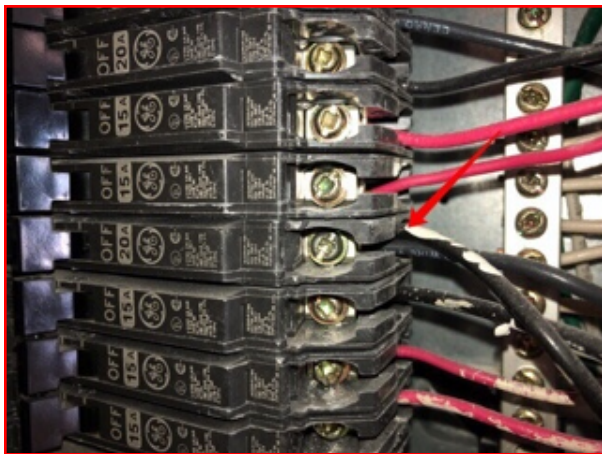
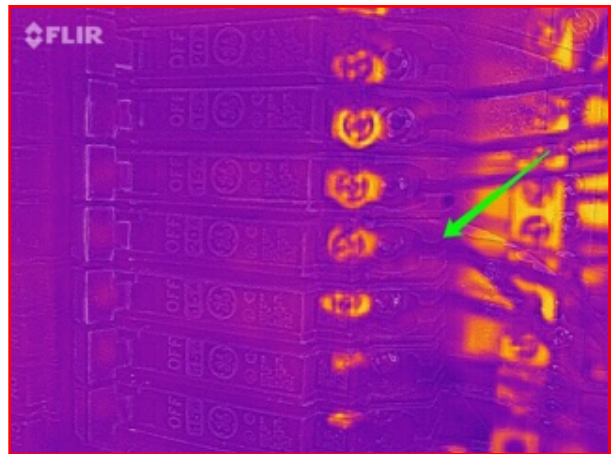
- Double-tapped 20 AMP breaker present with multiple circuits connected to a single circuit breaker within main distribution panel. (Breakers do not appear to be over heating or over loaded at the time of inspection.)

Recommend having a licensed electrician properly install additional circuit breakers to connect double-tapped circuits to their own individual circuit breaker within main distribution panel. (Estimate \$250 - \$500)

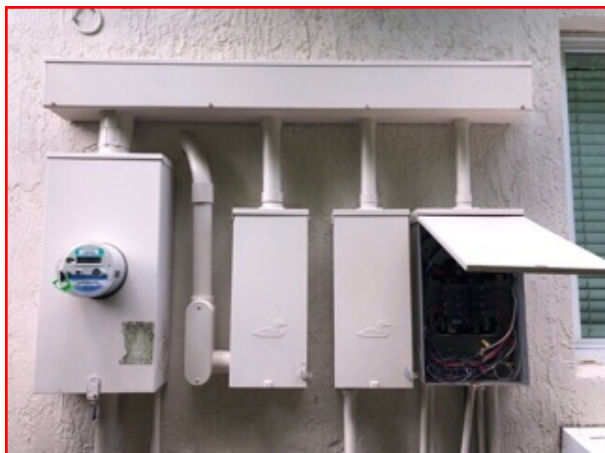
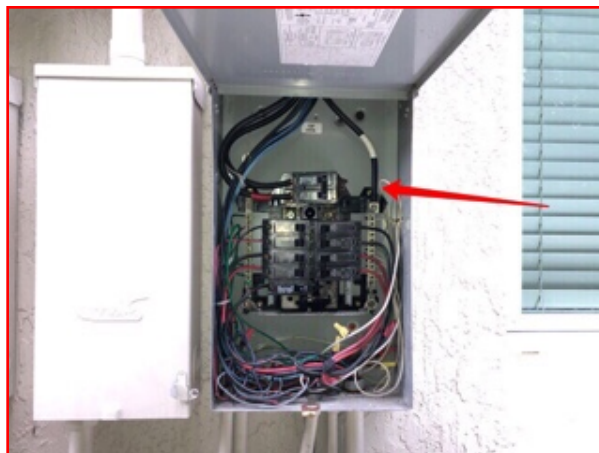
27) Comment 40: Electrical Sub-panel located next to service meter missing cover plate at time of inspection.

Recommend replacing missing cover plate within Sub-panel. (Estimate: \$50 - \$150)

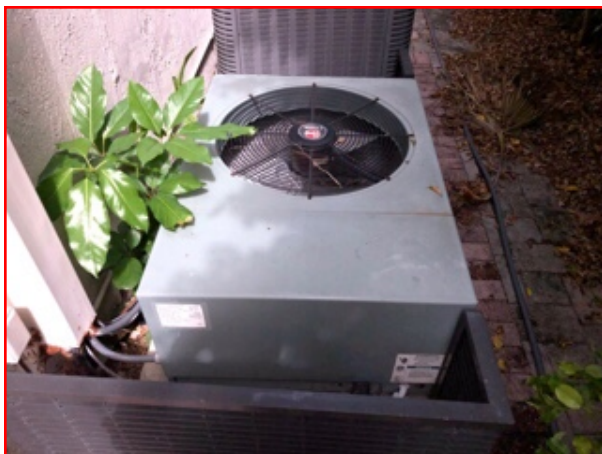
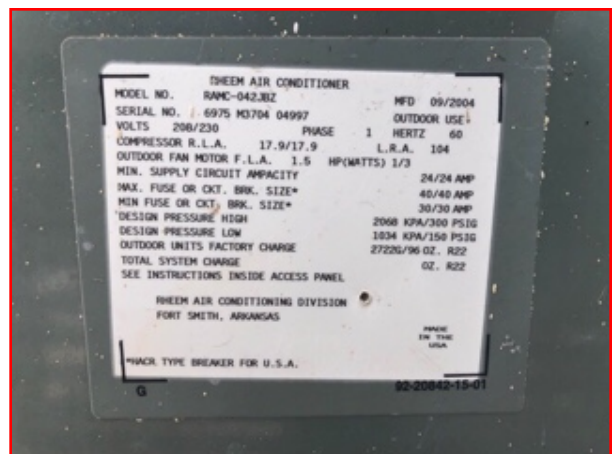
29) Comment 42: HVAC system exterior compressor unit.

- HVAC currently 15 years old.
- HVAC system does not appear to be compressing or cooling refrigerant line properly at the time of the inspection. As HVAC system unit is nearing end of efficient life expectancy, estimate system may need to be replaced. (Estimate: \$2,000 - \$4,000)

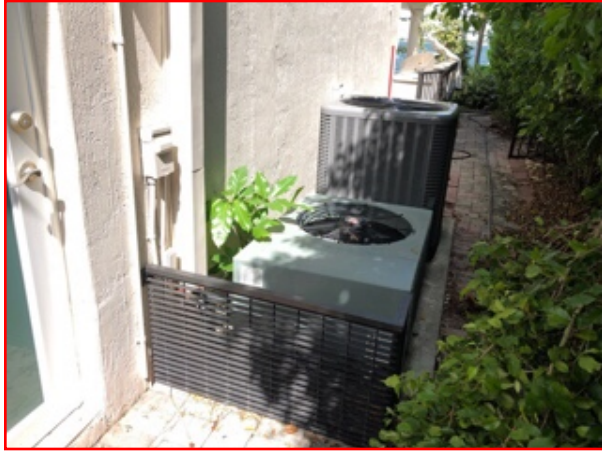
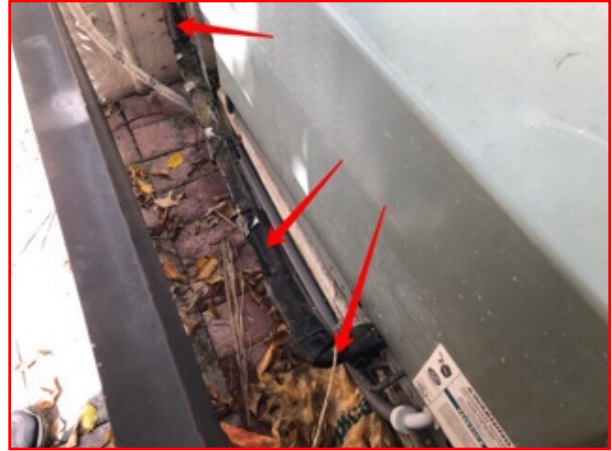
30) Comment 43: Insulation weathered/worn away around refrigerant line to exterior compressor unit.

- Missing insulation may cause refrigerant line to condensate and cause water damage to surrounding areas.

Recommend replacing insulation around refrigerant line to exterior compressor unit. (Estimate: \$100 - \$200)

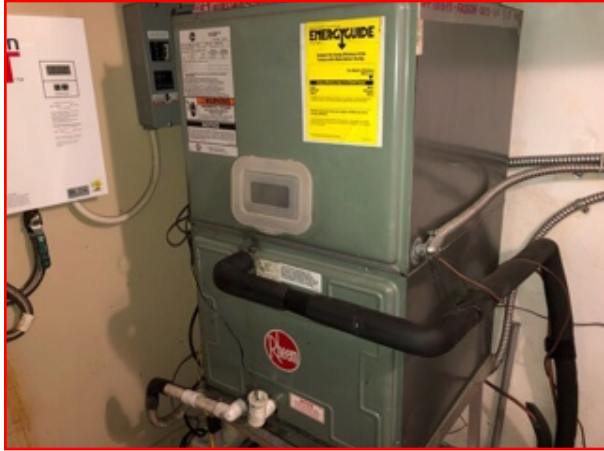
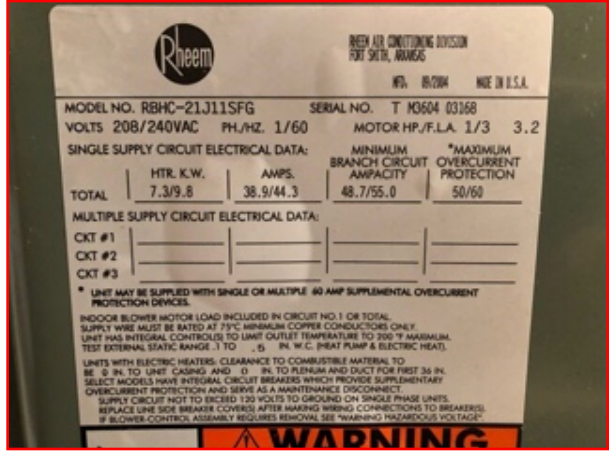
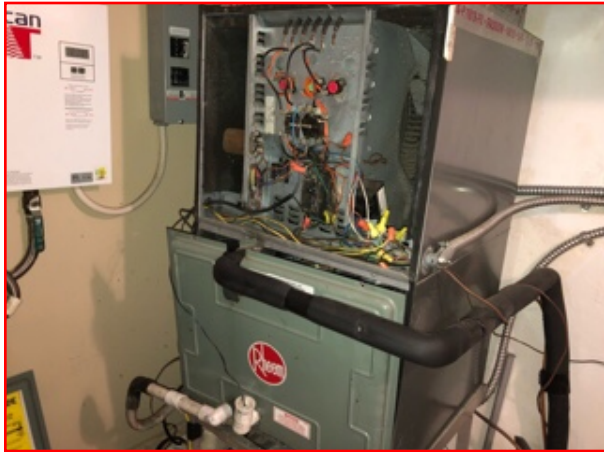
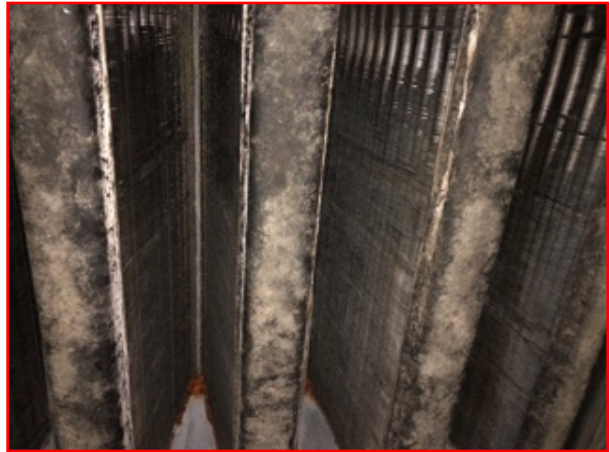
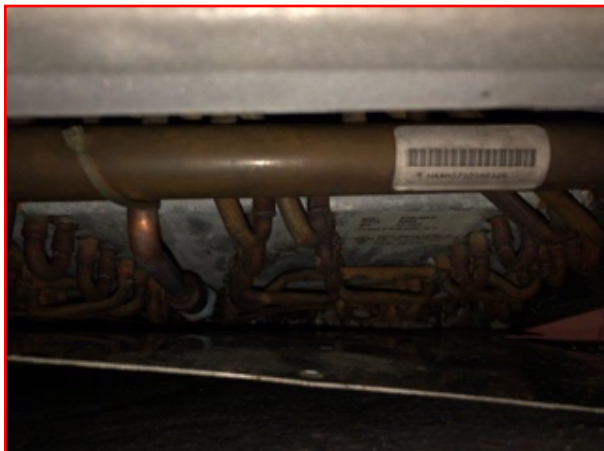
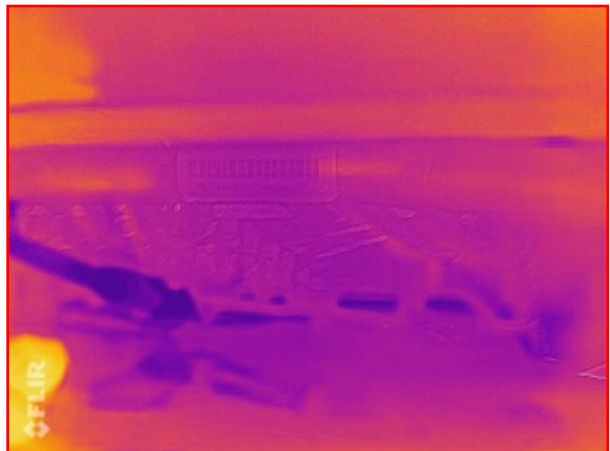
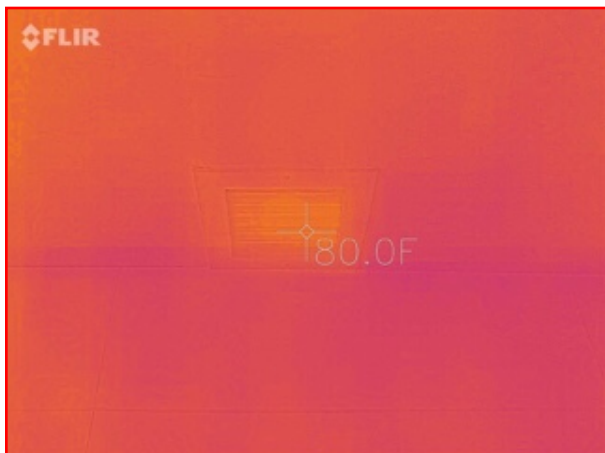
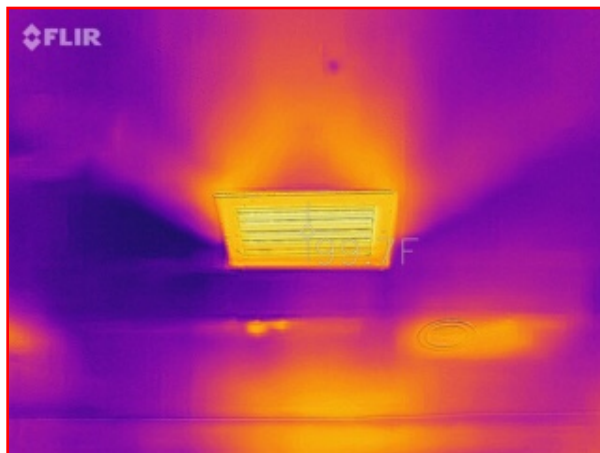
31) Comment 44: HVAC system air handler unit.

- HVAC system controlling first floor bathroom, kitchen & living room.
- HVAC system in fair condition at the time of inspection.
- A/C radiator & coils appear in fair condition at the time of inspection.
- Minor debris build up along exterior of radiator.
- HVAC system coils do not appear to be cooling properly. Estimate due to compressor unit not functioning properly.
- HVAC currently 15 years old and nearing end of efficient life expectancy.

Recommend further evaluation by a licensed HVAC technician and repair or replace accordingly. (Estimate \$2,000 - \$4,000)

Recommend having HVAC system serviced/cleaned periodically by a licensed HVAC technician for better maintenance.

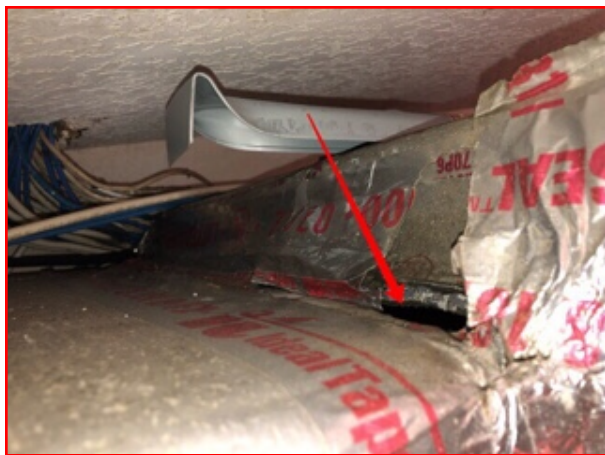
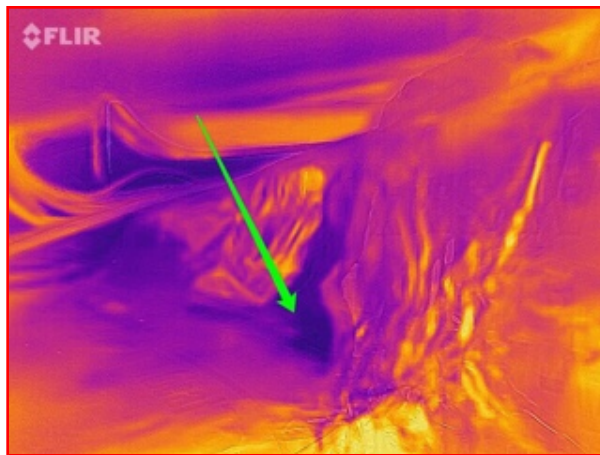
32) Comment 47: Torn foil ducting tape around plenum connection causing air to leave plenum, and not properly distribute through duct system.

Recommend re-sealing plenum connection to prevent seepage of conditioned air through ducting system. (Estimate: \$100 - \$200)

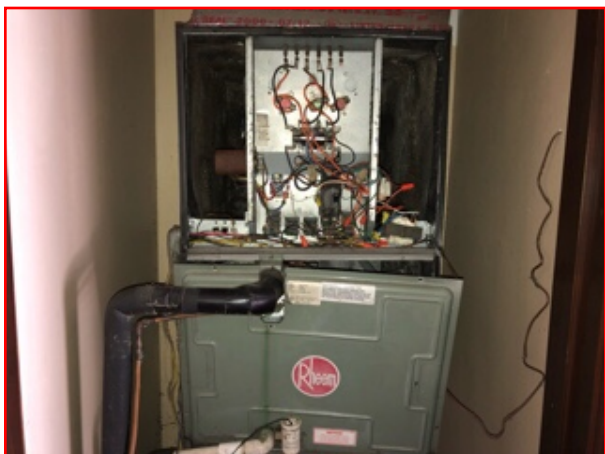
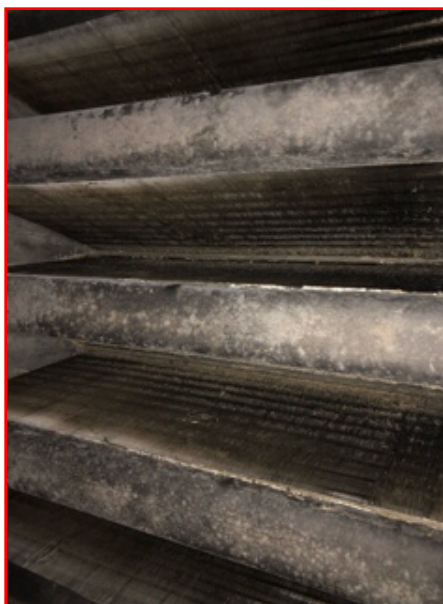
33) Comment 50: Heavy debris build-up along base of radiator.

Recommend having HVAC system services/cleaned by a licensed HVAC technician for better maintenance. (Estimate: \$250 - \$500)

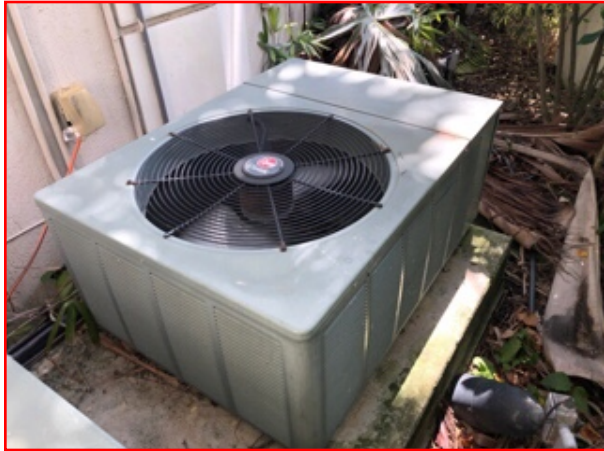
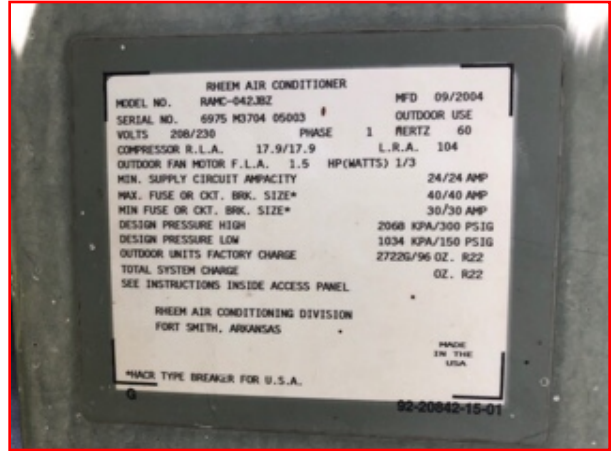
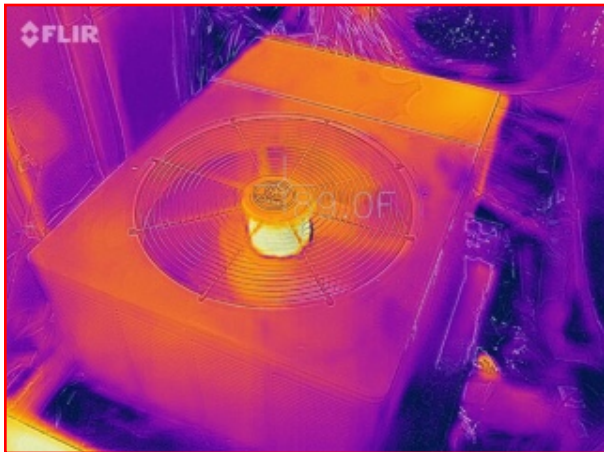
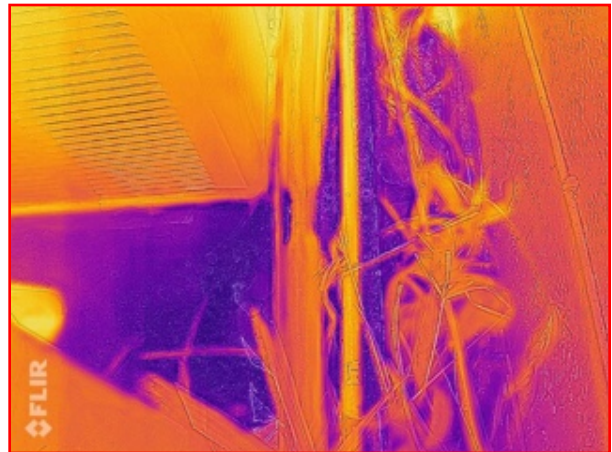
34) Comment 51: HVAC system exterior compressor unit.

- HVAC currently 15 years old.
- HVAC system does not appear to be compressing or cooling refrigerant line properly at the time of the inspection. As HVAC system unit is nearing end off efficient life expectancy, estimate system may need to be replaced. (Estimate: \$2,000 - \$4,000)

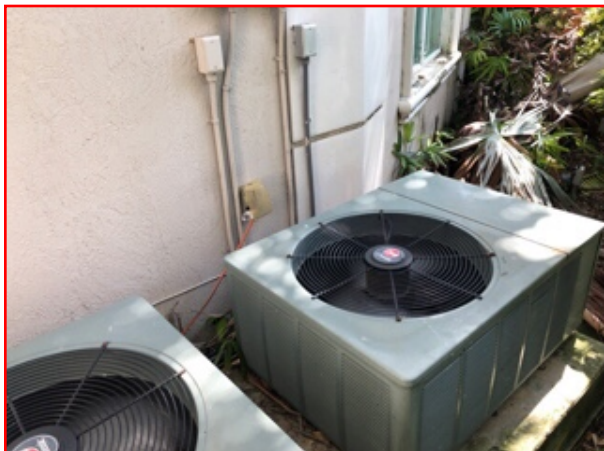
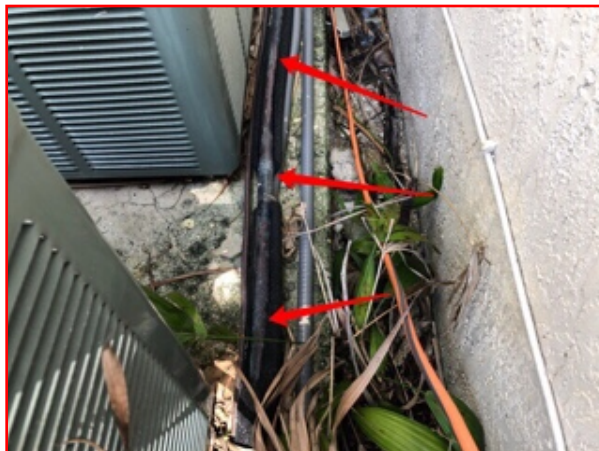
35) Comment 52: Insulation weathered/worn away around refrigerant line to exterior compressor unit.

- Missing insulation may cause refrigerant line to condensate and cause water damage to surrounding areas.

Recommend replacing insulation around refrigerant line to exterior compressor unit. (Estimate: \$100 - \$200)

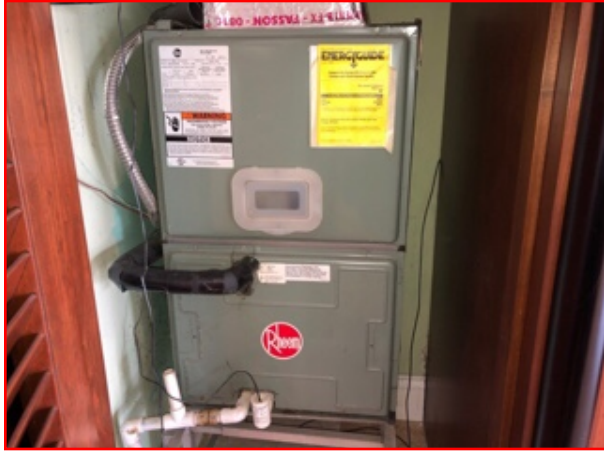
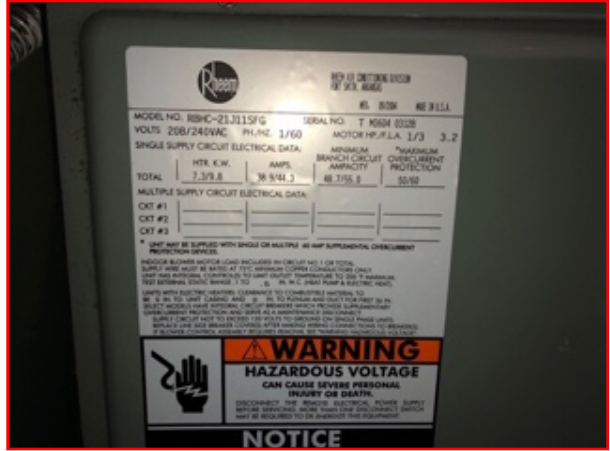
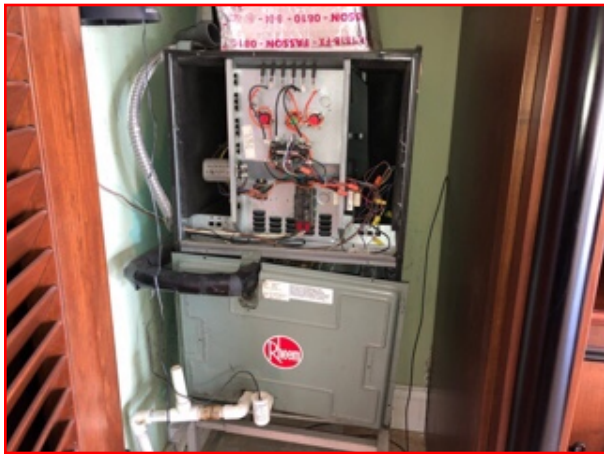
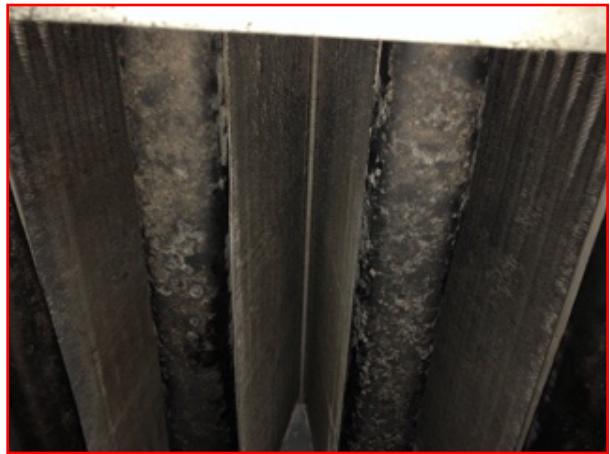
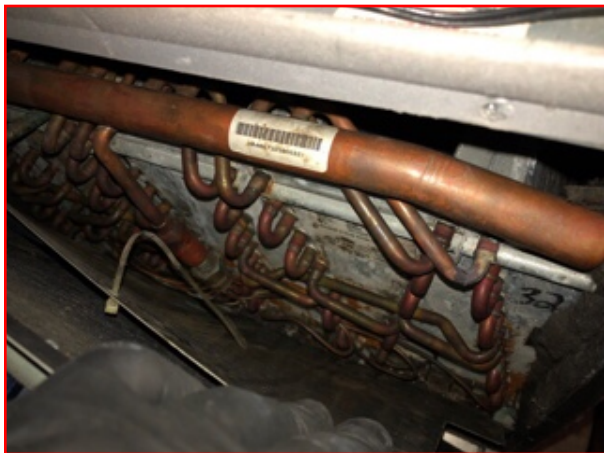
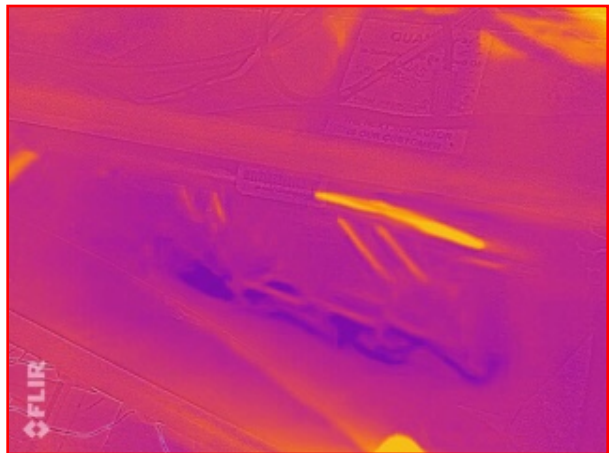
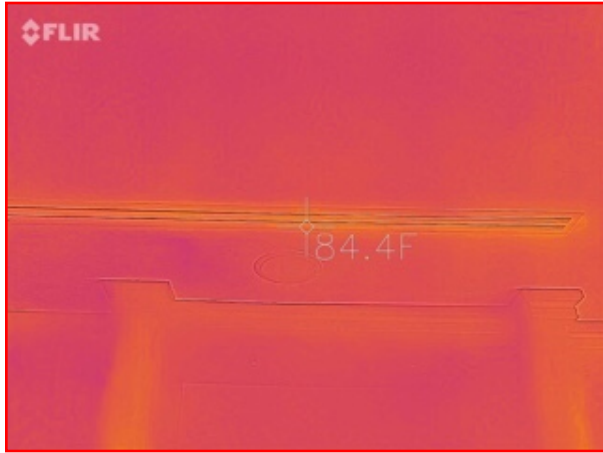
36) Comment 53: HVAC system air handler unit.

- HVAC system controlling living room & dining room.
- HVAC system in fair condition at the time of inspection.
- A/C radiator & coils appear in fair condition at the time of inspection.
- Minor debris build up along exterior of radiator.
- HVAC system not heating at the time of the inspection.
- HVAC system coils do not appear to be cooling properly. Estimate due to compressor unit not functioning properly.
- HVAC currently 15 years old and nearing end of efficient life expectancy.

Recommend further evaluation by a licensed HVAC technician and repair or replace accordingly. (Estimate \$2,000 - \$4,000)

Recommend having HVAC system serviced/cleaned periodically by a licensed HVAC technician for better maintenance.

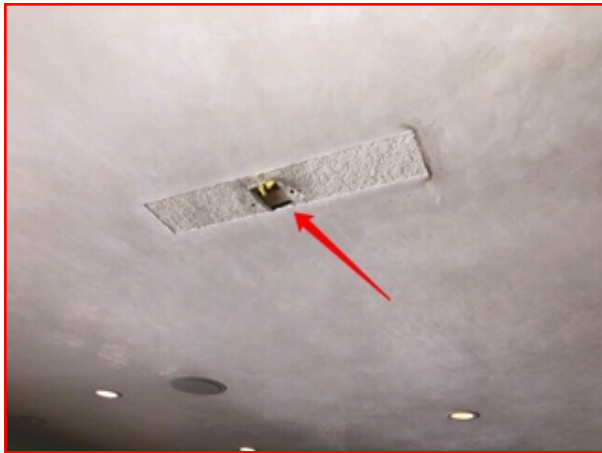
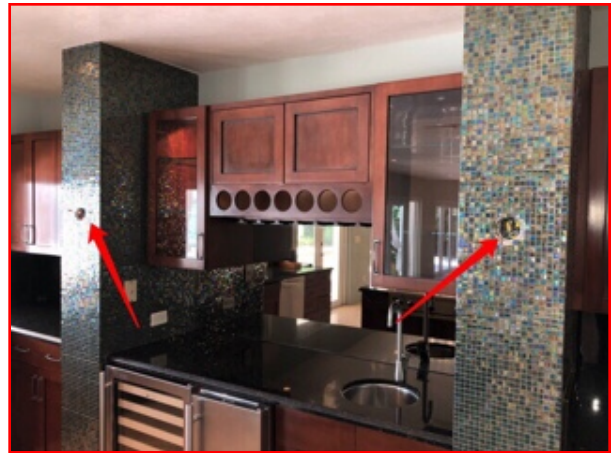
37) Comment 55: Missing lighting fixtures throughout kitchen leaving exposed wiring. Replace missing lighting fixtures. (Detailed quotation required)

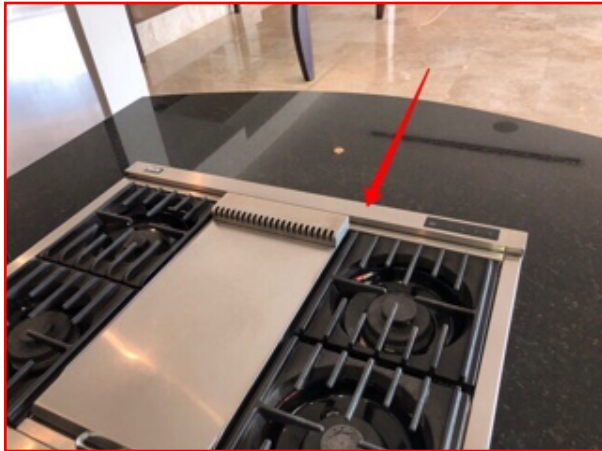
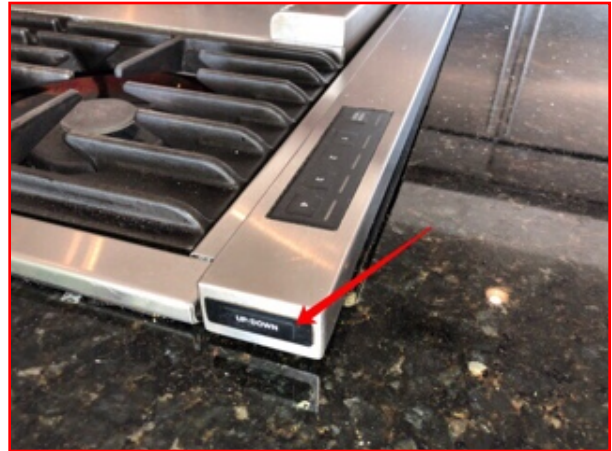
38) Comment 58: Retractable range hood over cooktop not functioning properly at the time of inspection.

Recommend further evaluation by a licensed technician and repair/replace accordingly.
(Estimate: \$500 - \$1,000)

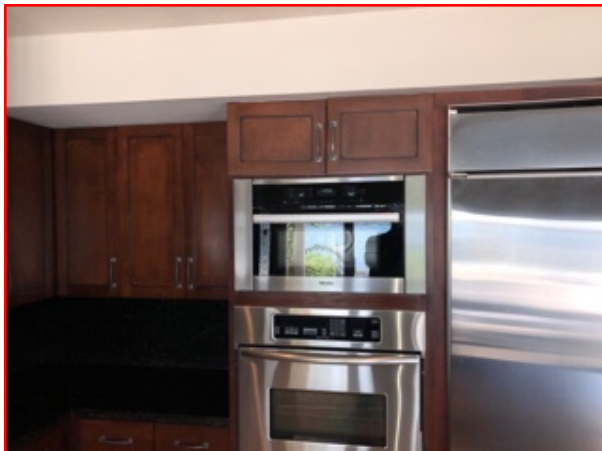
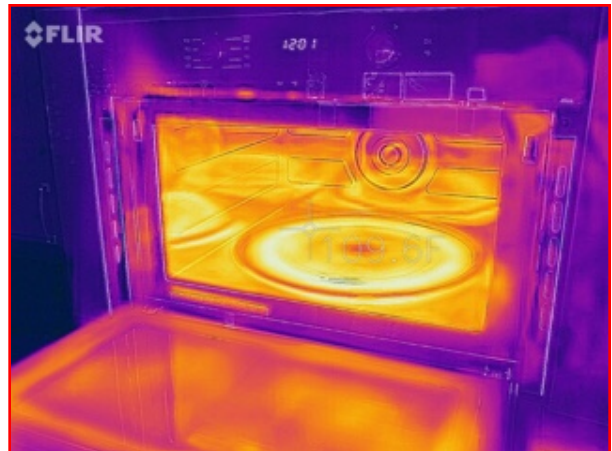
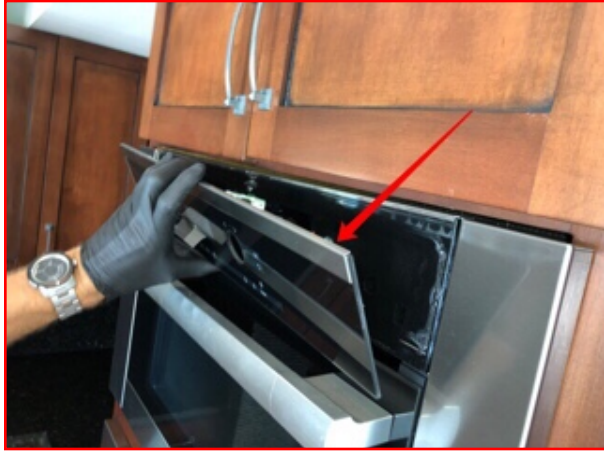
39) Comment 60: Microwave functioning properly at the time of inspection.

- Control panel is currently broken/loose.

Recommend further evaluation by a licensed technician and repair/replace accordingly.
(Estimate: \$100 - \$250)

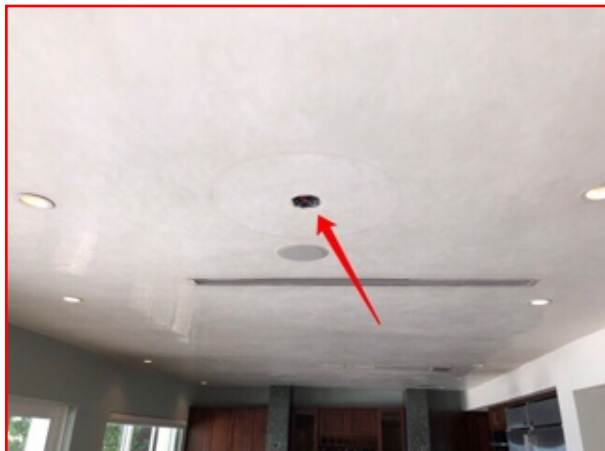
Figure 68-1

41) Comment 68: Missing overhead lighting fixture in living room leaving exposed wiring. Replace missing lighting fixture. (Detailed quotation required)

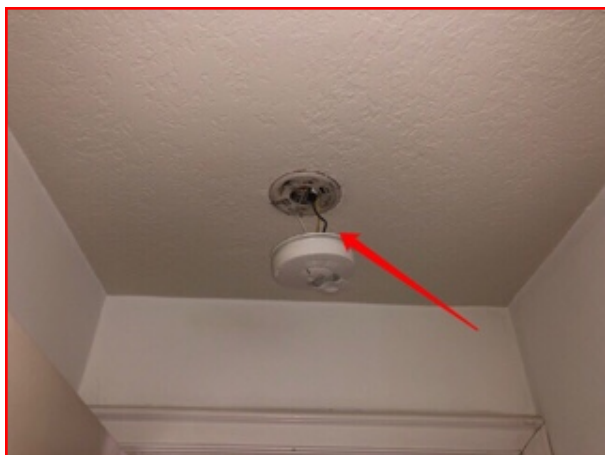
Figure 70-1

42) Comment 70: Smoke detector not properly installed & missing battery within downstairs bedroom #1.

Properly connect smoke detector, and replace missing 9V battery. (Estimate: \$25 - \$50)

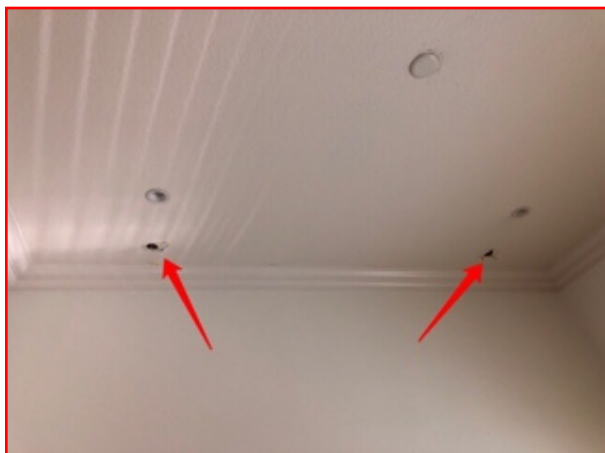
Figure 71-1

43) Comment 71: Missing overhead lighting fixtures within downstairs bedroom #1 leaving exposed wiring.

Replace missing lighting fixtures. (Detailed quotation required)

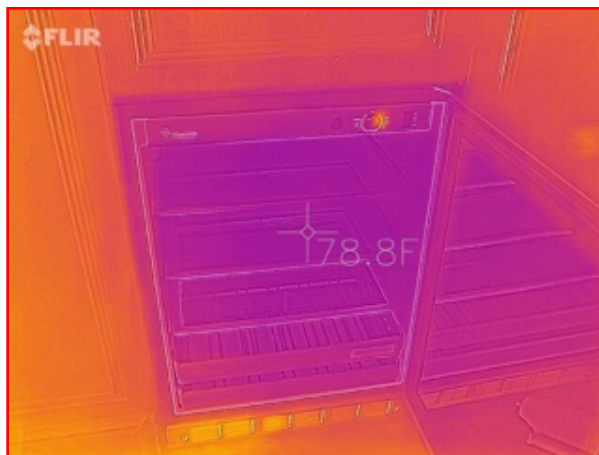
Figure 75-2

44) Comment 75: Built-in mini wine refrigerator within upstairs master bedroom not functioning properly at the time of inspection.

Repair or replace mini wine refrigerator. (Estimate: \$400 - \$800)

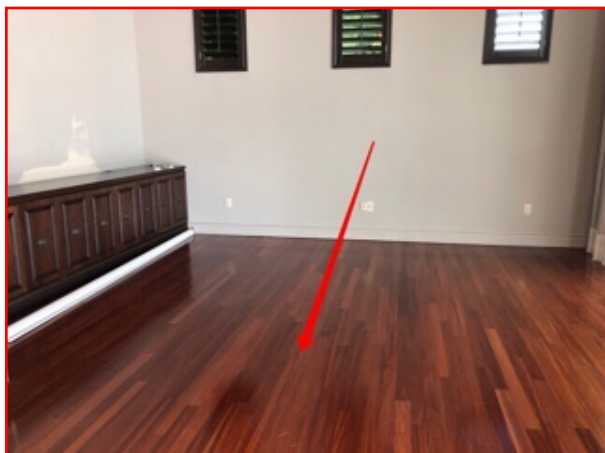
Figure 76-1

45) Comment 76: Loose wood flooring within master bedroom popping when pressure is applied.

Recommend further evaluation of sub-flooring below and repair/replace accordingly. (Estimate: \$250 - \$500)

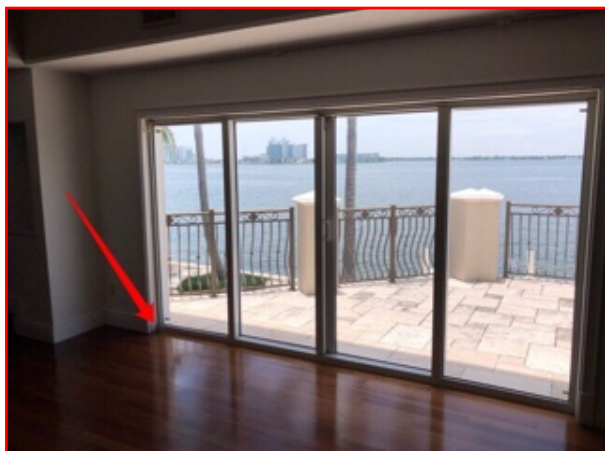
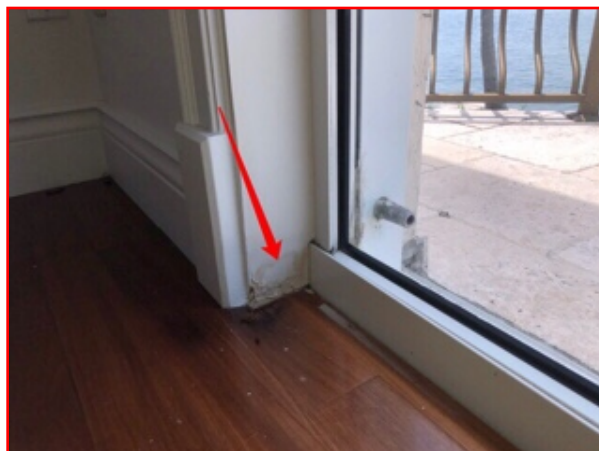
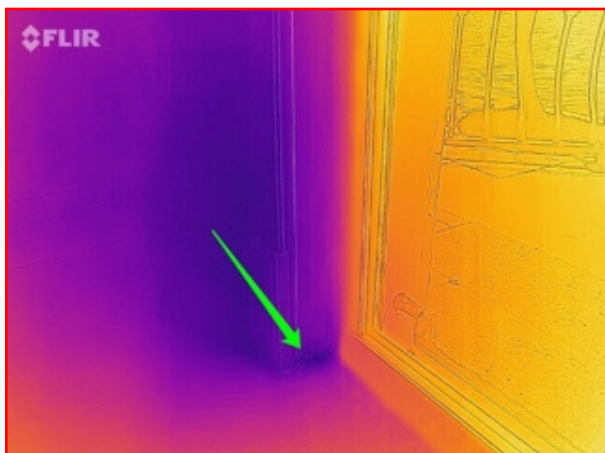
47) Comment 78: Minor water damage found around corner rear sliding glass door/window frame in master bedroom to exterior terrace.

- Indications of minor moisture intrusion along interior walls around door/window frame at the time of inspection.

Recommend repairing/re-sealing around exterior of window framing to prevent possible moisture intrusion or water damage in the future. (Estimate: \$150 - \$300)

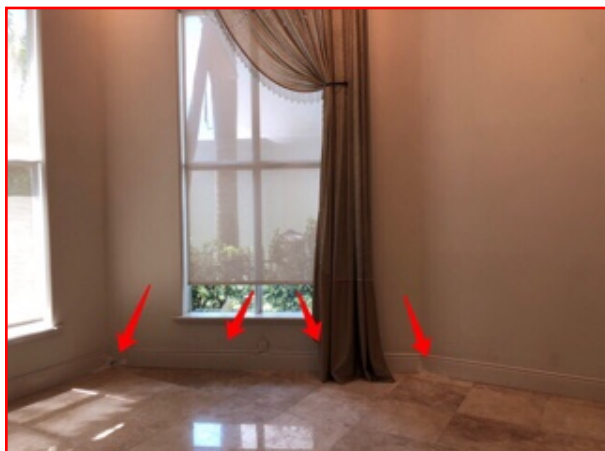
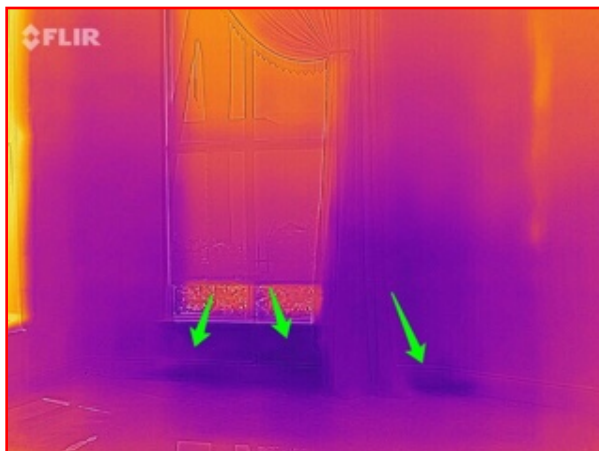
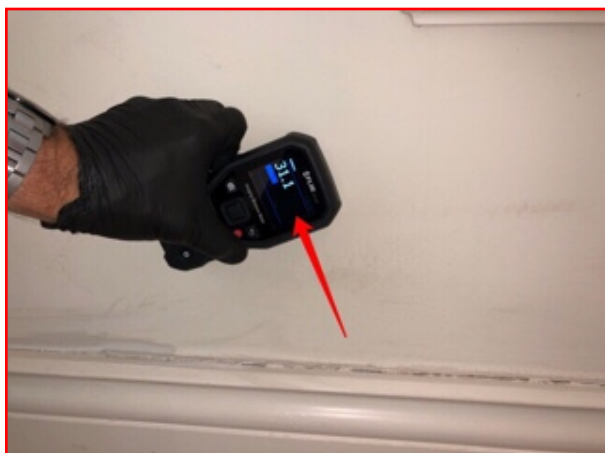
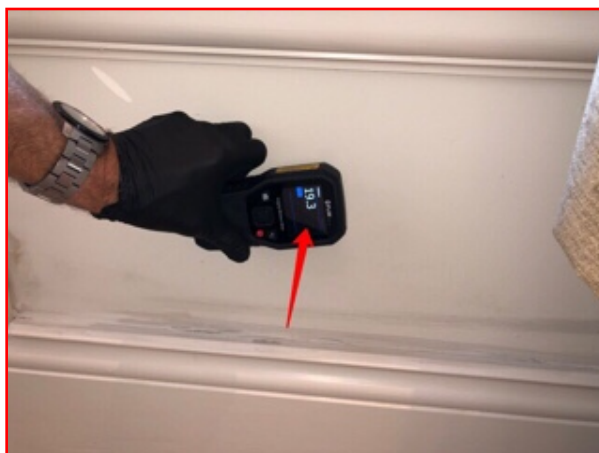
48) Comment 80: Apparent water damage to drywall around base of wall & baseboards below dining room window.

- Indications of current moisture intrusion detected in wall. Estimate leaking from window frame above.

Recommend re-sealing window above to prevent further leaking & water damage.

Replace water damaged drywall & baseboards. (Estimate: \$250 - \$500)

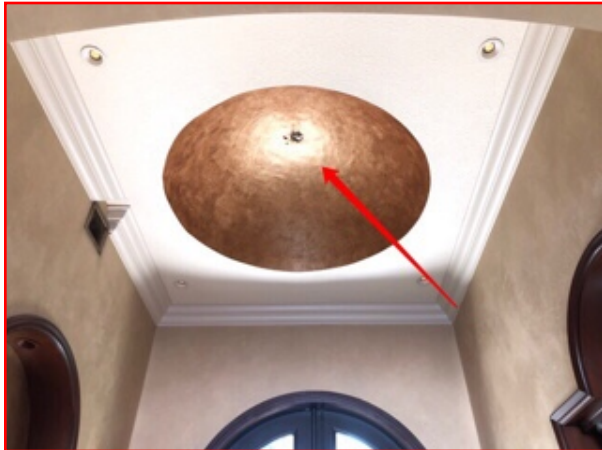
Figure 82-1

49) Comment 82: Missing overhead lighting fixture/chandelier in over front entrance/foyer leaving exposed wiring.

Replace missing lighting fixture/chandelier. (Detailed quotation required)

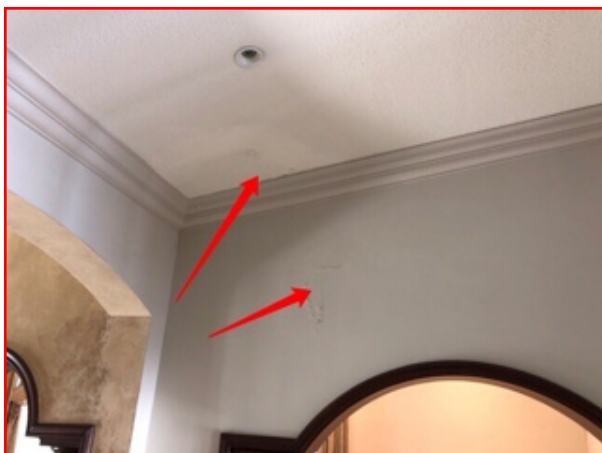
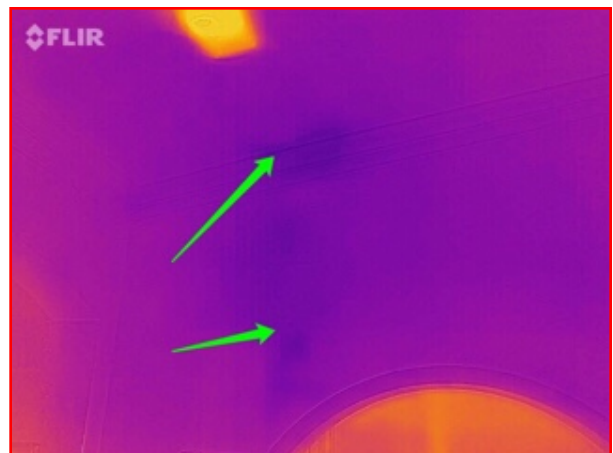
50) Comment 83: Water damage/active moisture intrusion detected along ceiling & wall over front entrance hallway adjacent to dining room.

- Estimate active roof leak from above currently causing moisture intrusion & water damage.

Recommend having a licensed roofer further evaluate roof coverings above & repair accordingly to prevent further moisture intrusion or water damage.

Recommend replacing water damaged drywall over front entrance hallway adjacent to dining room. (Estimate: \$1,000 - \$2,000)

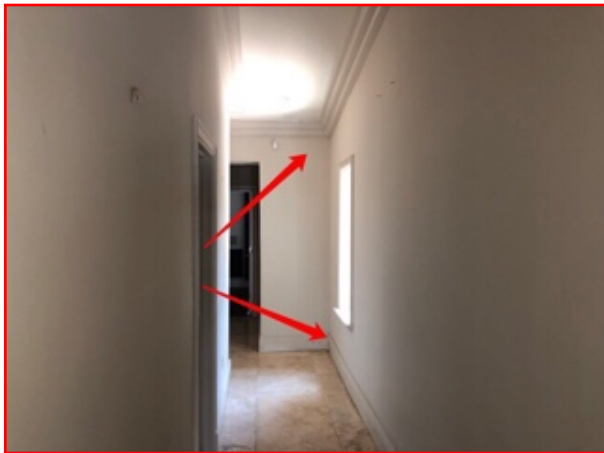
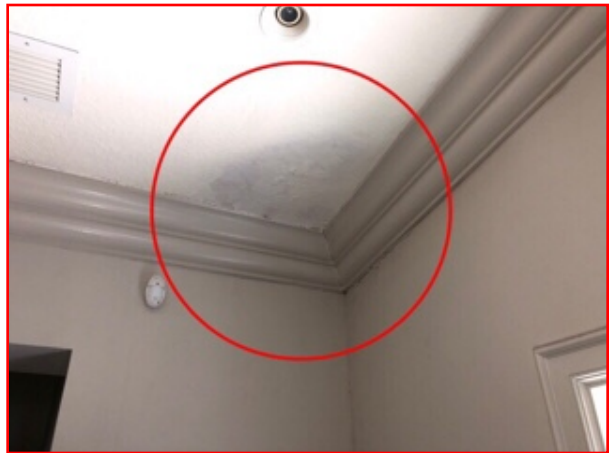
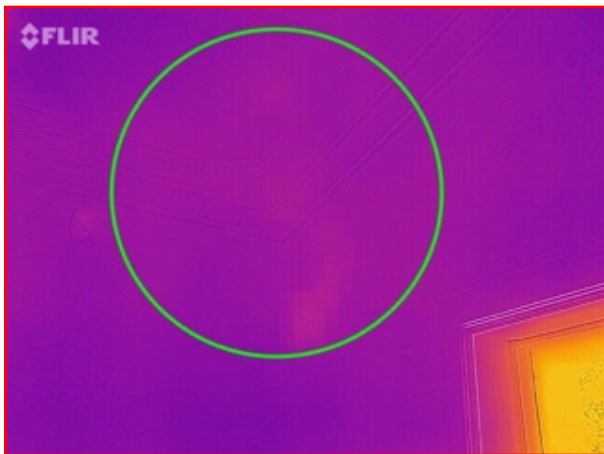
51) Comment 84: Water damage/active moisture intrusion detected along ceiling & wall over downstairs bedroom hallway.

- Estimate active roof leak from above currently causing moisture intrusion & water damage.

Recommend having a licensed roofer further evaluate roof coverings above & repair accordingly to prevent further moisture intrusion or water damage.

Recommend replacing water damaged drywall & baseboards in downstairs hallway. (Estimate: \$1,000 - \$2,000)
