Home Pro Miami

Home Inspection Report

1175 Sample Dr

Inspected on Thu, Aug 29 2019 at 10:00 AM

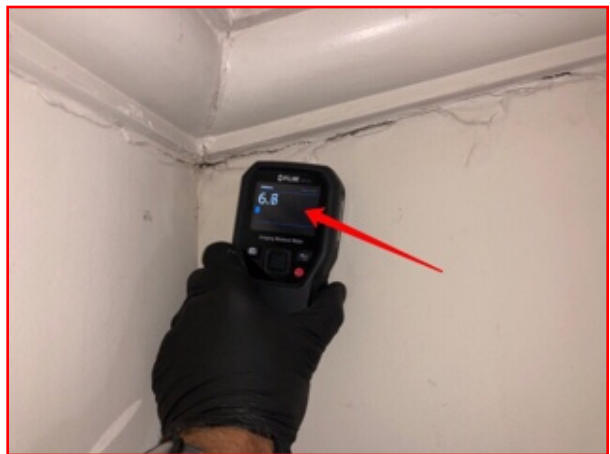
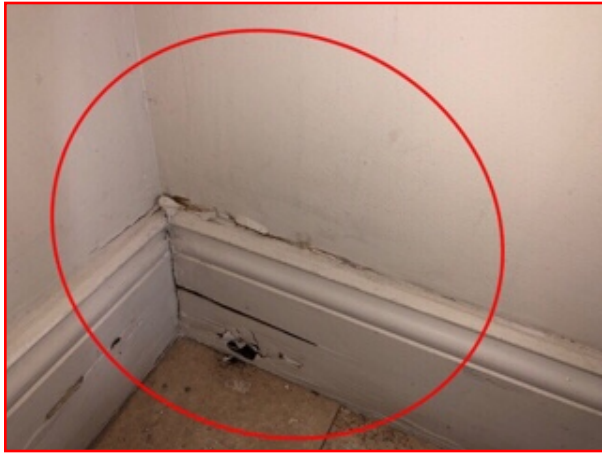
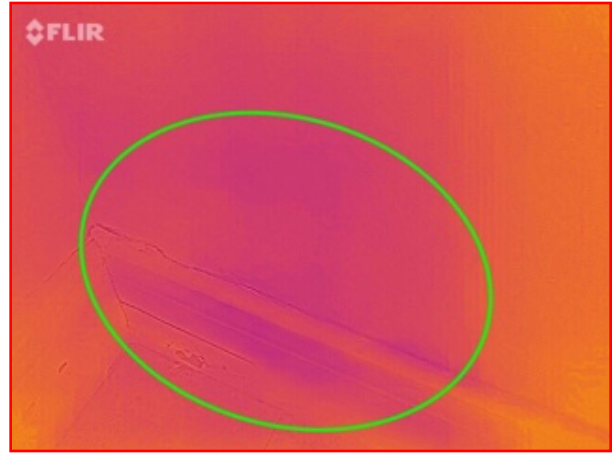
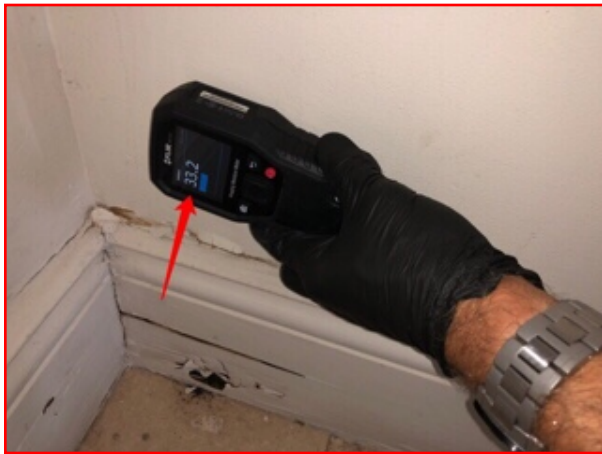
51) Comment 84: Water damage/active moisture intrusion detected along ceiling & wall over downstairs bedroom hallway.

- Estimate active roof leak from above currently causing moisture intrusion & water damage.

Recommend having a licensed roofer further evaluate roof coverings above & repair accordingly to prevent further moisture intrusion or water damage.

Recommend replacing water damaged drywall & baseboards in downstairs hallway. (Estimate: \$1,000 - \$2,000)

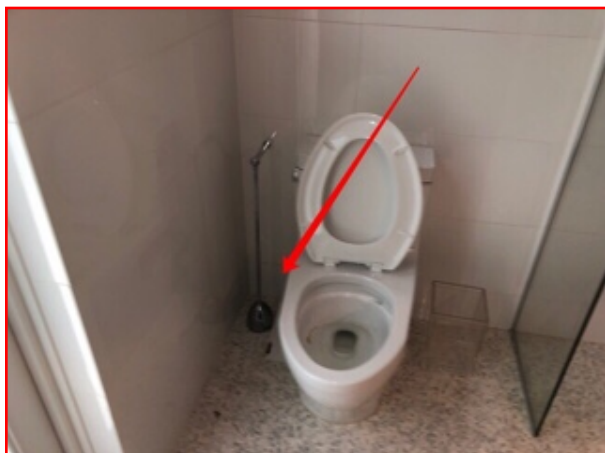
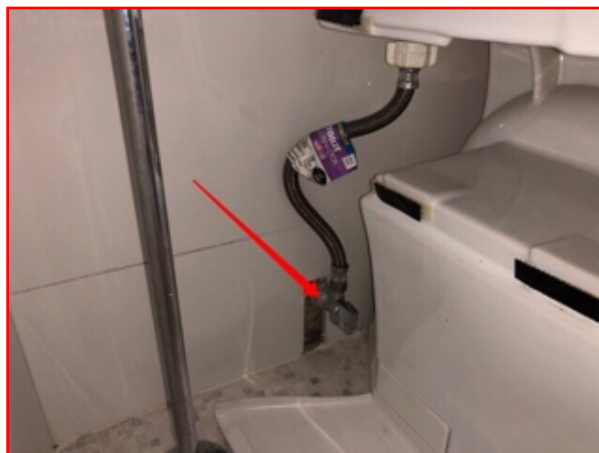
52) Comment 86: Water supply turn-stop valve to toilet fixture leaking at the time of inspection.

Replace water supply turn-stop valve to toilet fixture. (Estimate: \$150 - \$300)

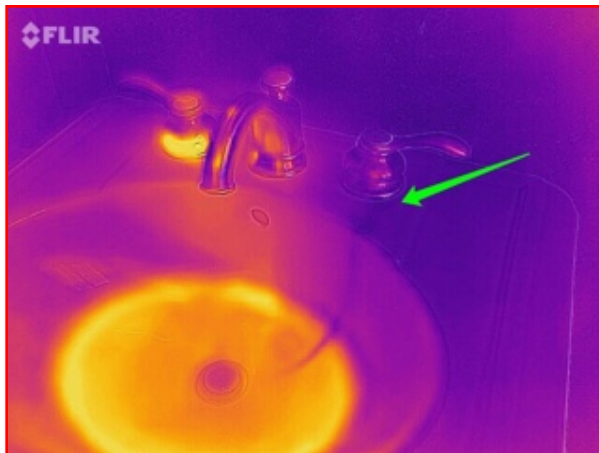
Figure 91-2

55) Comment 91: Sink fixture cold water valve handle leaking above sink.
Repair/replace cold water valve handle to sink faucet fixture. (Estimate: \$100 - \$200)

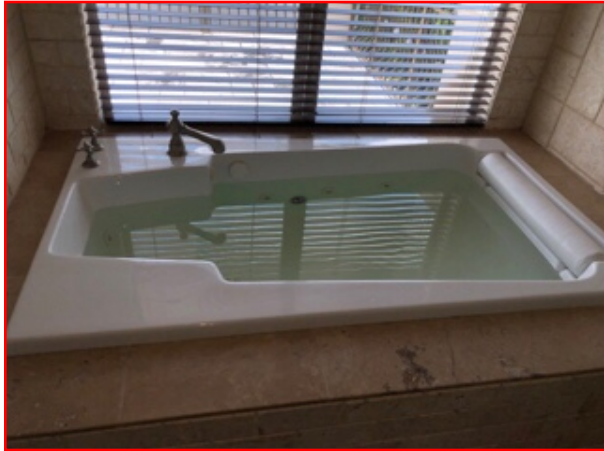
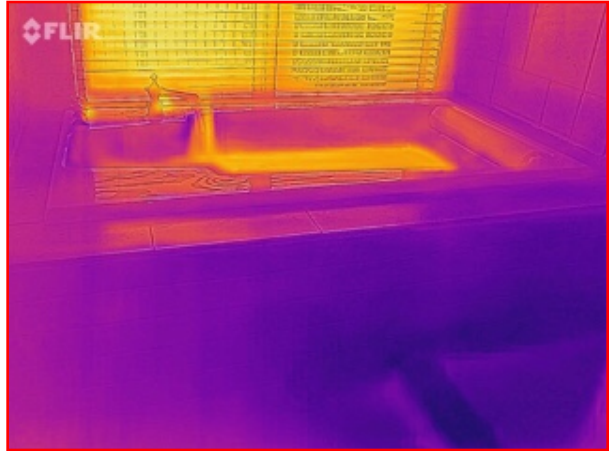
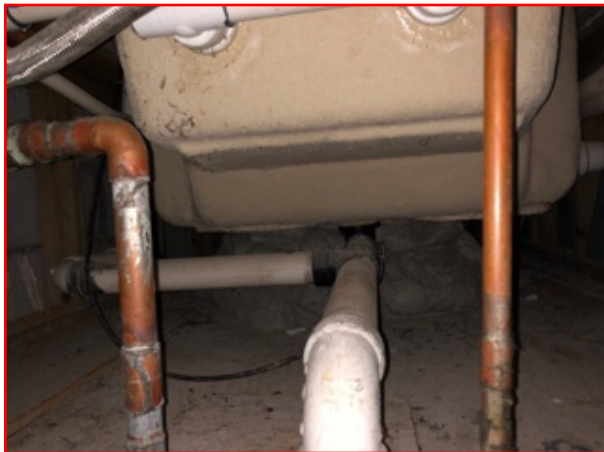
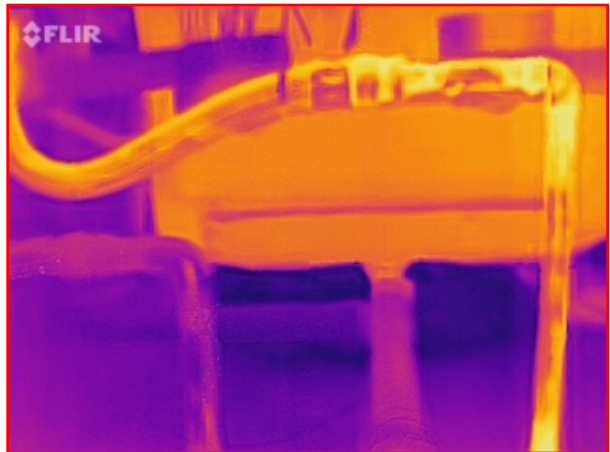
- No indications of leaking from around jacuzzi tub at the time of inspection.
- Jacuzzi motor does not activate with control panel.

Recommend further evaluation by a professional contractor and repair/replace accordingly. (Estimate: \$500 - \$1,000)

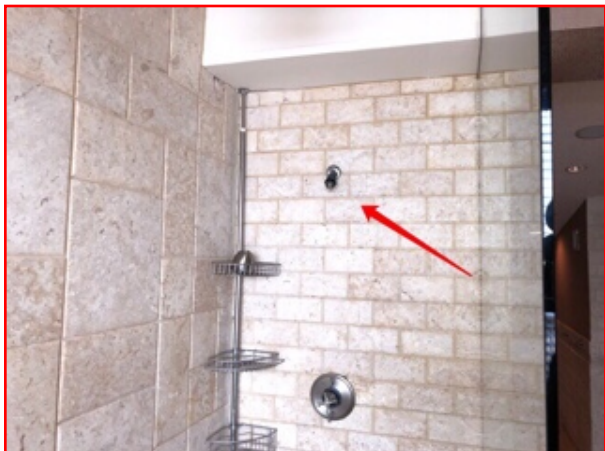
Figure 94-1

57) Comment 94: Wall mounted shower head fixture removed within stand-up shower fixture.

Replace shower head fixture. (Estimate: \$150 - \$300)

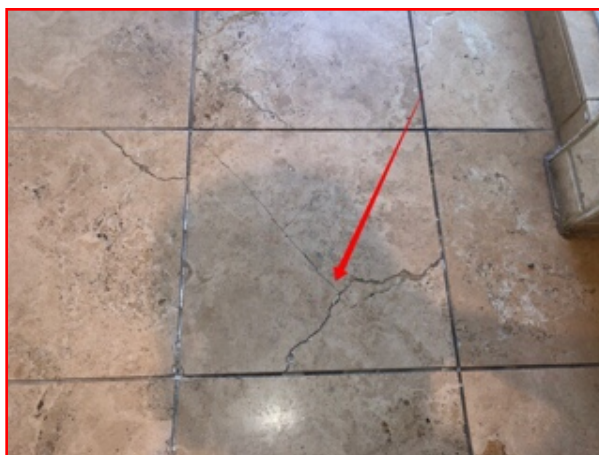
Figure 95-2

58) Comment 95: Broken flooring tile within master bathroom.
Replace broken flooring tile. (Estimate: \$150 - \$300)

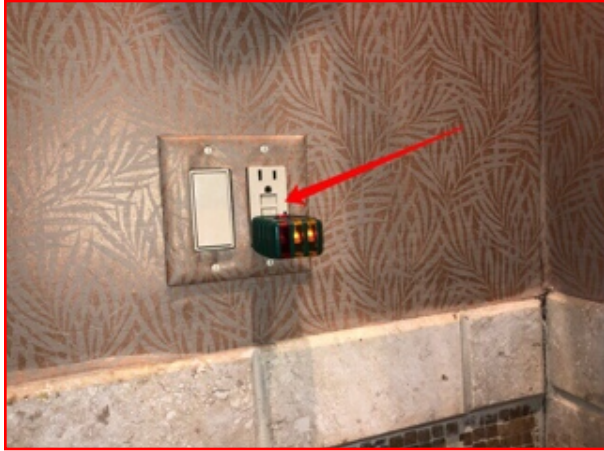
Figure 96-1

59) Comment 96: Bathroom GFCI outlet functioning properly, but does not trip when electrical surge is detected.
Recommend replacing GFCI outlet. (Estimate: \$50 - \$100)
