## Home Inspection Report

**60 Sample Dr**

**Unit 1234**

Inspected on Tue, Feb 7 2017 at 1:00 PM

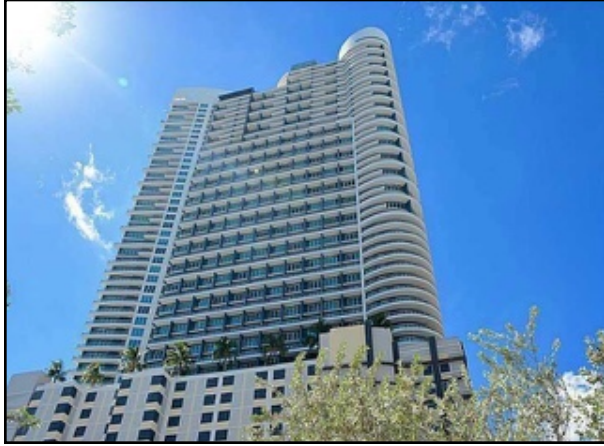
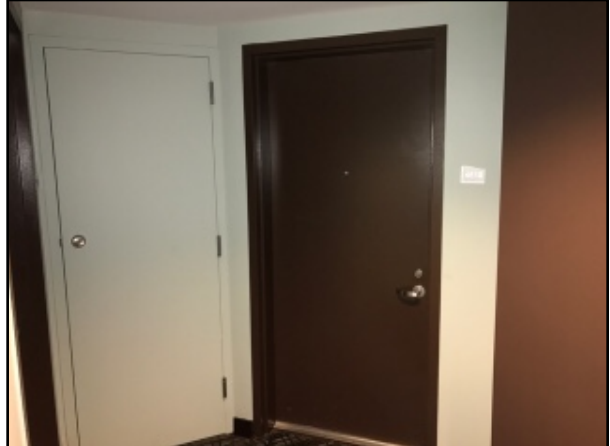
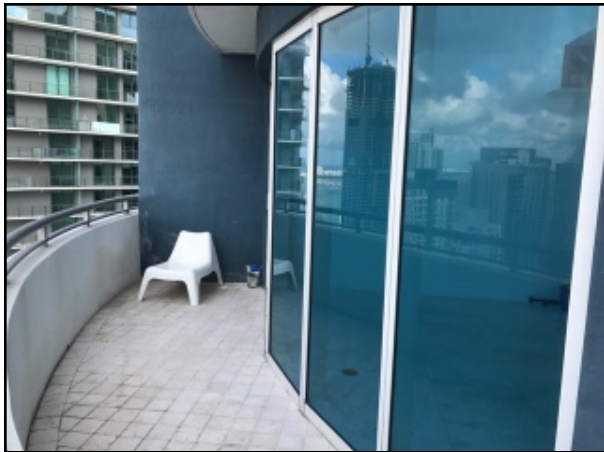
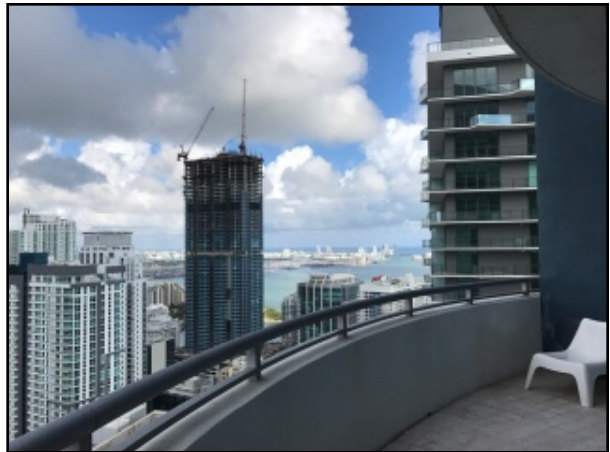
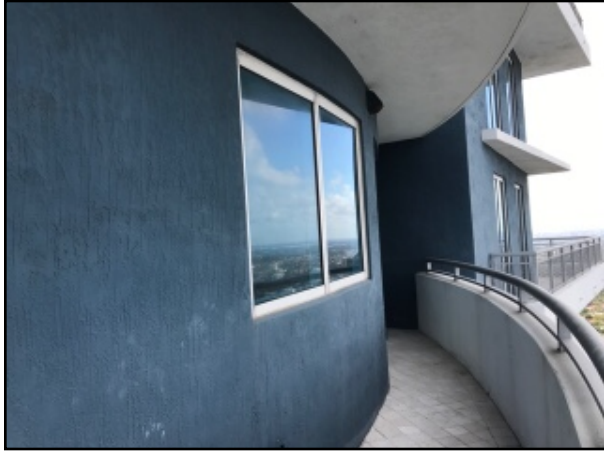
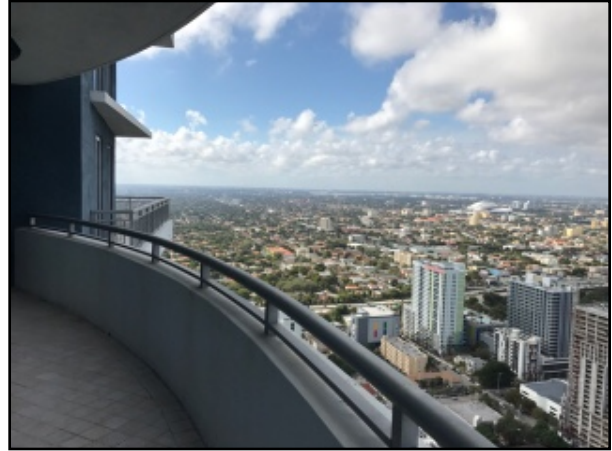
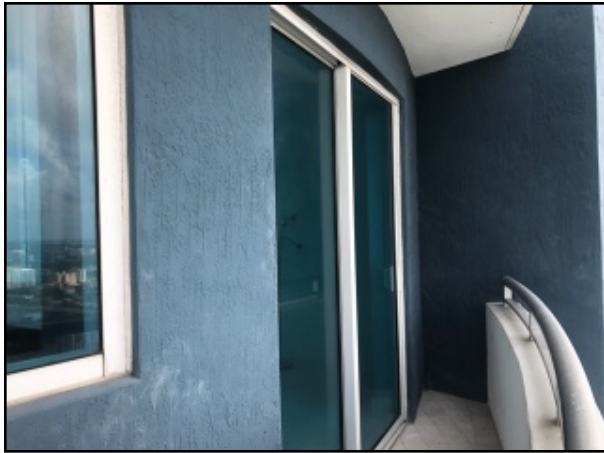
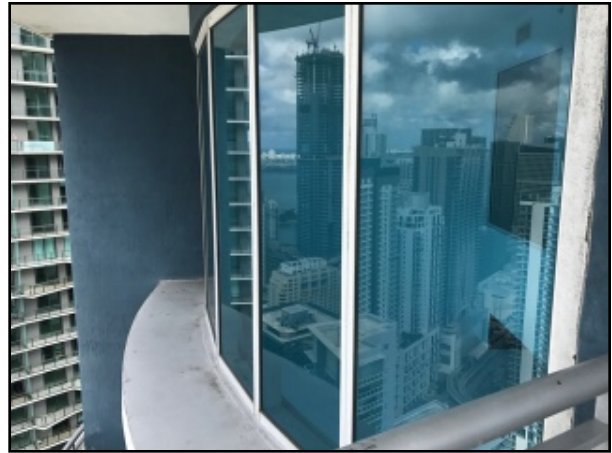
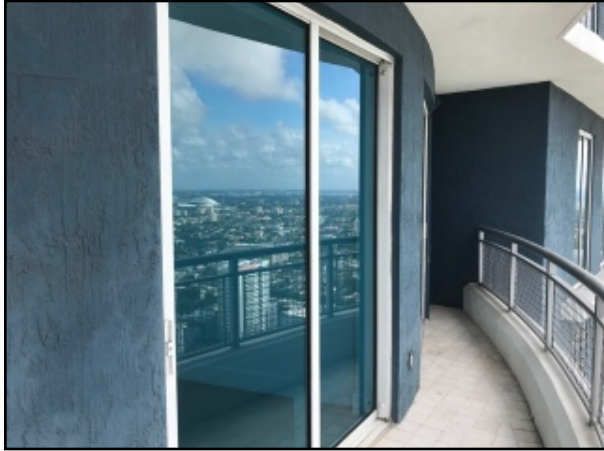
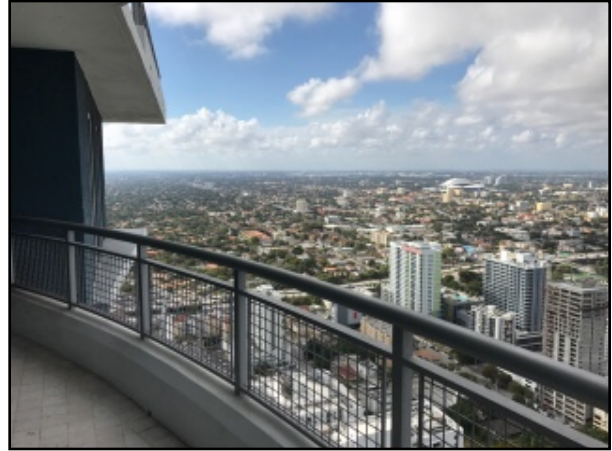
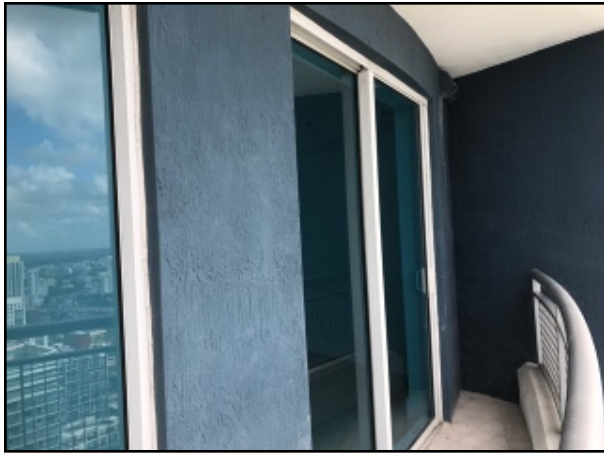
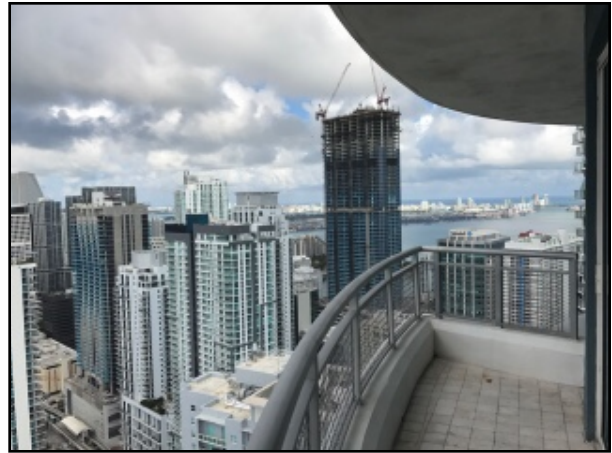
Comment 1:  
Exterior/Site & Balcony Photos.

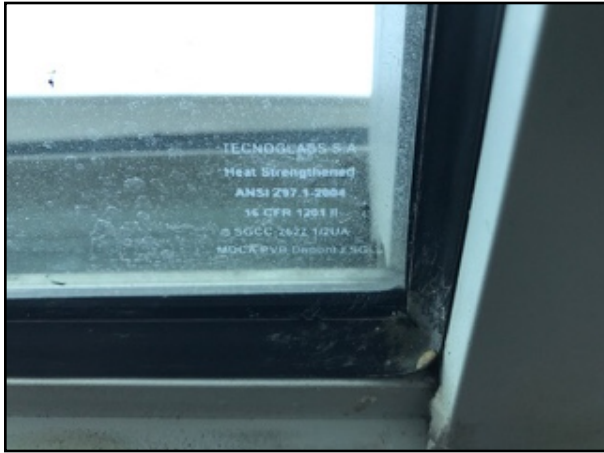
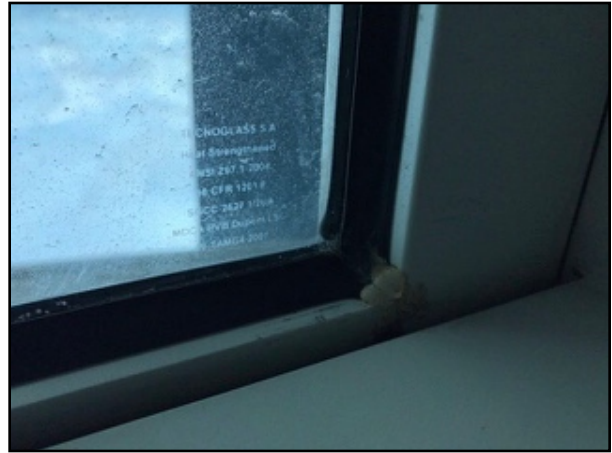
Comment 2:  
Wind Mitigation / Storm Protection.  
- Impact Windows

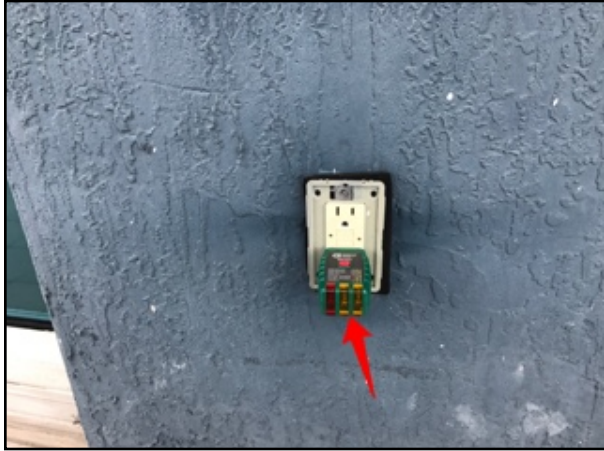
Figure 3-3

The exterior outlets are missing a weather proof cover along lower and upper balconies.

Replace exterior GFCI outlet along upper balcony and weather proof exterior covers over exterior outlets. (Estimate: \$100 - \$250)

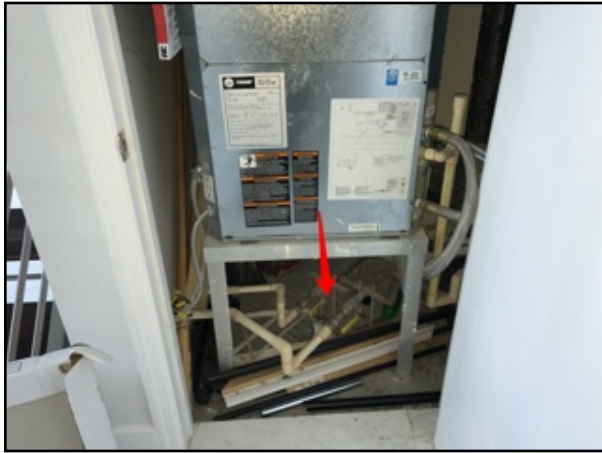
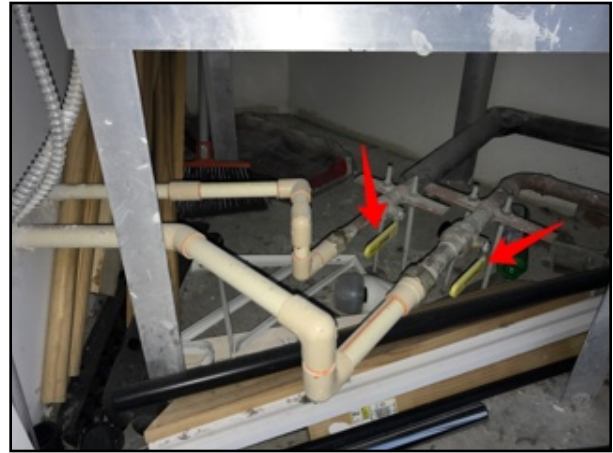
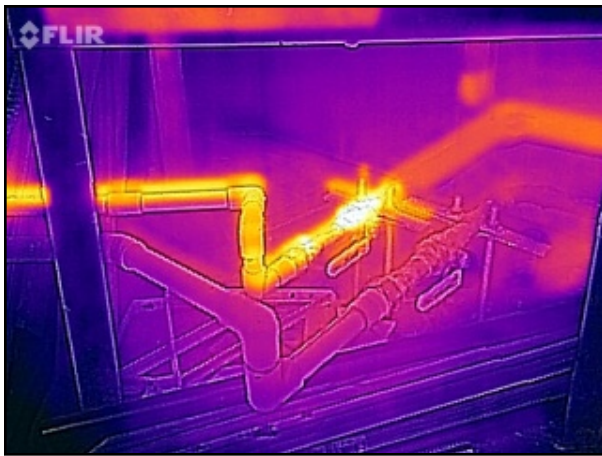
Main water shut-off valves (hot & cold water lines) are located within A/C closet next to air handler unit.

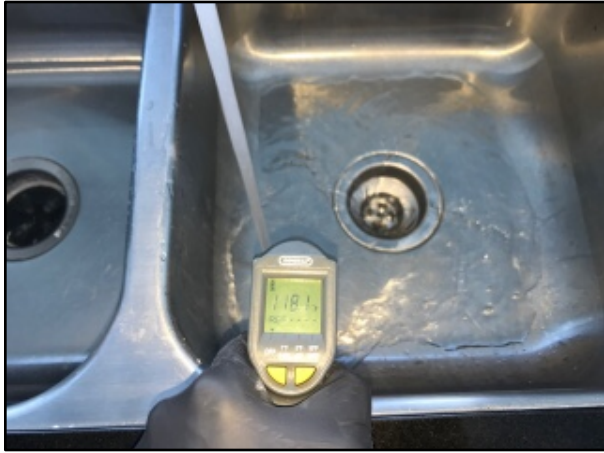
Figure 5-1

Hot water systems are controlled/maintained by building.

- Hot water systems functioning properly at the time of inspection.

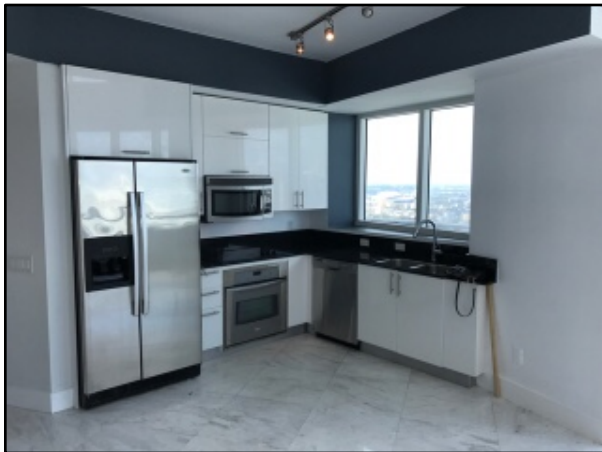
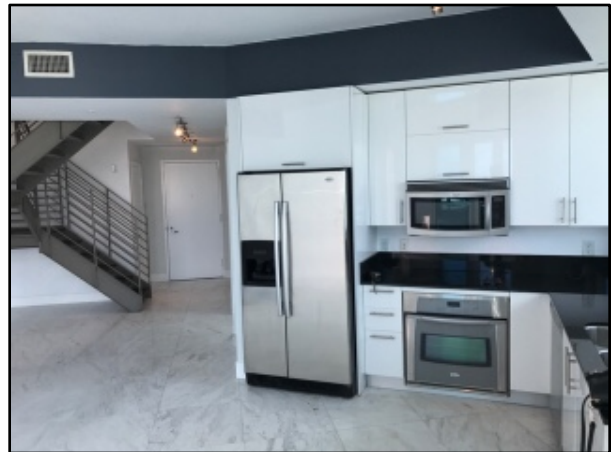
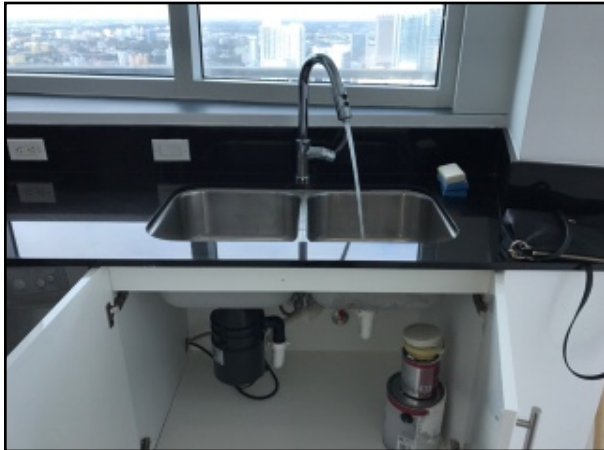
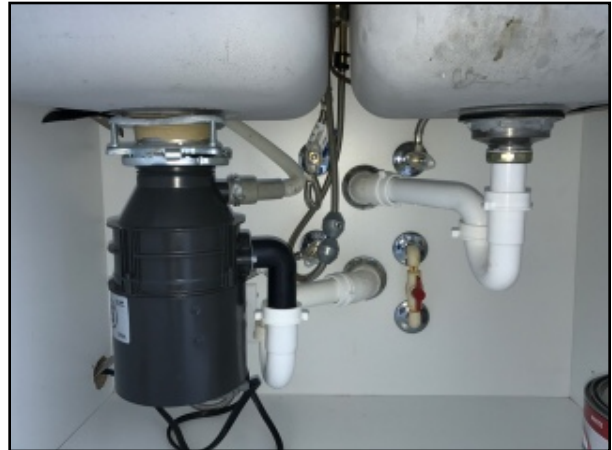
Comment 12:  
Kitchen Photos.

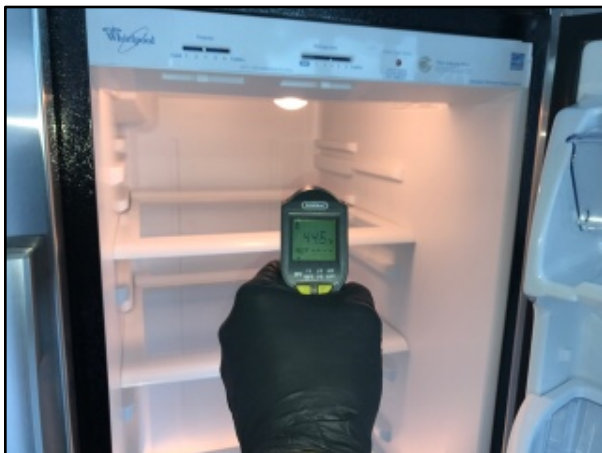
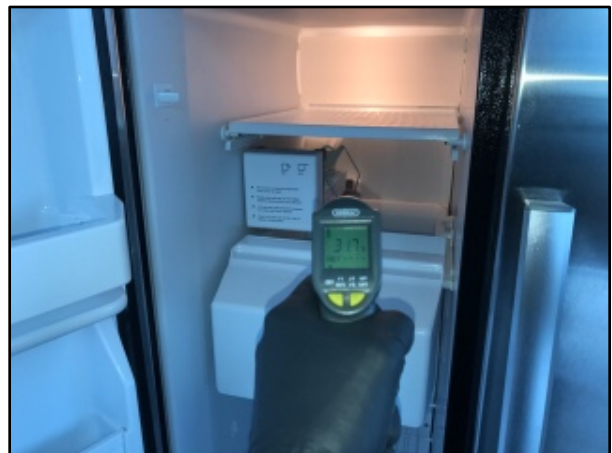
Refrigerator/freezer appears to be functioning properly.

- Power turned-off to appliance prior to inspection.
- Unit cooling during inspection.

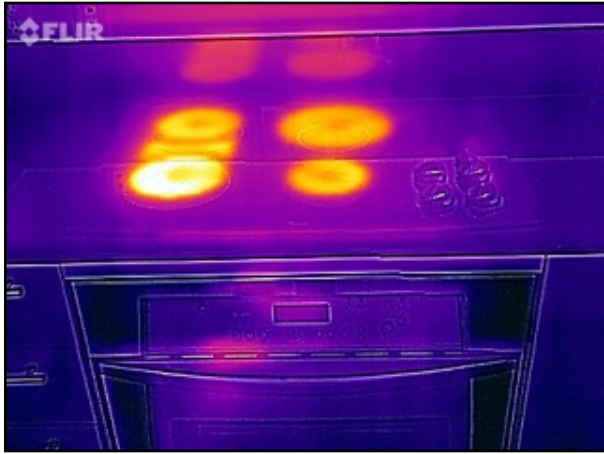
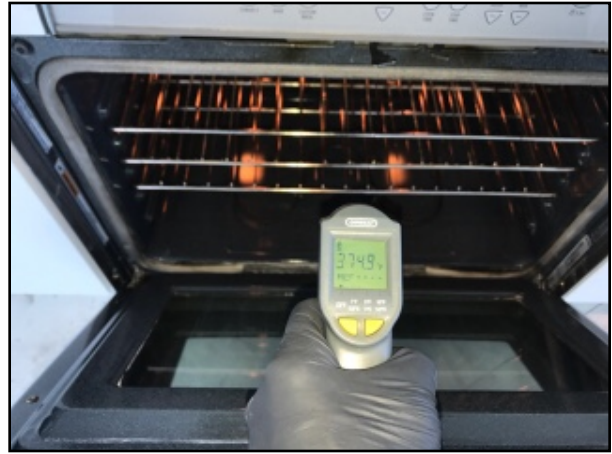
Comment 15:  
Range oven & cooktop functioning properly.

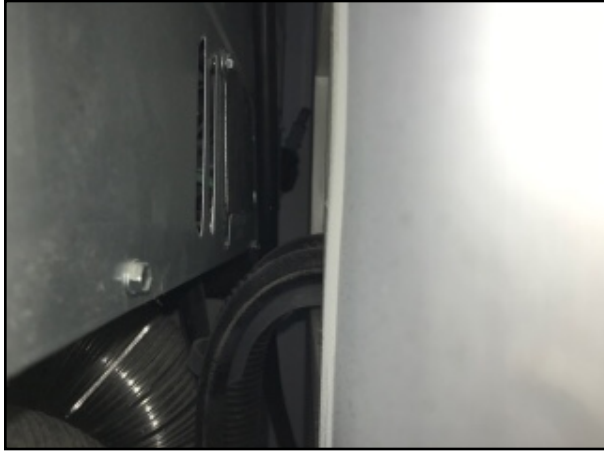
Figure 16-3

**Comment 16:**  
Laundry closet located within upstairs hallway closet.  
- No indications of water damage or leaking at the time of inspection.

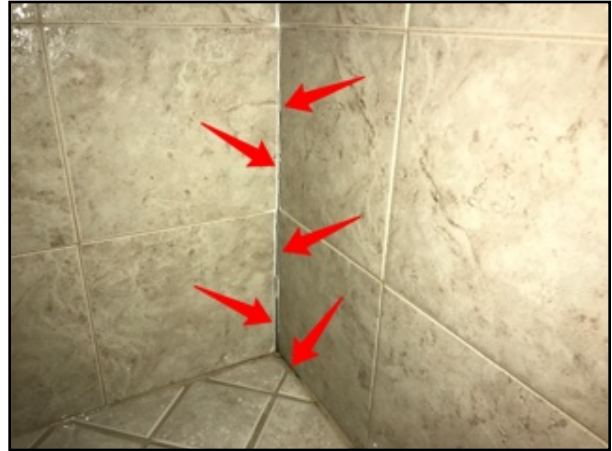
Figure 24-2

Shower walls have missing or loose grout.

- No indications of moisture intrusion or water damage to interior walls around shower.

Recommend re-grouting/caulking shower tiles to prevent possible moisture intrusion into wall. (Estimate: \$100 - \$200)

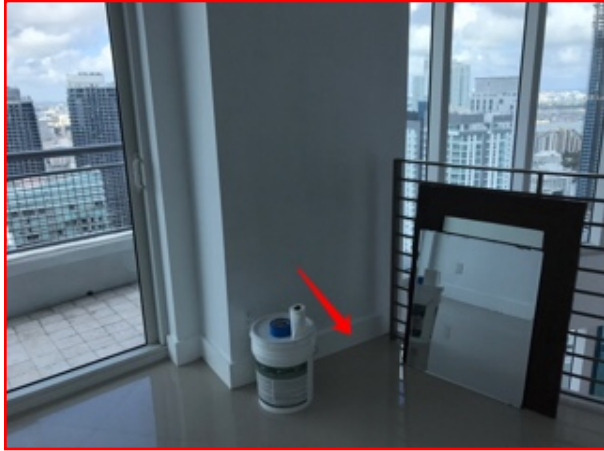
Figure 13-7

5) Comment 13: Apparent water staining to soffit around A/C duct over kitchen.

- When checking area using thermal imaging equipment & moisture meters, moisture intrusion/water damage detected along surrounding kitchen wall and base of wall in upstairs bedroom directly above kitchen.

- Indications of current moisture intrusion & water damage to the interior at the time of inspection (base of upstairs bedroom wall adjacent to balcony and downstairs kitchen wall and soffit around A/C duct).

- Estimate moisture intrusion source to be coming from balcony joint for upstairs second bedroom where balcony Slab meets exterior wall.

Report moisture intrusion/ water damage to building to be further investigated by building engineer and repaired accordingly. (Estimate: Detailed quotation required)

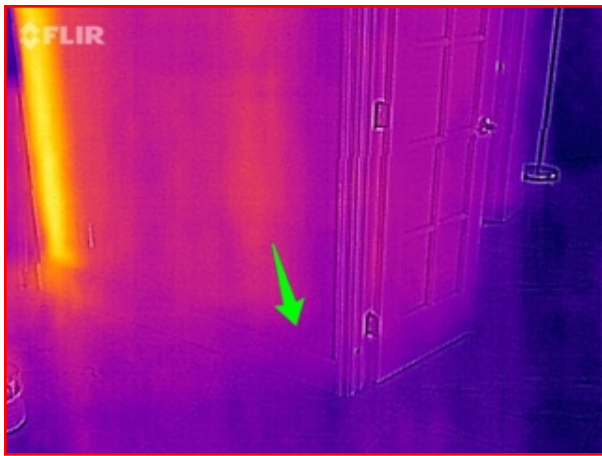
Figure 24-3

8) Comment 24: Shower walls have missing or loose grout.

- No indications of moisture intrusion or water damage to interior walls around shower.

Recommend re-grouting/caulking shower tiles to prevent possible moisture intrusion into wall. (Estimate: \$100 - \$200)

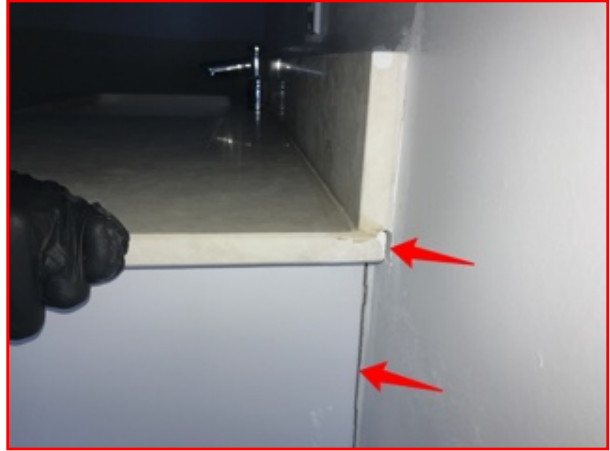
Figure 30-2

11) Comment 30: Vanity & countertop are loose and grouting/seal along back wall is deteriorated.

Recommend re/sealing vanity countertop in place. (Estimate: \$50 - \$150)
